Post Installation Report

Charlton Parish Council - Toddlers Play Area

Nailstone Road, Carlton, Nr Market Bosworth, Leicestershire,
CV13 0DH

Post Installation Report - 13 July 2015 at 16:58 Inspector: Kevin Joyce RPII Annual Inspector

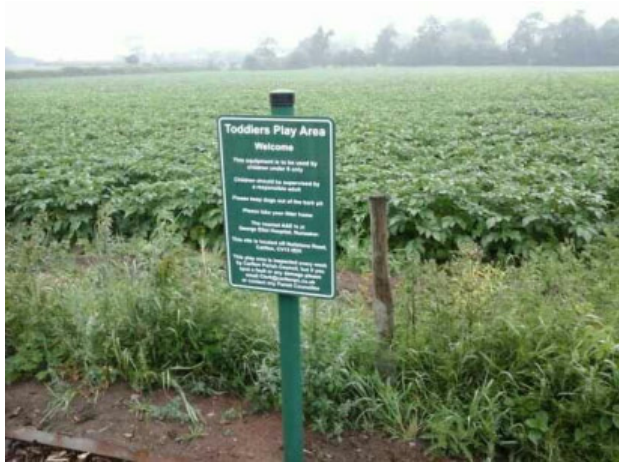
Item: Ancillary Items - Sign
Manufacturer: Not Identified
Surface Type: N/A
Equipment Compliance: N/A
Surface Area Compliance: N/A
Ref/Part Number:
Total Findings: 1

This item is satisfactory - no work required

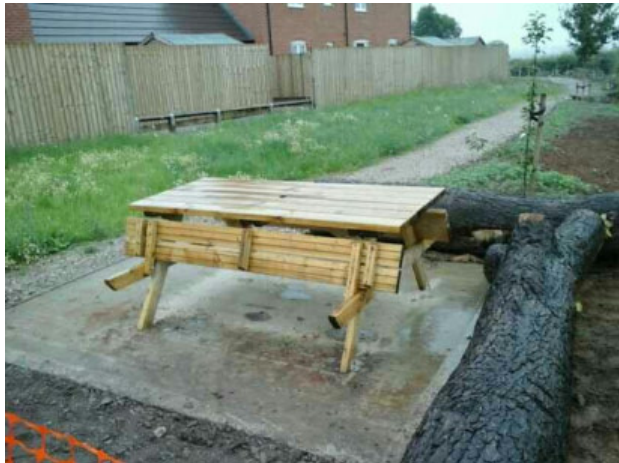
Item: Ancillary Items - Picnic Table
Manufacturer: Not Identified
Surface Type: N/A
Equipment Compliance: N/A
Surface Area Compliance: N/A
Ref/Part Number:
Total Findings: 1

There are potential crush points due to the fact the seat sections of this item are liftable - Consider securing the seat slats to the framework to prevent them being lifted

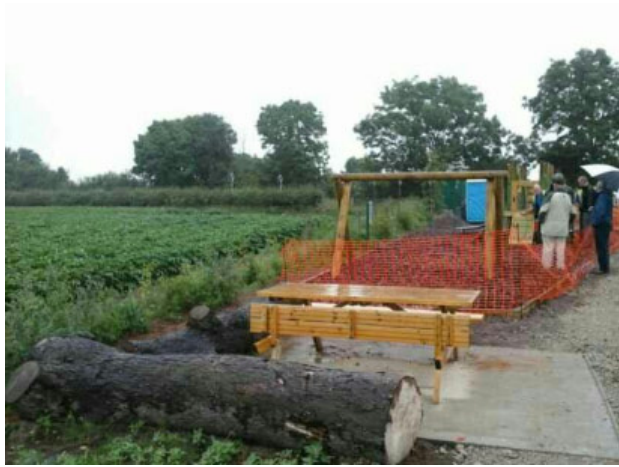
Item: Ancillary Items - Site General
Manufacturer: Not Applicable
Surface Type: All Weather Surface
Equipment Compliance: N/A
Surface Area Compliance: N/A
Ref/Part Number:
Total Findings: 2

At the time of the inspection temporary fencing including road pins were delineating the play area - Ensure the road pins and fencing are removed before allowing public access

There are trip hazards at the edges of the impact absorbing surface - Reinststate surrounding surface levels to remove the trip points

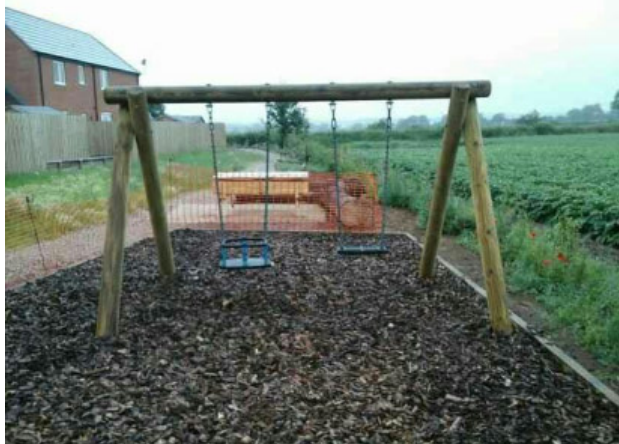
Item: Swings - 1 Bay Mixed Seat, 1 Cradle, 1 Flat
Manufacturer: Wicksteed Playscapes
Surface Type: Bark Mulch
Equipment Compliance: Yes
Surface Area Compliance: Yes
Ref/Part Number:
Total Findings: 2

The use of mixed seats in one bay is not generally recommended but in some circumstances can be justified using risk assessment considering the type and number of users anticipated in the area - Ensure a suitable and sufficient risk assessment has been undertaken

The swing seats do not sit in a straight line underneath the top bar. The cradle seat is angled inwards - Although the required spaces between the seats and the seats to frame are maintained through out the arc of swing it is felt the issue should be addressed. Refer to manufacturer

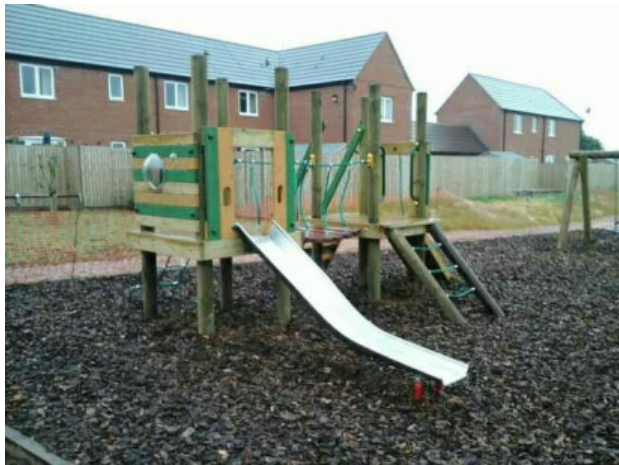
Item: Activity Equipment - Multi Play (Junior)
Manufacturer: Wicksteed Playscapes
Surface Type: Bark Mulch
Equipment Compliance: No
Surface Area Compliance: Yes
Ref/Part Number:
Total Findings: 3

The item has a potential head and neck entrapment in the top spacing of the climbing net. The height of the lower edge of the top rope is 600mm but when the bark settles the entrapment will be above that height - Remove the entrapment

There are finger entrapments in the shackles of the rope bridge and the item fails to meet the requirements of BS EN 1176:2008 Part 1 4.2.7.6 Entrapment of fingers - Remove the entrapments

There is a potential finger entrapment at the top of the angled climber. Although the entrapment sits below the height of 1m it may well pose an issue given the angled climber may in some instances require use of the hands to negotiate - Consider removing this potential point of entrapment

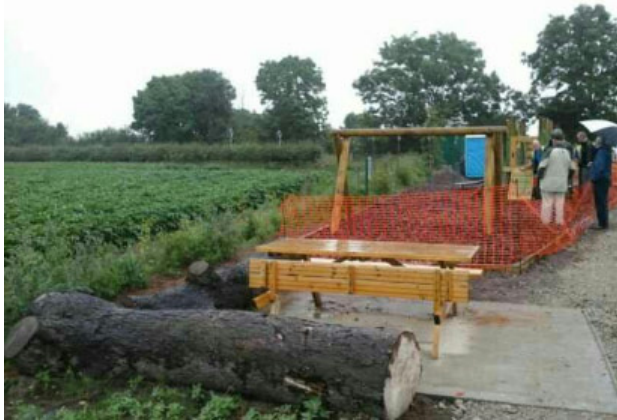
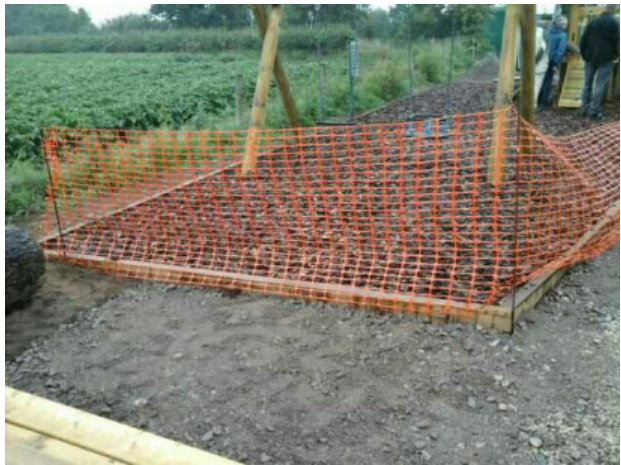
! 12 - Moderate Risk (Finding 1)			
Item:	Ancillary Items - Site General	Risk Level:	M - Moderate Risk
Manufacturer:	Not Applicable	Surface:	All Weather Surface

Finding:	At the time of the inspection temporary fencing including road pins were delineating the play area	Action:	Ensure the road pins and fencing are removed before allowing public access

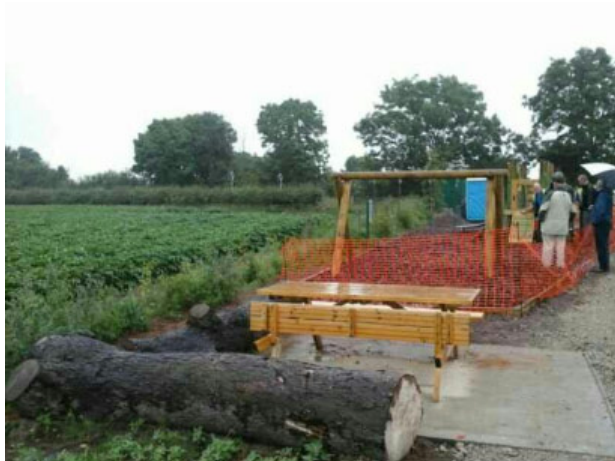
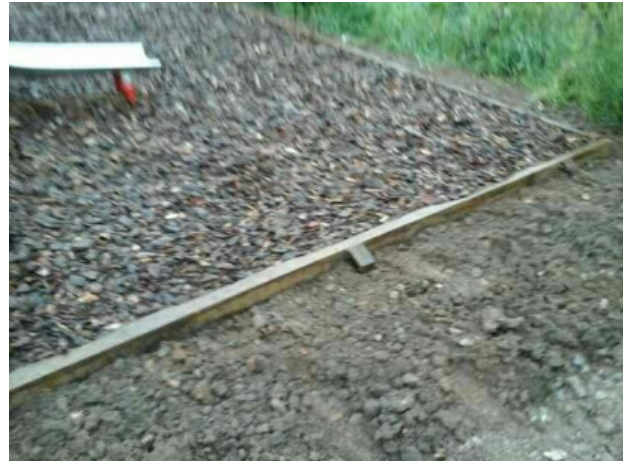
8 - Low Risk (Finding 2)

Finding: There are trip hazards at the edges of the impact absorbing surface

Action: Reinstate surrounding surface levels to remove the trip points

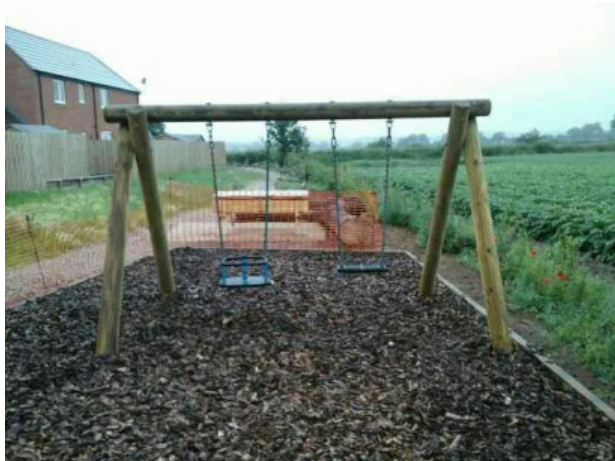
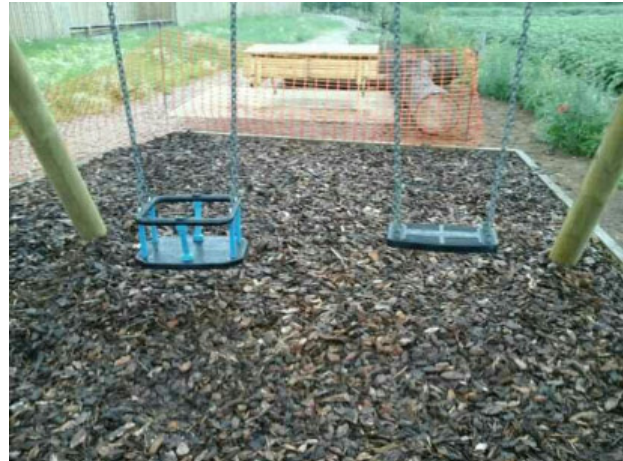
0 - Risk Assessment not Undertaken (Finding 1)

Finding: The use of mixed seats in one bay is not generally recommended but in some circumstances can be justified using risk assessment considering the type and number of users anticipated in the area

Action: Ensure a suitable and sufficient risk assessment has been undertaken

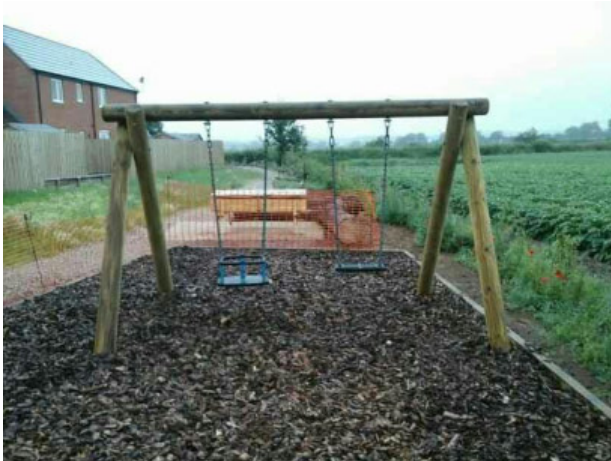
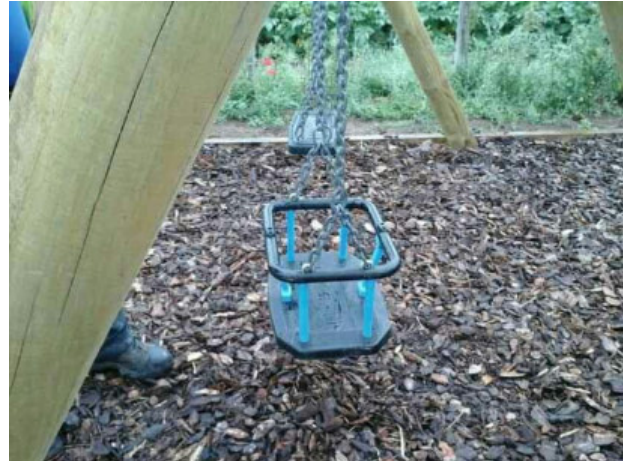
6 - Low Risk (Finding 2)

Finding: The swing seats do not sit in a straight line underneath the top bar. The cradle seat is angled inwards
Action: Although the required spaces between the seats and the seats to frame are maintained through out the arc of swing it is felt the issue should be addressed. Refer to manufacturer

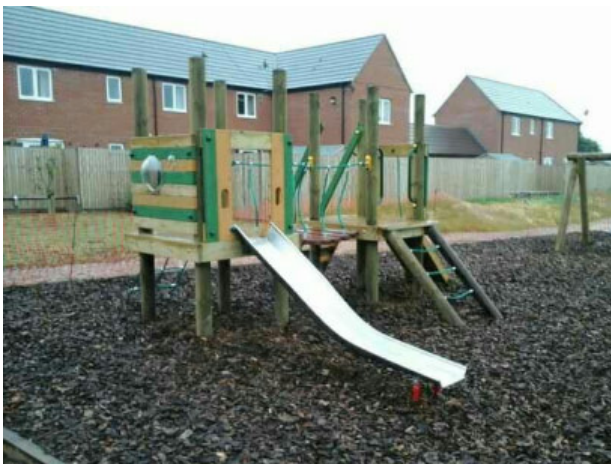
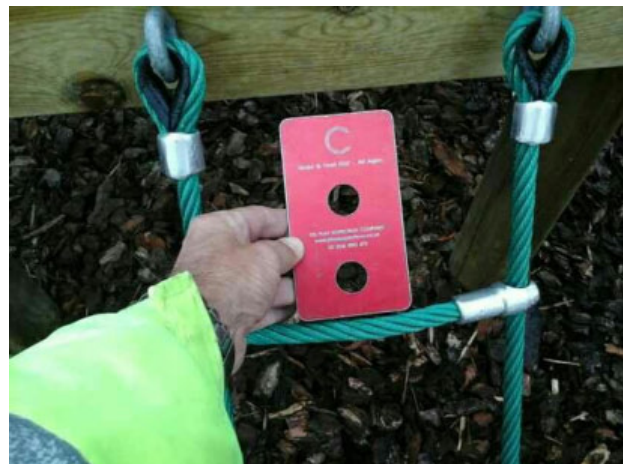
5 - Very Low Risk (Finding 1)

Finding: The item has a potential head and neck entrapment in the top spacing of the climbing net. The height of the lower edge of the top rope is 600mm but when the bark settles the entrapment will be above that height
Action: Remove the entrapment

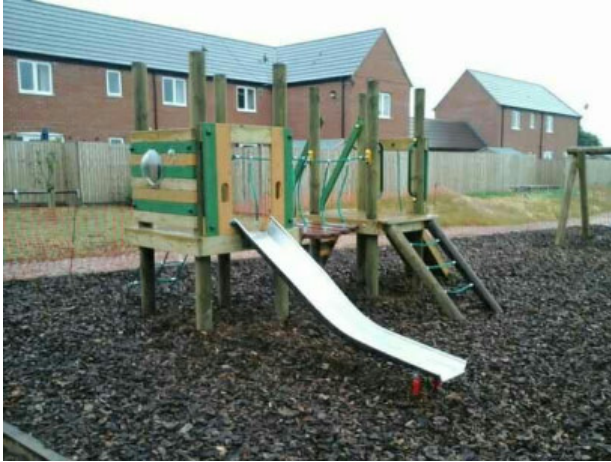
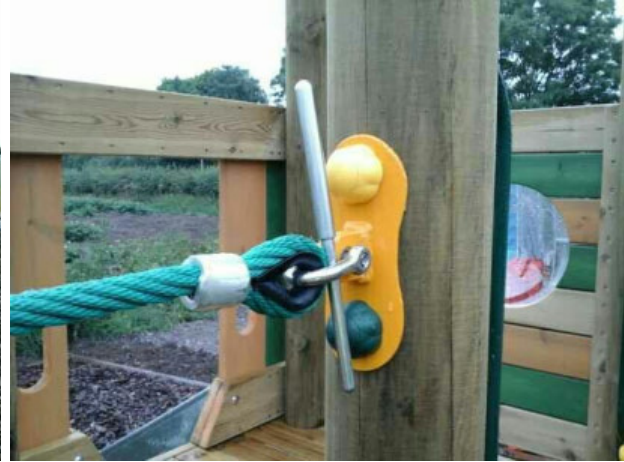
5 - Very Low Risk (Finding 2)

Finding: There are finger entrapments in the shackles of the rope bridge and the item fails to meet the requirements of BS EN 1176:2008 Part 1 4.2.7.6 Entrapment of fingers

Action: Remove the entrapments

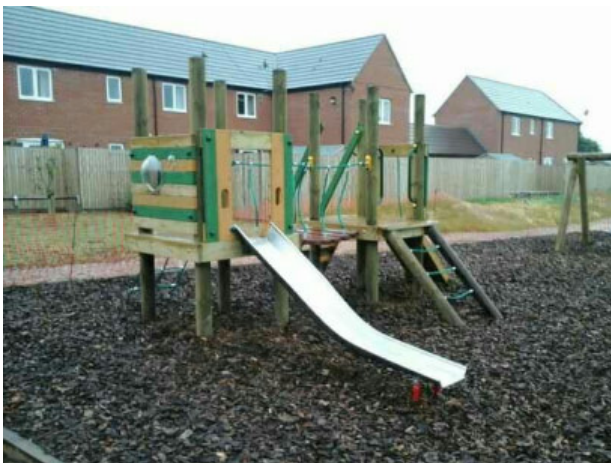
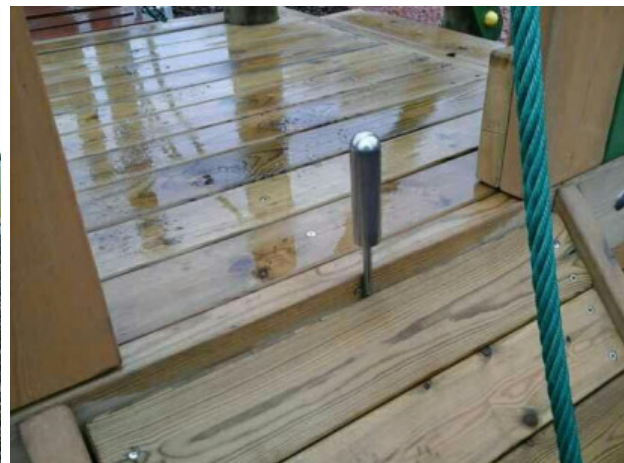
5 - Very Low Risk (Finding 3)

Finding: There is a potential finger entrapment at the top of the angled climber. Although the entrapment sits below the height of 1m it may well pose an issue given the angled climber may in some instances require use of the hands to negotiate

Action: Consider removing this potential point of entrapment
