## Annual Inspection

Carlton Parish Council

Toddlers Play Area

Carlton Diamond Jubilee Orchard, Nailstone Road,  
Carlton, Nuneaton , CV13 0BN

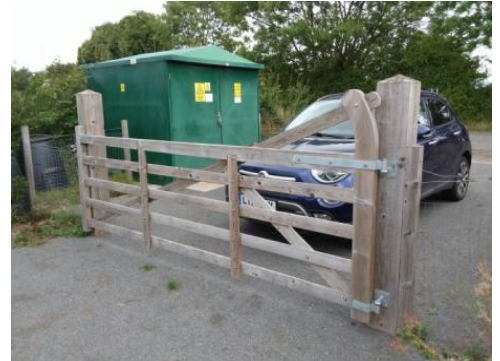
**Item:** Gate - Maintenance  
**Manufacturer:** Not Identified  
**Surface Type:** Gravel  
**Equipment Compliance:** N/A  
**Surface Area Compliance:** N/A

There are projecting bolt thread(s) present - Remove excess thread length and deburr or provide cap

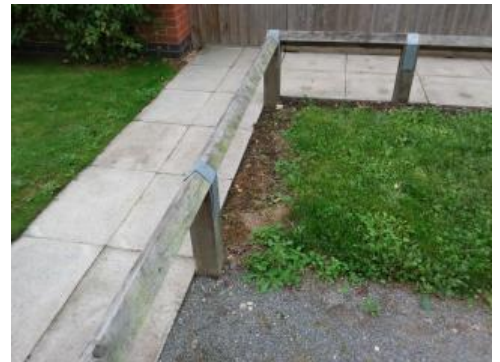
**Item:** Fencing - Post & Rail  
**Manufacturer:** Not Applicable  
**Surface Type:** Grass  
**Equipment Compliance:** N/A  
**Surface Area Compliance:** N/A

This item is satisfactory - no work required

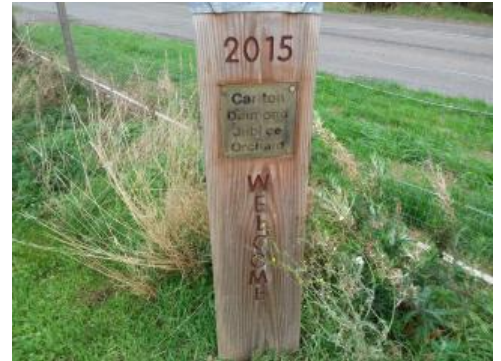
**Item:** Sign  
**Manufacturer:** Not Identified  
**Surface Type:** Grass  
**Equipment Compliance:** N/A  
**Surface Area Compliance:** N/A

This item is satisfactory - no work required

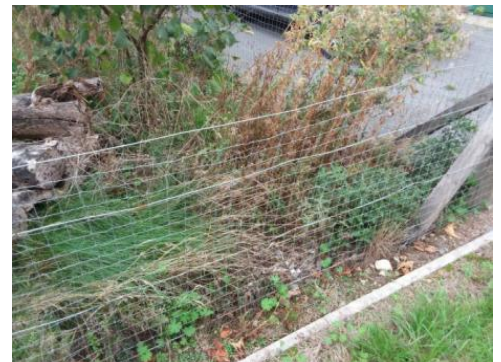
**Item:** Fence - Timber & Mesh Infill  
**Manufacturer:** Not Identified  
**Surface Type:** N/A  
**Equipment Compliance:** N/A  
**Surface Area Compliance:** N/A

The fence is damaged in places - Repair or replace all affected sections

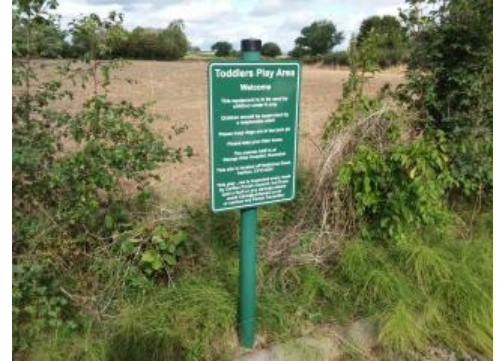
**Item:** Sign  
**Manufacturer:** Not Applicable  
**Surface Type:** Grass  
**Equipment Compliance:** N/A  
**Surface Area Compliance:** N/A

This item is satisfactory - no work required

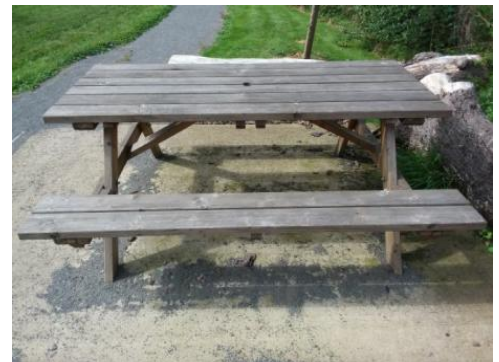
**Item:** Picnic Table  
**Manufacturer:** Not Identified  
**Surface Type:** Concrete  
**Equipment Compliance:** N/A  
**Surface Area Compliance:** N/A

A number of fixing(s) have worked loose - Secure all loose fixings

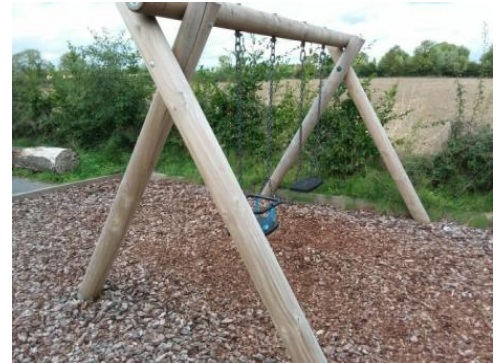
**Item:** 1 Bay Mixed Seat, 1 Cradle, 1 Flat  
**Manufacturer:** Wicksteed Playgrounds  
**Surface Type:** Bark Mulch  
**Equipment Compliance:** Yes  
**Surface Area Compliance:** Yes

The swing seat frames are corroding - Monitor for any further deterioration and replace as required

The timber has a number of splits/shakes or air cracks and this may affect the stability or allow water ingress which will accelerate the rotting process - Monitor to ensure the splits do not cross through fixing points of the structure and/or cause any instability

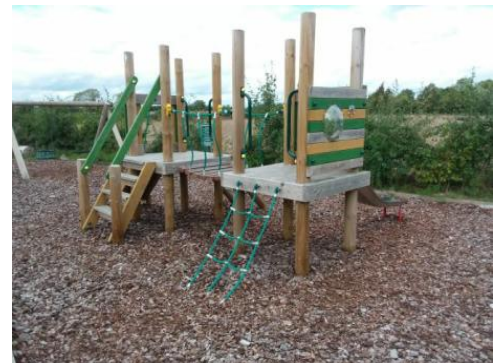
**Item:** Multi Play (Junior)  
**Manufacturer:** Wicksteed Playgrounds  
**Surface Type:** Bark Mulch  
**Equipment Compliance:** No  
**Surface Area Compliance:** Yes

The timber has a number of splits/shakes or air cracks and this may affect the stability or allow water ingress which will accelerate the rotting process - Monitor to ensure the splits do not cross through fixing points of the structure and/or cause any instability

The raised timber edge forms a hard object within the falling space of the equipment in contravention of the requirements of BS EN 1176 Part 1 - Monitor use

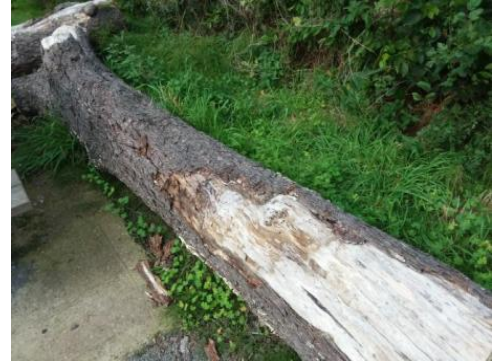
**Item:** Log Seating  
**Manufacturer:** Natural Feature  
**Surface Type:** Grass  
**Equipment Compliance:** N/A  
**Surface Area Compliance:** N/A

Fungus or algae was found on the equipment - Remove fungi or algae from the equipment

Parts of the timber are rough or splintered - Remove all rough or sharp edges

There is some evidence of rot in the timber - Monitor for any further deterioration and replace as required

The bark is flaking off the item - Remove the loose bark and maintain

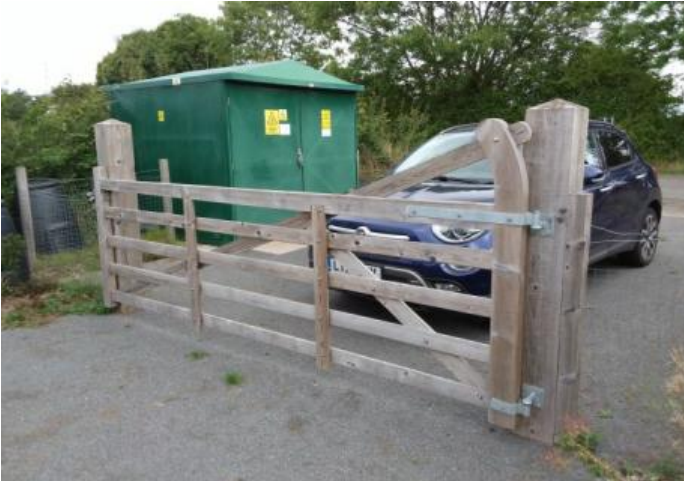
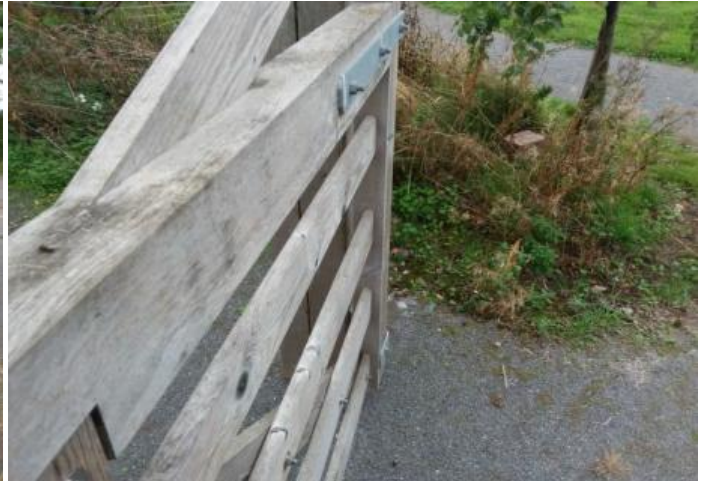
**Item:** Ancillary Items - Gate - Maintenance  
**Manufacturer:** Not Identified

**Finding:** There are projecting bolt thread(s) present

**Action:** Remove excess thread length and deburr or provide cap

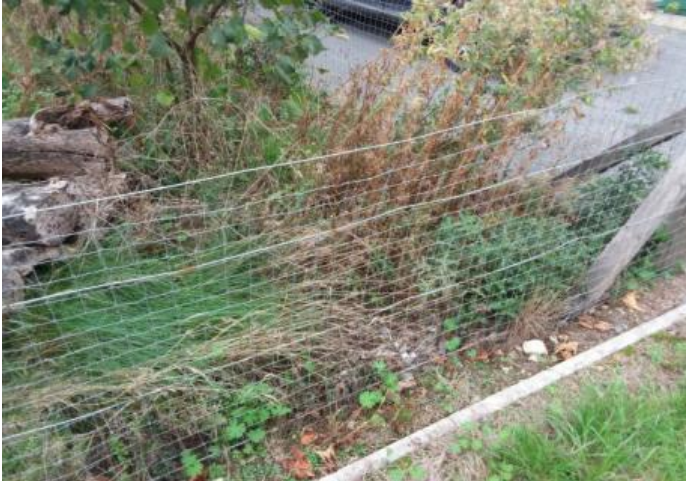
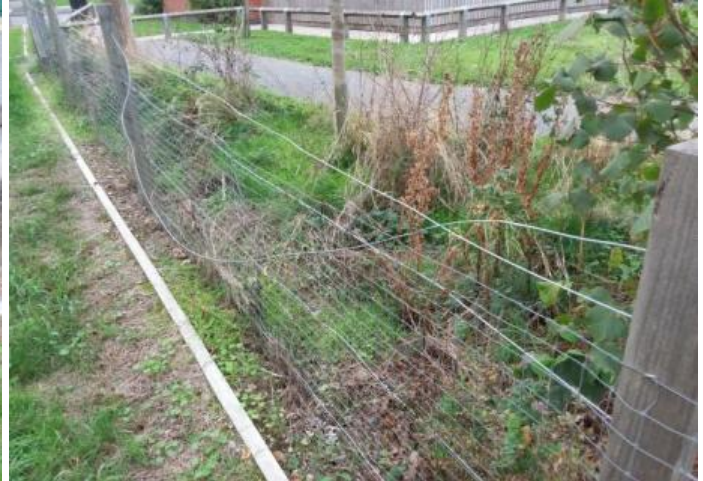
**Item:** Ancillary Items - Fence - Timber & Mesh Infill **Risk Level:** L - Low Risk  
**Manufacturer:** Not Identified **Surface:** N/A

**Finding:** The fence is damaged in places

**Action:** Repair or replace all affected sections

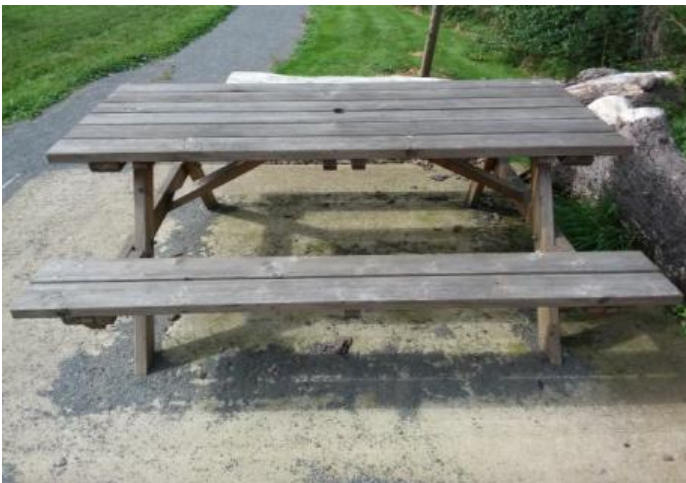
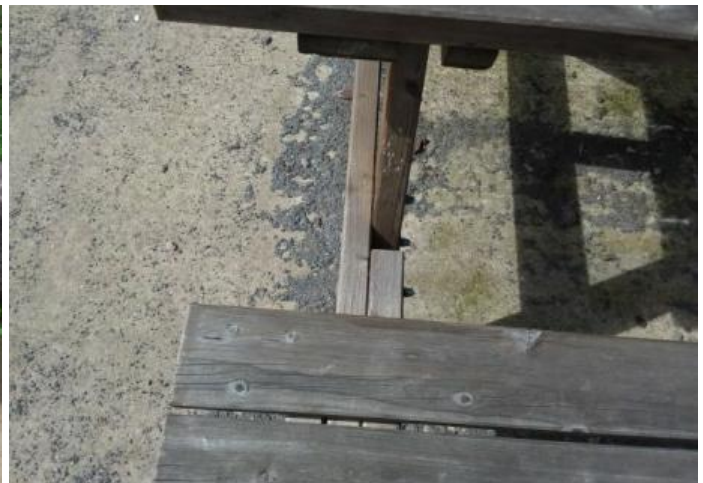
**Item:** Ancillary Items - Picnic Table **Risk Level:** L - Low Risk  
**Manufacturer:** Not Identified **Surface:** Concrete

**Finding:** A number of fixing(s) have worked loose

**Action:** Secure all loose fixings

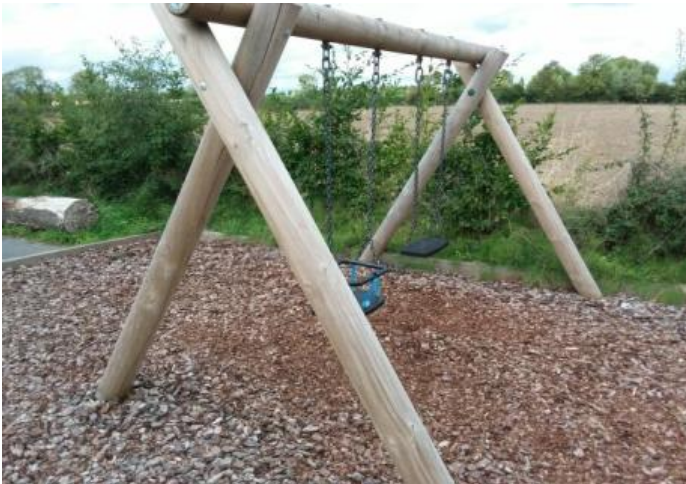
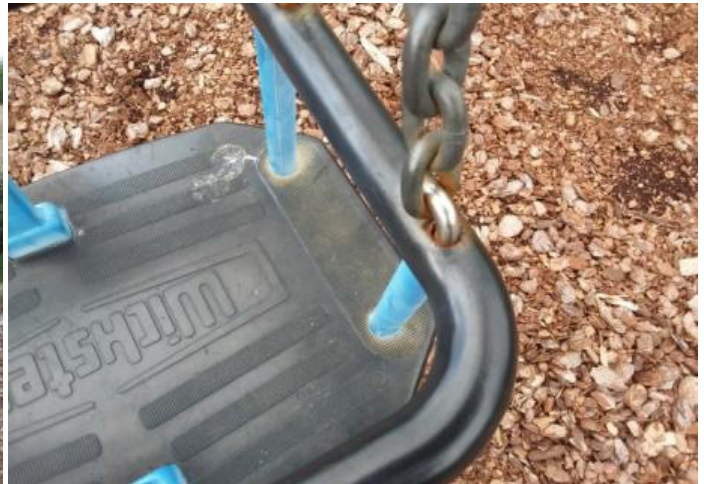
**Item:** Swings - 1 Bay Mixed Seat, 1 Cradle, 1 Flat **Risk Level:** L - Low Risk  
**Manufacturer:** Wicksteed Playgrounds **Surface:** Bark Mulch

**Finding:** The swing seat frames are corroding

**Action:** Monitor for any further deterioration and replace as required

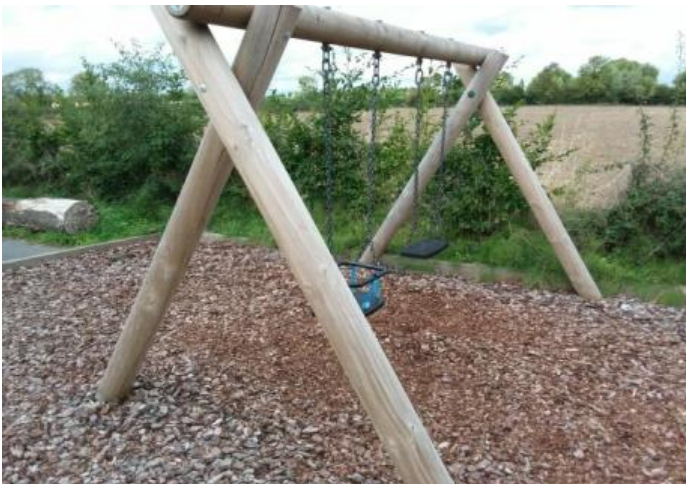
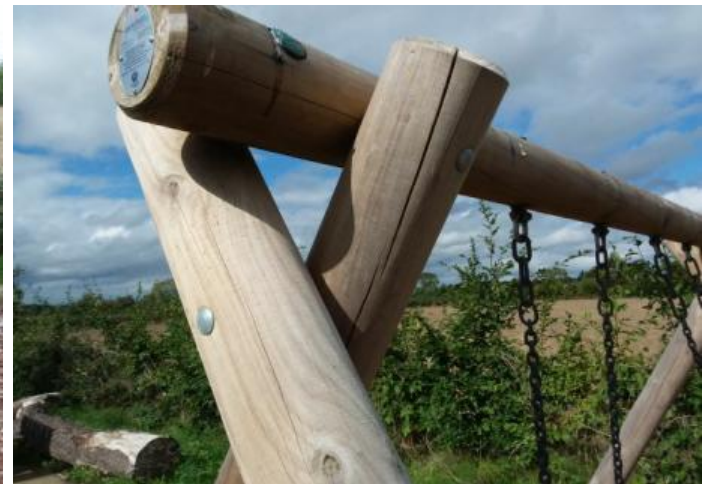
**Item:** Swings - 1 Bay Mixed Seat, 1 Cradle, 1 Flat **Risk Level:** L - Low Risk  
**Manufacturer:** Wicksteed Playgrounds **Surface:** Bark Mulch

**Finding:** The timber has a number of splits/shakes or air cracks and this may affect the stability or allow water ingress which will accelerate the rotting process

**Action:** Monitor to ensure the splits do not cross through fixing points of the structure and/or cause any instability

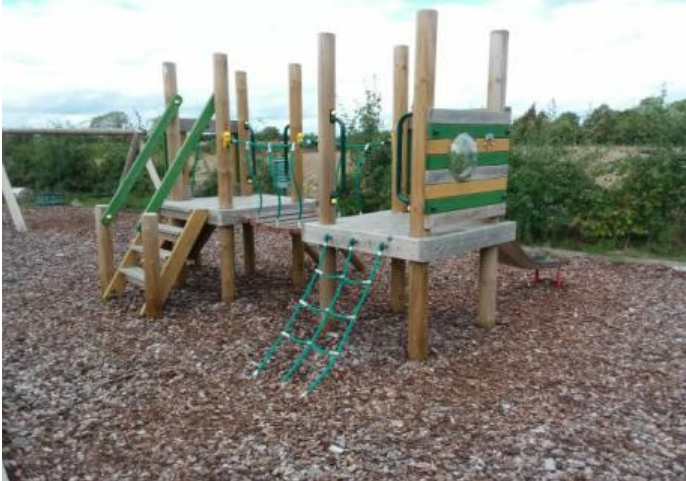
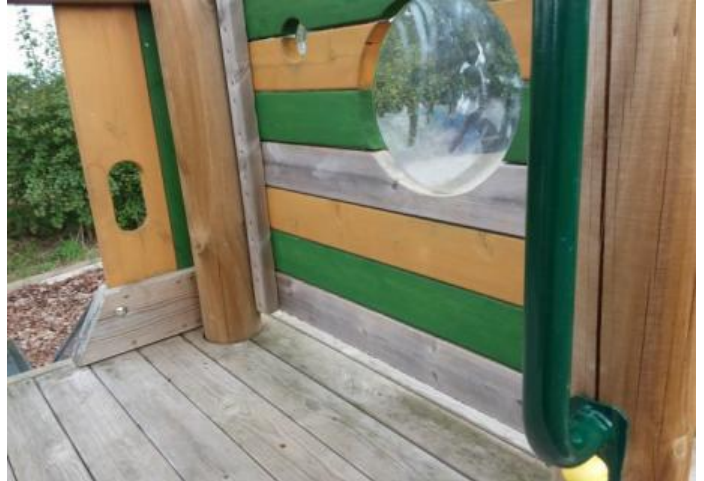
**Item:** Activity Equipment - Multi Play (Junior)  
**Manufacturer:** Wicksteed Playgrounds

**Finding:** The timber has a number of splits/shakes or air cracks and this may affect the stability or allow water ingress which will accelerate the rotting process

**Action:** Monitor to ensure the splits do not cross through fixing points of the structure and/or cause any instability

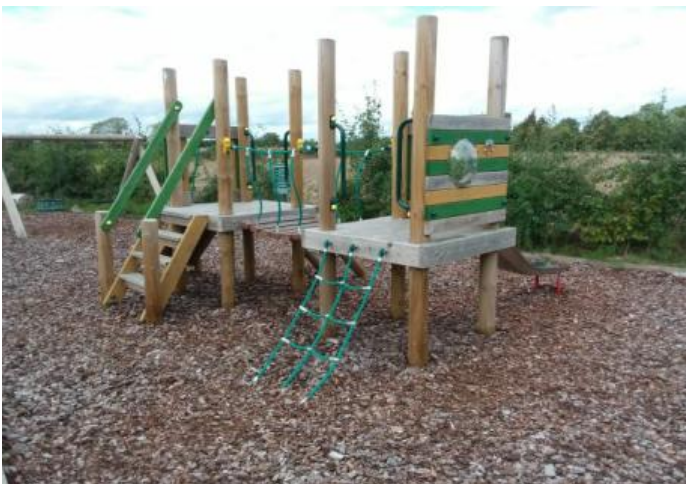
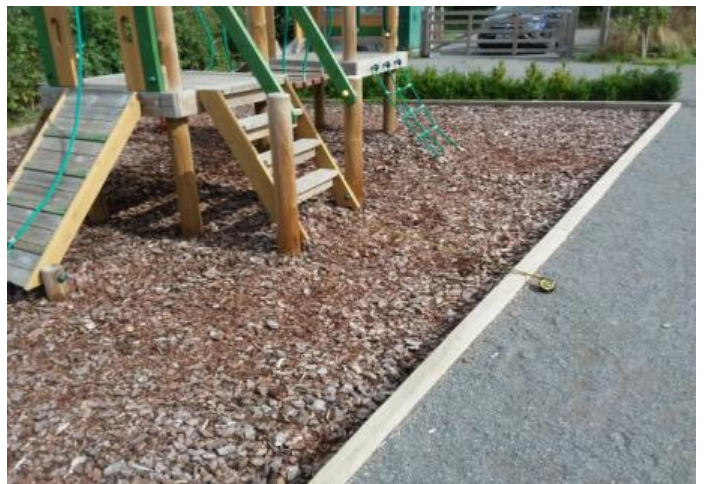
**Item:** Activity Equipment - Multi Play (Junior)  
**Manufacturer:** Wicksteed Playgrounds

**Finding:** The raised timber edge forms a hard object within the falling space of the equipment in contravention of the requirements of BS EN 1176 Part 1

**Action:** Monitor use

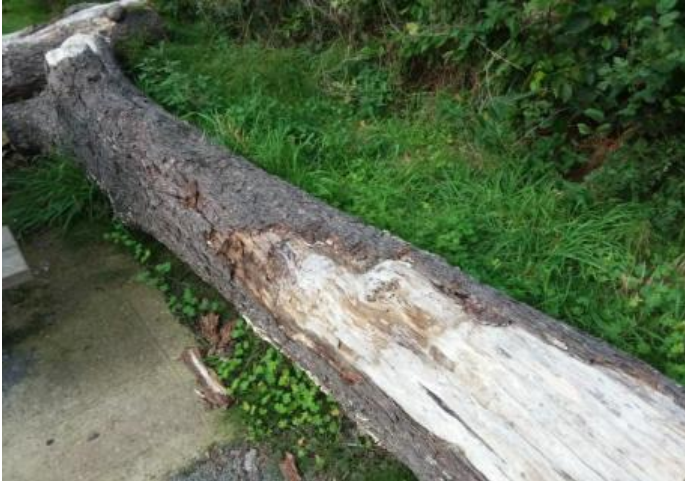
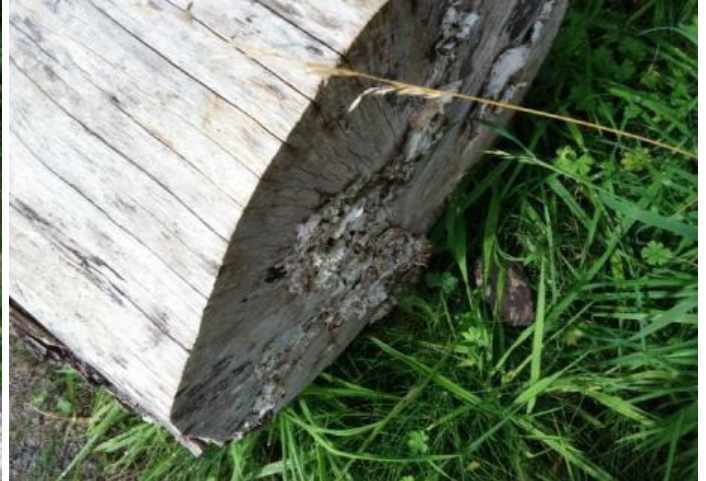
**Item:** Ancillary Items - Log Seating

**Finding:** Fungus or algae was found on the equipment

**Action:** Remove fungi or algae from the equipment

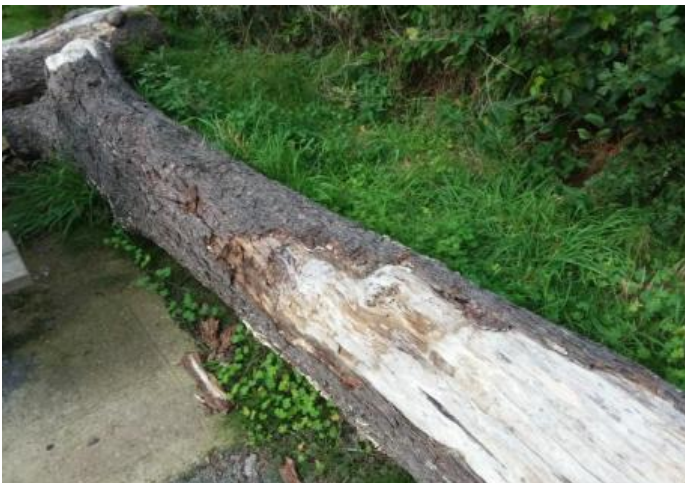
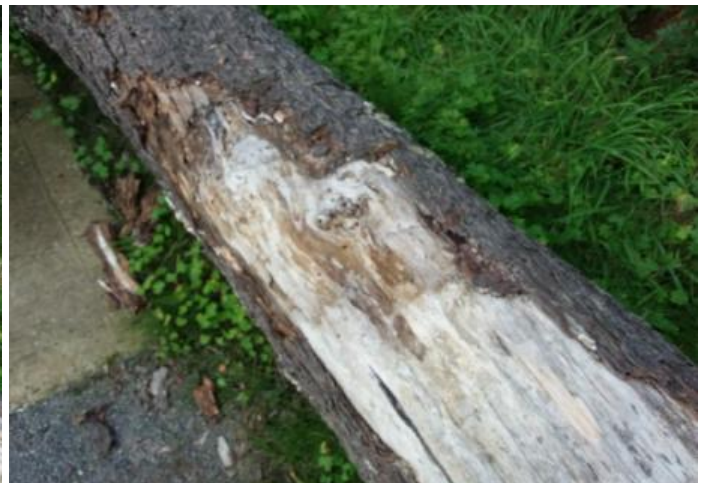
**Item:** Ancillary Items - Log Seating

**Finding:** Parts of the timber are rough or splintered

**Action:** Remove all rough or sharp edges

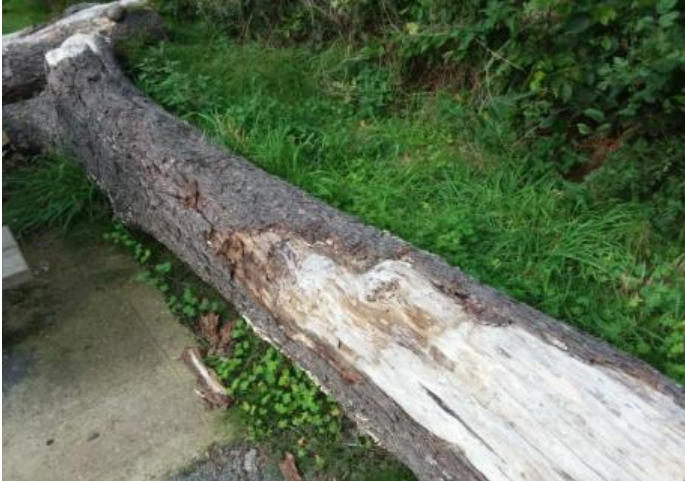
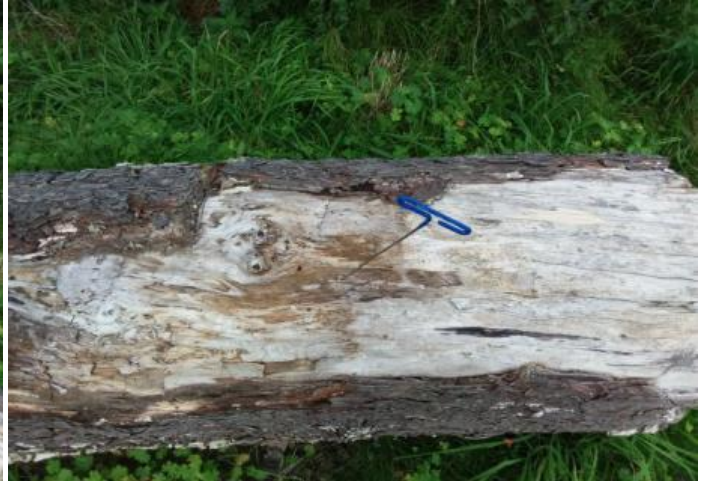
**Item:** Ancillary Items - Log Seating

**Finding:** There is some evidence of rot in the timber

**Action:** Monitor for any further deterioration and replace as required

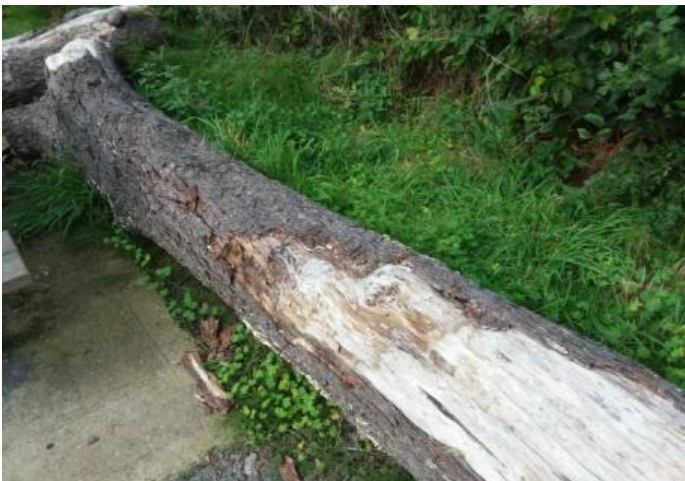
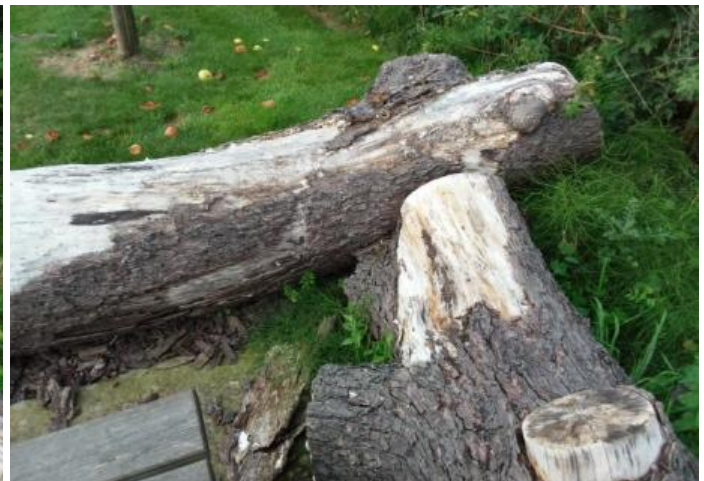
**Item:** Ancillary Items - Log Seating

**Finding:** The bark is flaking off the item

**Action:** Remove the loose bark and maintain
