Survey of horse chestnut tree in churchyard

Date: 05 August 2014

Subject: Horse Chestnut in Churchyard

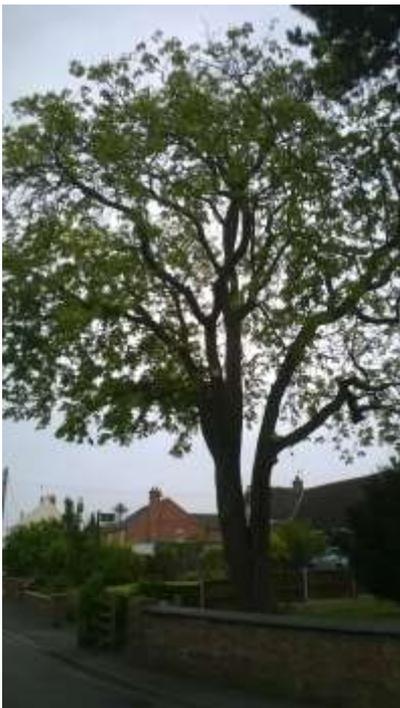
The foliage is small in size and its density becoming noticeably sparse, with some upper branch ends/twigs with no leaves whatsoever. I am unable to say whether these have actually died back or just lost the leaves. There is a low infestation of chestnut leaf-miner (*Cameraria ohridella*), but rather less than on many other chestnuts I have seen.

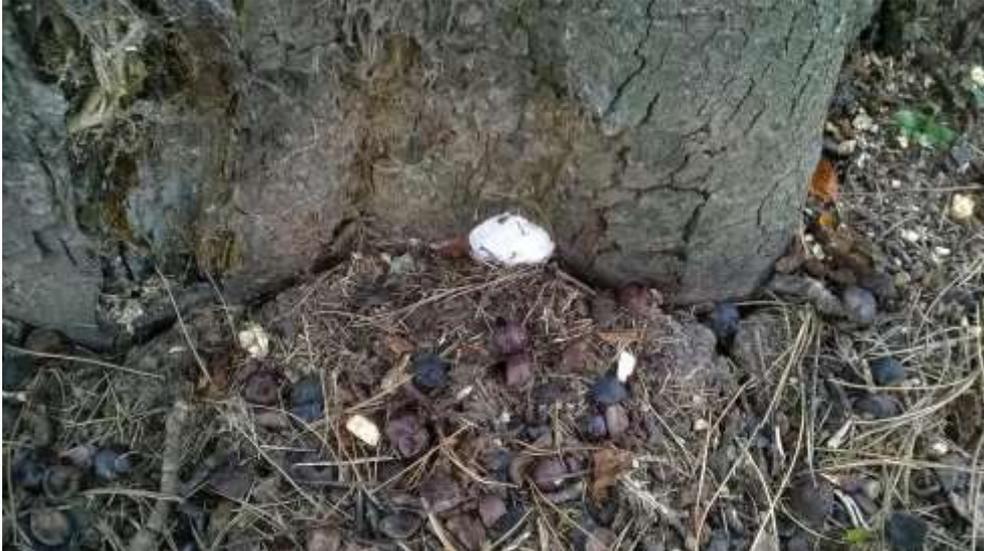
More importantly, there is a new appearance of a fruiting body of *Ganoderma* spp fungus at the base.

The previously identified cavity and decay do not seem significantly different to their appearance as described by Julian Simpson, but the breakout of an active fruiting body of a basal decay fungus is of concern. Its appearance suggests that the fungus has broken out from any internal chemical barriers previously laid down by the tree, and now has access to 'new' food sources in the otherwise sound wood. This fungus may also be at least partly responsible for the poor appearance and decline of the crown.

Its proximity to the road and the angle of its growth mean that the further decay activity becomes of more concern, but there would be little point in contemplating a crown reduction to lessen the 'sail' of the crown - on a declining tree this would be counter-productive. It would divert energy from roots to twig regrowth which is not wanted, and would reduce the capability to form internal chemical barriers, as well as resulting in an unattractive tree. Unfortunately, all these new factors lead me to conclude that the tree is coming to the end of its safe life and its removal should now be considered.
