Annual Inspection

Carlton Parish Council

Toddlers Play Area

Carlton Diamond Jubilee Orchard, Nailstone Road, Carlton,
Nuneaton, CV13 0BN

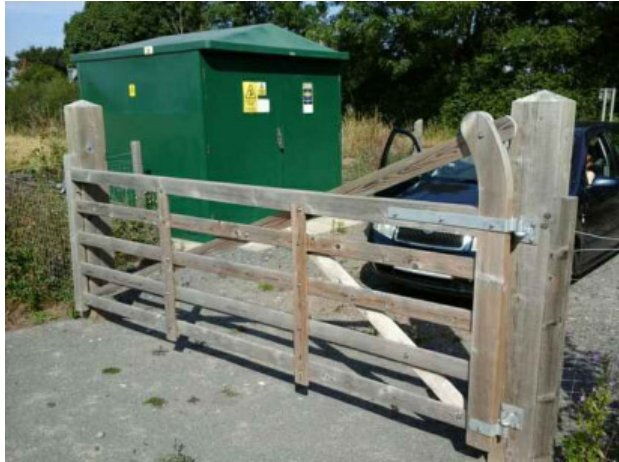
Item: Ancillary Items - Gate - Maintenance
Manufacturer: Not Identified
Surface Type: Gravel
Equipment Compliance: N/A
Surface Area Compliance: N/A
Ref/Part Number:
Total Findings: 1

There are projecting bolt thread(s) present - Remove excess thread length and deburr or provide cap

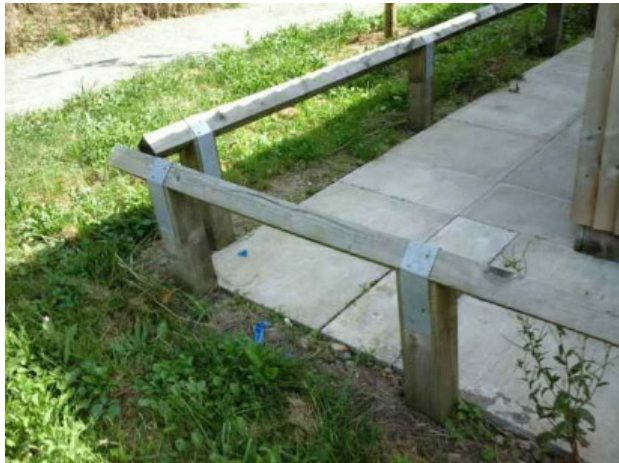
This item is satisfactory - no work required

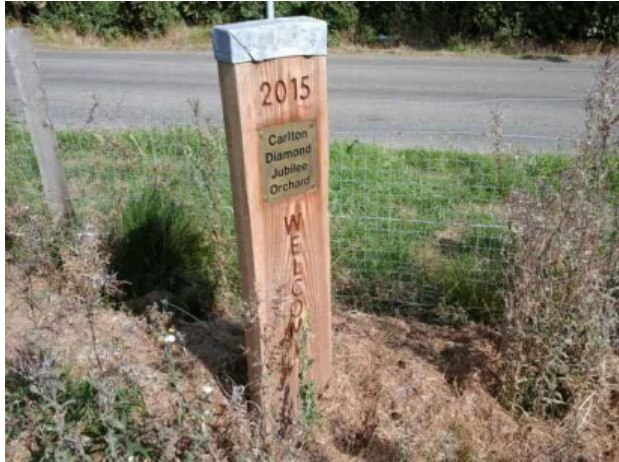
This item is satisfactory - no work required

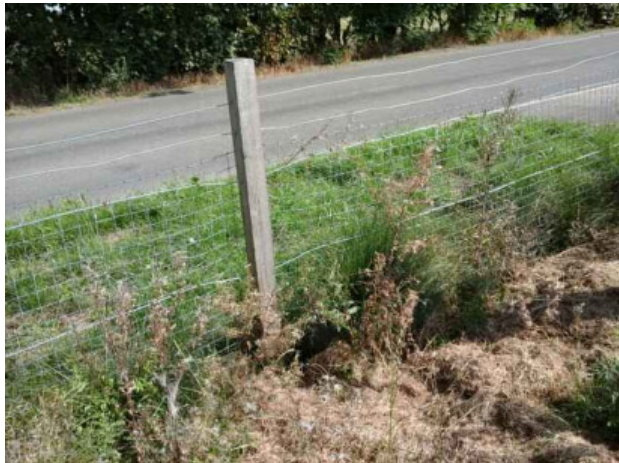
This item is satisfactory - no work required

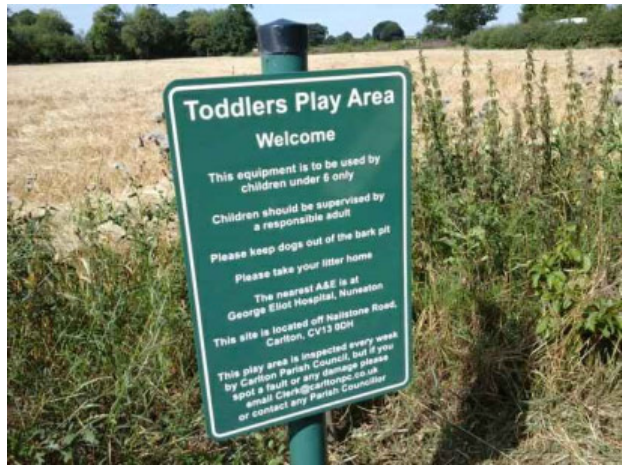
This item is satisfactory - no work required

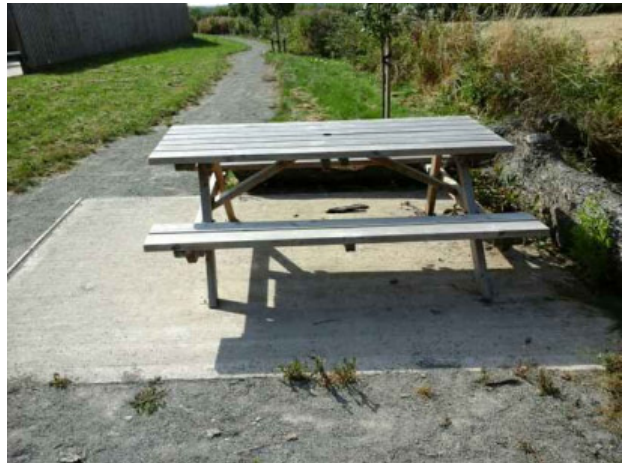
There is some minor movement within the structure - Monitor for any further deterioration and repair as required

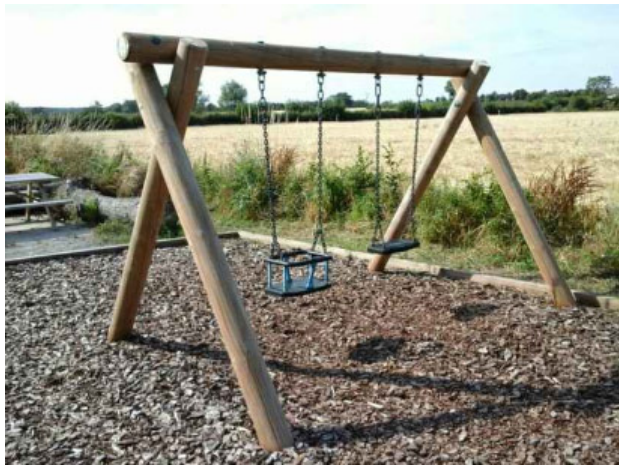
The use of mixed seats in one bay is not generally recommended but in some circumstances can be justified using risk assessment considering the type and number of users anticipated in the area - Ensure a suitable and sufficient risk assessment has been undertaken

The timber has a number of splits (shakes) although these are not considered to be a problem at present - Monitor to ensure the splits do not cross through fixing points of the structure and cause any instability

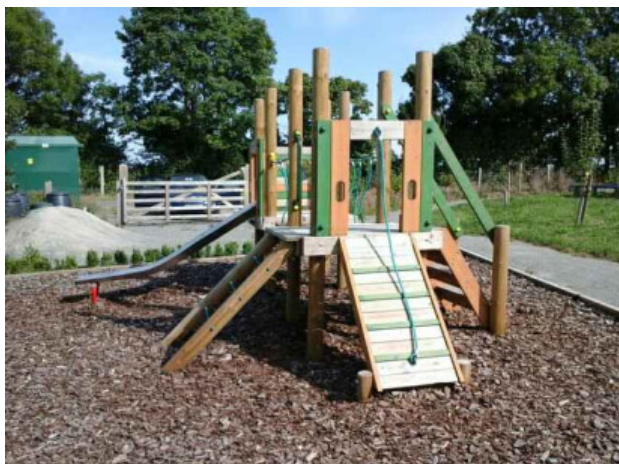
The timber edge forms a hard projecting object within the falling space of the equipment in contravention of the requirements of BS EN 1176 Part 1 - Monitor use

The timber has a number of splits (shakes) although these are not considered to be a problem at present - Monitor to ensure the splits do not cross through fixing points of the structure and cause any instability

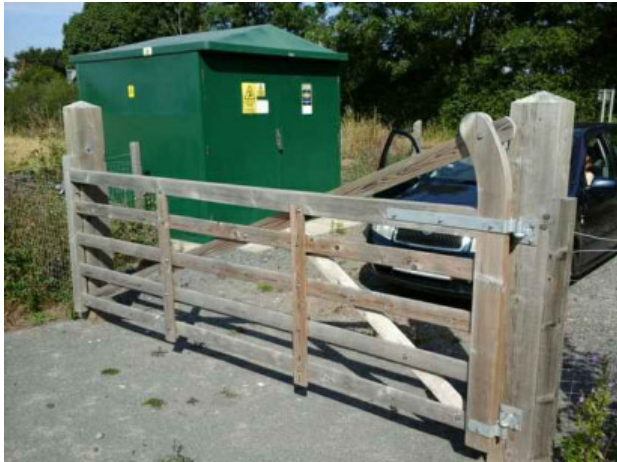
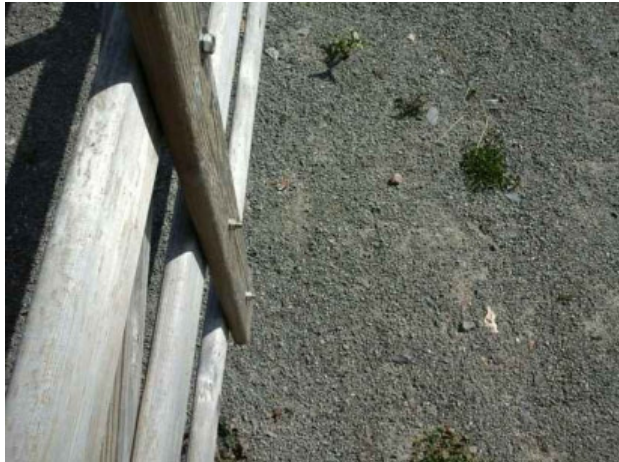
Item:	Ancillary Items - Gate - Maintenance	Risk Level:	L - Low Risk
Manufacturer:	Not Identified	Surface:	Gravel

Finding:	There are projecting bolt thread(s) present	Action:	Remove excess thread length and deburr or provide cap
-----------------	---	----------------	---

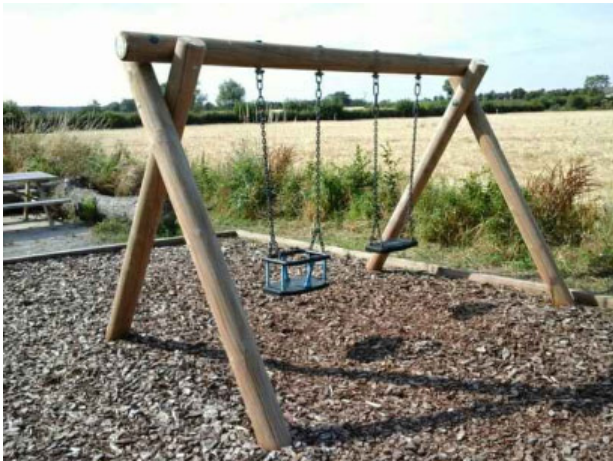
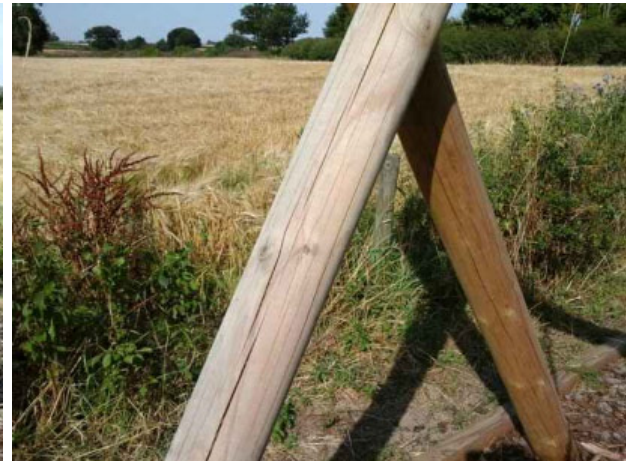
Item: Swings - 1 Bay Mixed Seat, 1 Cradle, 1 Flat **Risk Level:** L - Low Risk

Finding: The timber has a number of splits (shakes) although these are not considered to be a problem at present

Action: Monitor to ensure the splits do not cross through fixing points of the structure and cause any instability

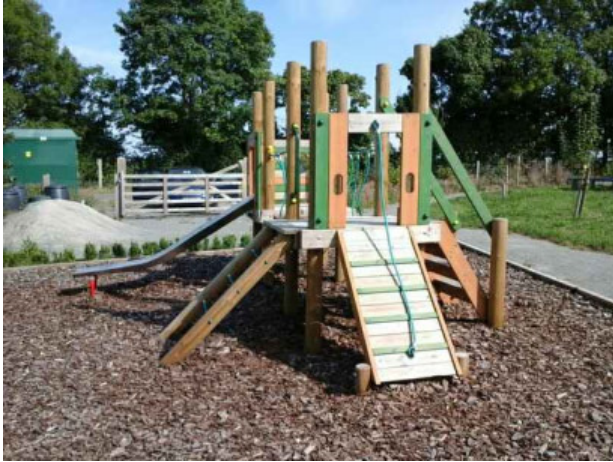
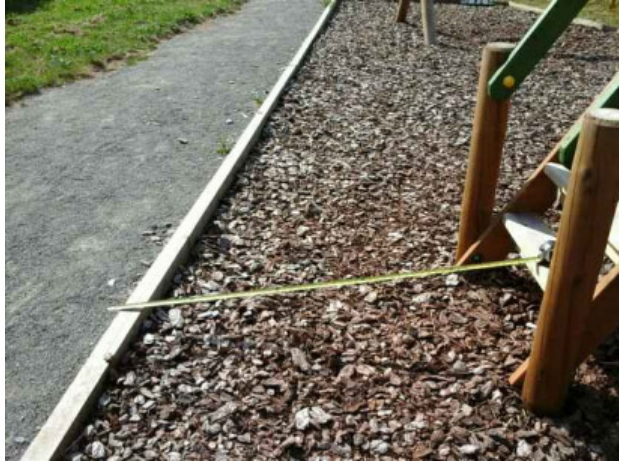
Item: Activity Equipment - Multi Play (Junior) **Risk Level:** L - Low Risk
Manufacturer: Wicksteed Playgrounds **Surface:** Bark Mulch

Finding: The timber edge forms a hard projecting object within the falling space of the equipment in contravention of the requirements of BS EN 1176 Part 1

Action: Monitor use

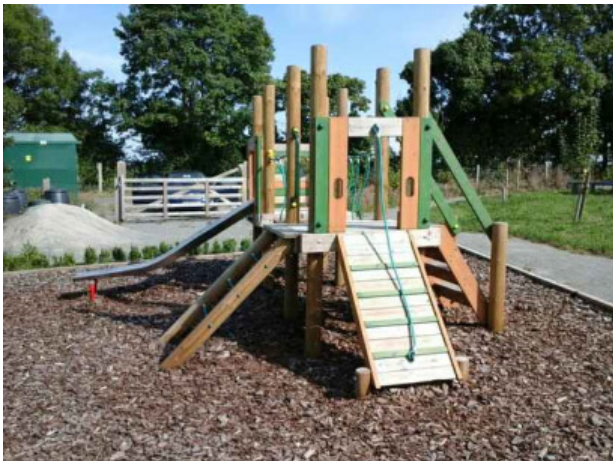
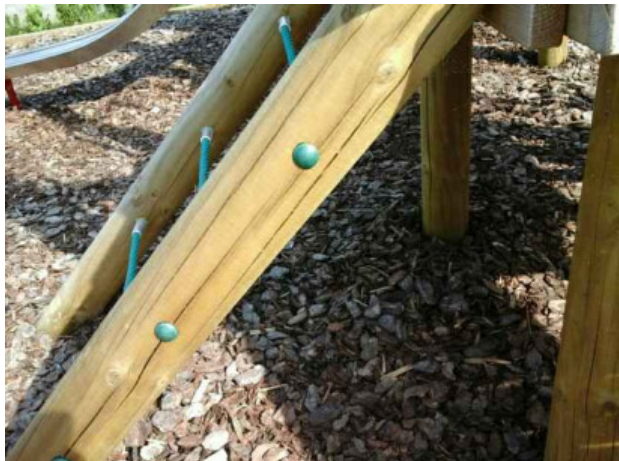
Item: Activity Equipment - Multi Play (Junior) **Risk Level:** L - Low Risk
Manufacturer: Wicksteed Playgrounds **Surface:** Bark Mulch

Finding: The timber has a number of splits (shakes) although these are not considered to be a problem at present

Action: Monitor to ensure the splits do not cross through fixing points of the structure and cause any instability
