Annual Inspection

Carlton Parish Council

Toddlers Play Area

Carlton Diamond Jubilee Orchard, Nailstone Road, Carlton,
Nuneaton, CV13 0BN

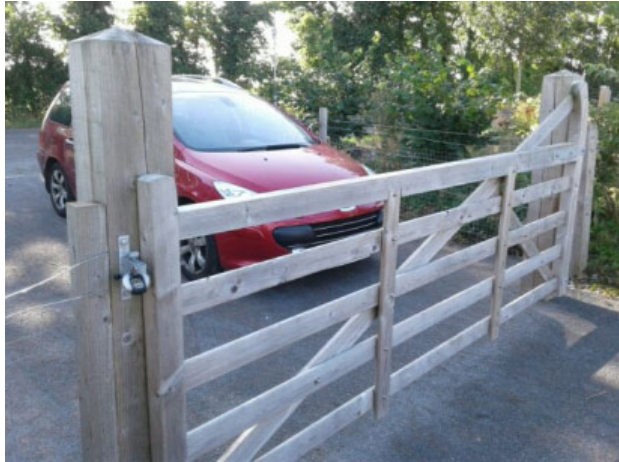
Item: Ancillary Items - Gate - Maintenance
Manufacturer: Not Identified
Surface Type: Gravel
Equipment Compliance: N/A
Surface Area Compliance: N/A
Ref/Part Number:
Total Findings: 1

There are projecting bolt thread(s) present - Remove excess thread length and deburr or provide cap

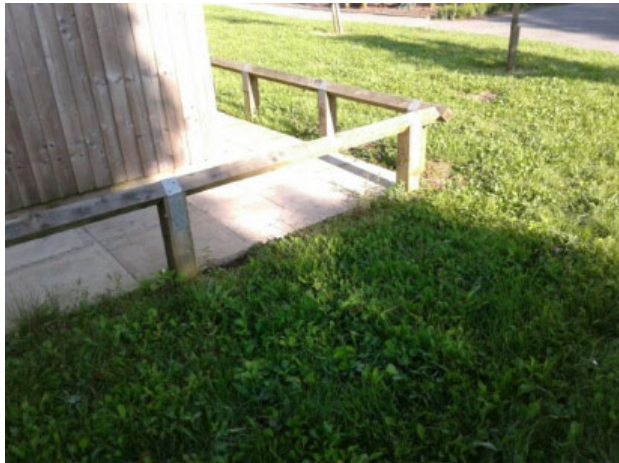
Item: Ancillary Items - Fencing - Post & Rail
Manufacturer: Not Applicable
Surface Type: Grass
Equipment Compliance: N/A
Surface Area Compliance: N/A
Ref/Part Number:
Total Findings: 1

This item is satisfactory - no work required

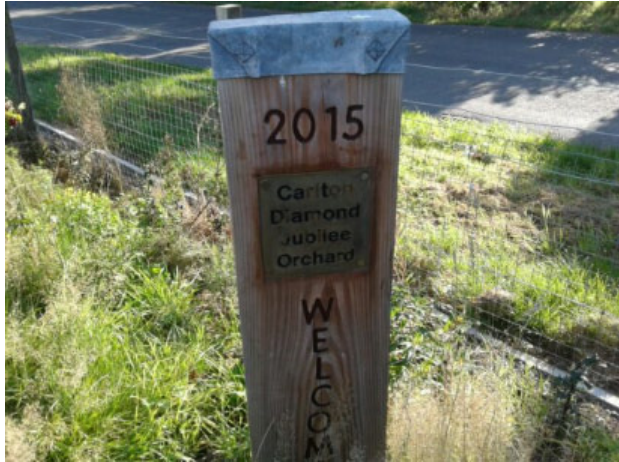
Item: Ancillary Items - Sign
Manufacturer: Not Identified
Surface Type: Grass
Equipment Compliance: N/A
Surface Area Compliance: N/A
Ref/Part Number:
Total Findings: 1

This item is satisfactory - no work required

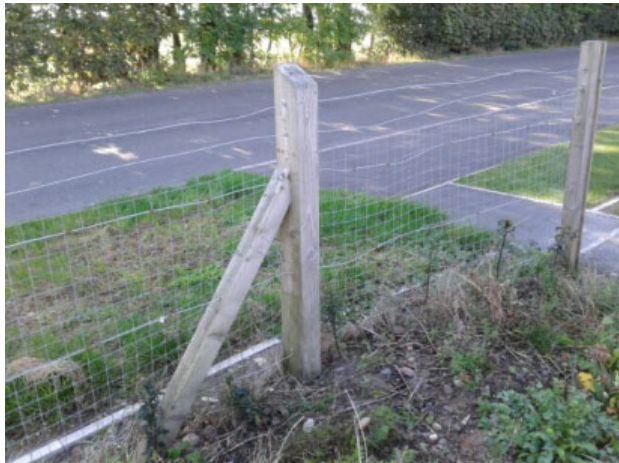
Item: Ancillary Items - Fence - Timber & Mesh Infill
Manufacturer: Not Identified
Surface Type: N/A
Equipment Compliance: N/A
Surface Area Compliance: N/A
Ref/Part Number:
Total Findings: 1

This item is satisfactory - no work required

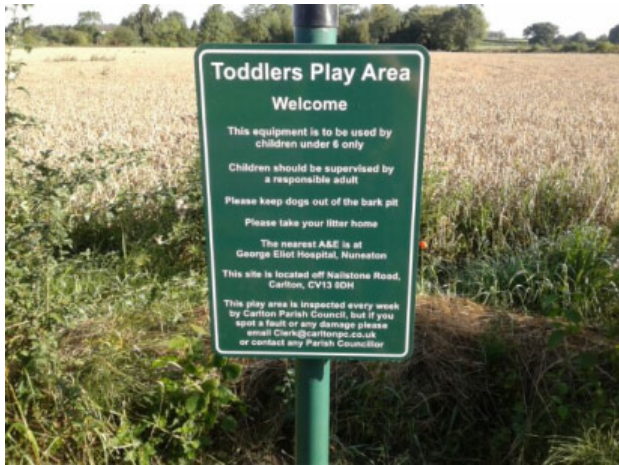
Item: Ancillary Items - Sign
Manufacturer: Not Applicable
Surface Type: Grass
Equipment Compliance: N/A
Surface Area Compliance: N/A
Ref/Part Number:
Total Findings: 1

This item is satisfactory - no work required

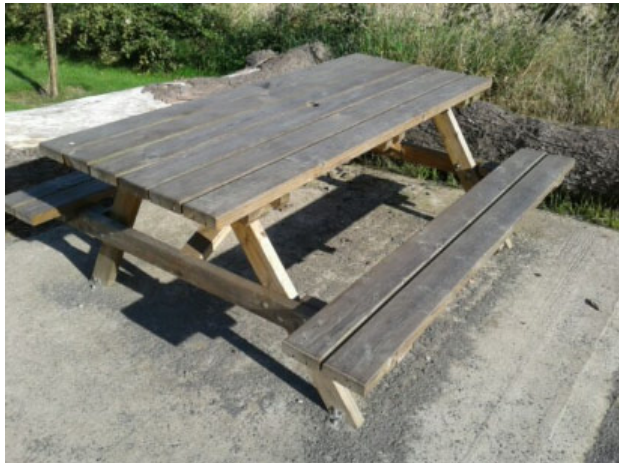
Item: Ancillary Items - Picnic Table
Manufacturer: Not Identified
Surface Type: Concrete
Equipment Compliance: N/A
Surface Area Compliance: N/A
Ref/Part Number:
Total Findings: 1

A number of fixing(s) have worked loose - Secure all loose fixings

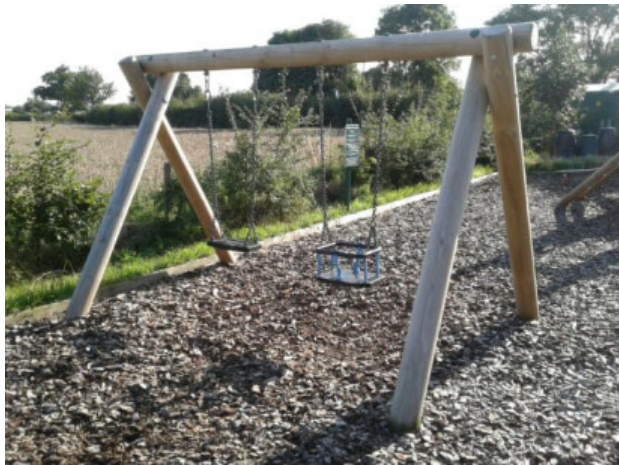
Item: Swings - 1 Bay Mixed Seat, 1 Cradle, 1 Flat
Manufacturer: Wicksteed Playgrounds
Surface Type: Bark Mulch
Equipment Compliance: Yes
Surface Area Compliance: Yes
Ref/Part Number:
Total Findings: 1
Life Expectancy: >10 Years

The timber has a number of splits (shakes) although these are not considered to be a problem at present - Monitor to ensure the splits do not cross through fixing points of the structure and cause any instability

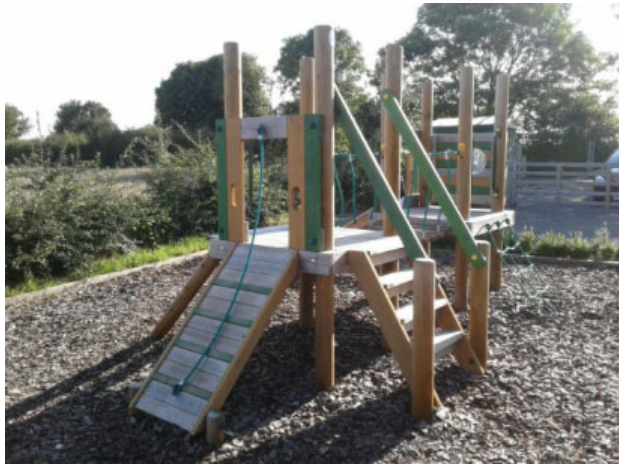
Item: Activity Equipment - Multi Play (Junior)
Manufacturer: Wicksteed Playgrounds
Surface Type: Bark Mulch
Equipment Compliance: No
Surface Area Compliance: Yes
Ref/Part Number:
Total Findings: 3
Life Expectancy: >10 Years

The raised timber edge forms a projecting obstacle within the falling space of the equipment which fails to meet the requirements of BS EN 1176 Part 1 - Monitor use

The unit is easily accessible and should have the appropriate barriers installed on the stairs as the height of the unit exceeds 600mm - Monitor use

The timber has a number of splits (shakes) although these are not considered to be a problem at present - Monitor to ensure the splits do not cross through fixing points of the structure and cause any instability

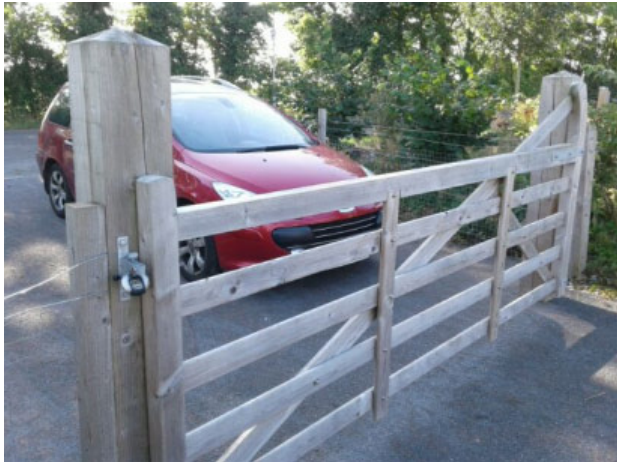
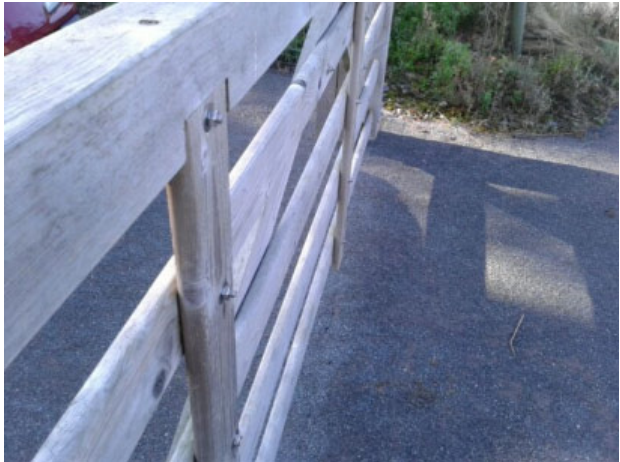
6 - Low Risk (Finding 1)			
Item:	Ancillary Items - Gate - Maintenance	Risk Level:	L - Low Risk
Manufacturer:	Not Identified	Surface:	Gravel

Finding:	There are projecting bolt thread(s) present	Action:	Remove excess thread length and deburr or provide cap

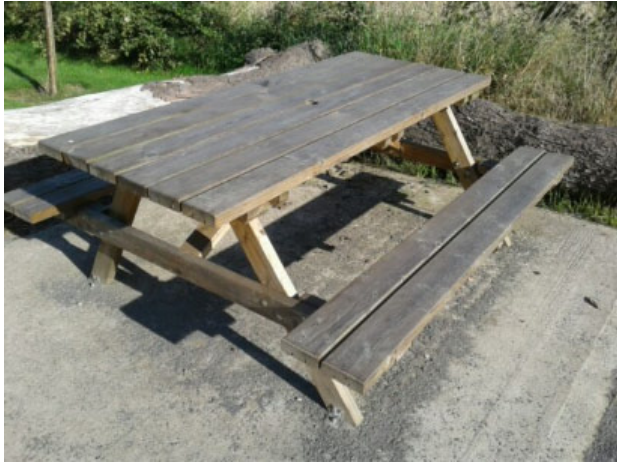
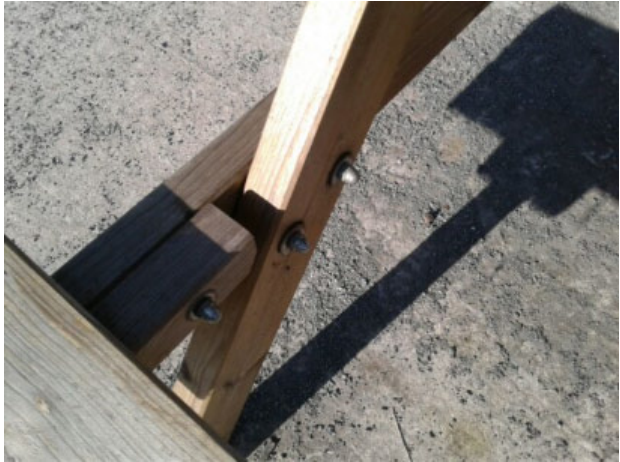
6 - Low Risk (Finding 1)			
Item:	Ancillary Items - Picnic Table	Risk Level:	L - Low Risk
Manufacturer:	Not Identified	Surface:	Concrete

Finding:	A number of fixing(s) have worked loose	Action:	Secure all loose fixings

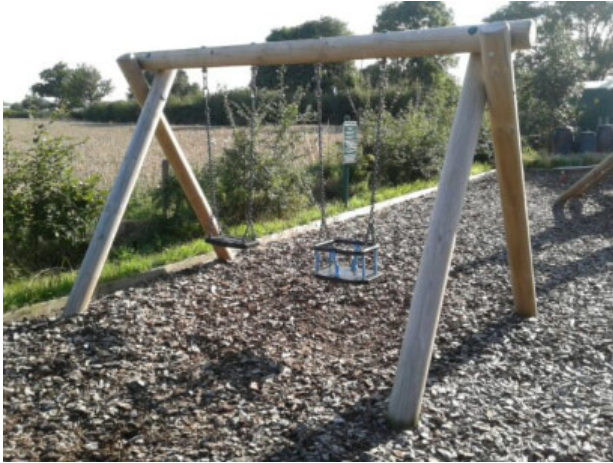
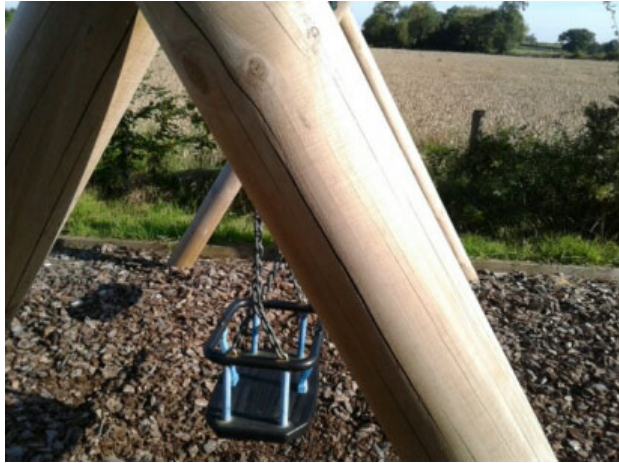
6 - Low Risk (Finding 1)

Finding: The timber has a number of splits (shakes) although these are not considered to be a problem at present

Action: Monitor to ensure the splits do not cross through fixing points of the structure and cause any instability

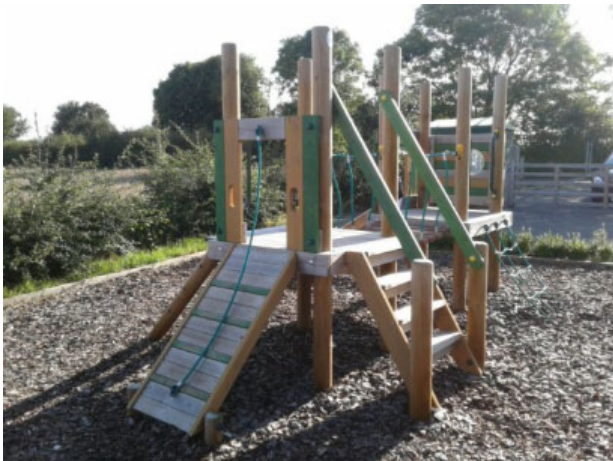
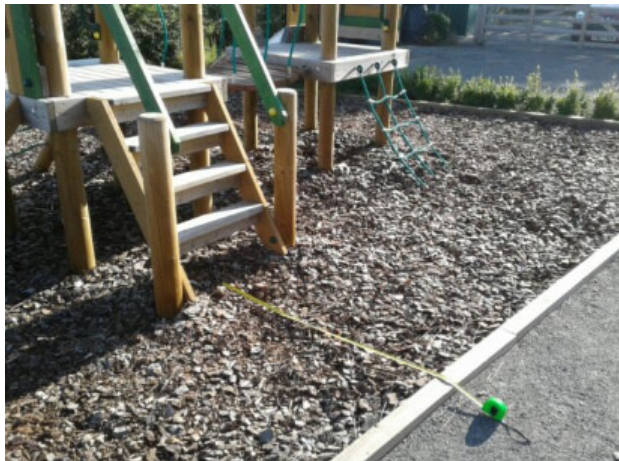
8 - Low Risk (Finding 1)

Finding: The raised timber edge forms a projecting obstacle within the falling space of the equipment which fails to meet the requirements of BS EN 1176 Part 1

Action: Monitor use

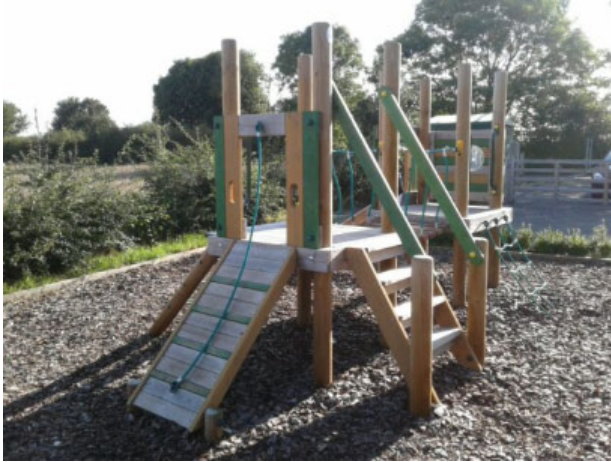
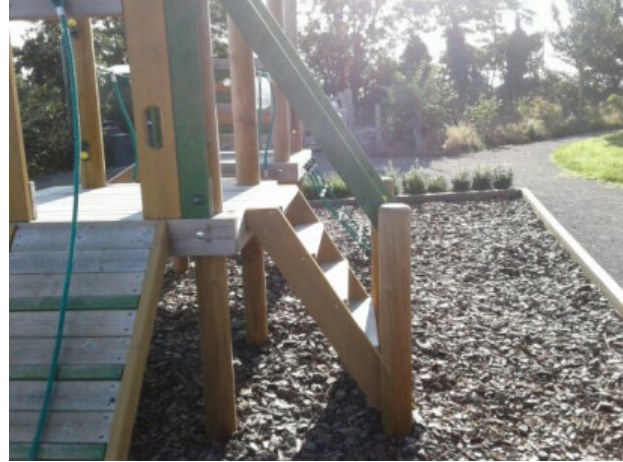
8 - Low Risk (Finding 2)

Finding: The unit is easily accessible and should have the appropriate barriers installed on the stairs as the height of the unit exceeds 600mm
Action: Monitor use

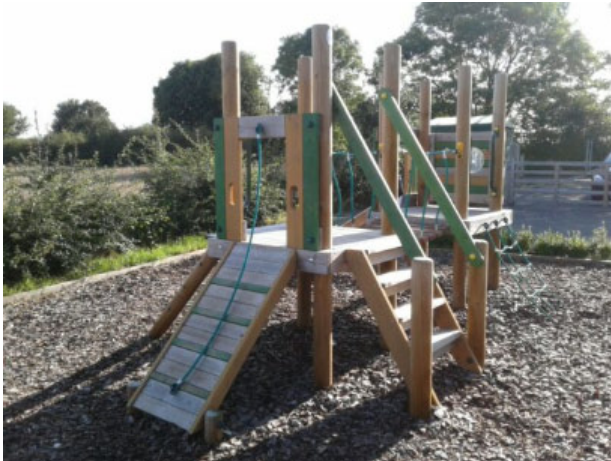
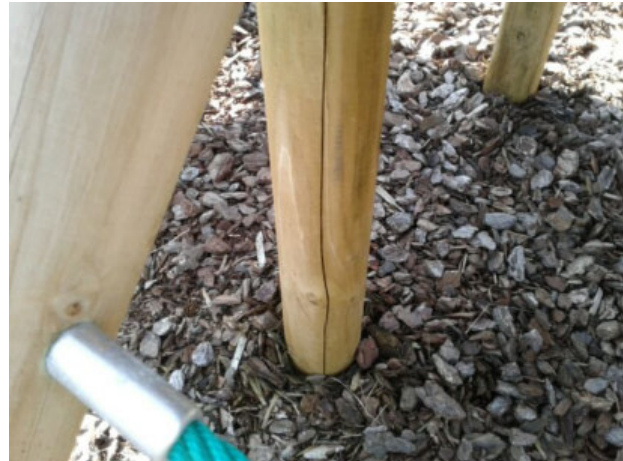
6 - Low Risk (Finding 3)

Finding: The timber has a number of splits (shakes) although these are not considered to be a problem at present
Action: Monitor to ensure the splits do not cross through fixing points of the structure and cause any instability
