Carlton Parish Council

Our Reference: 25133-TDC-XX-XX-LT-Z-0001-P01

RE: EXTERNAL BOUNDARY WALL INSPECTION - ST ANDREWS CHURCH, CARLTON, NUNEATON,

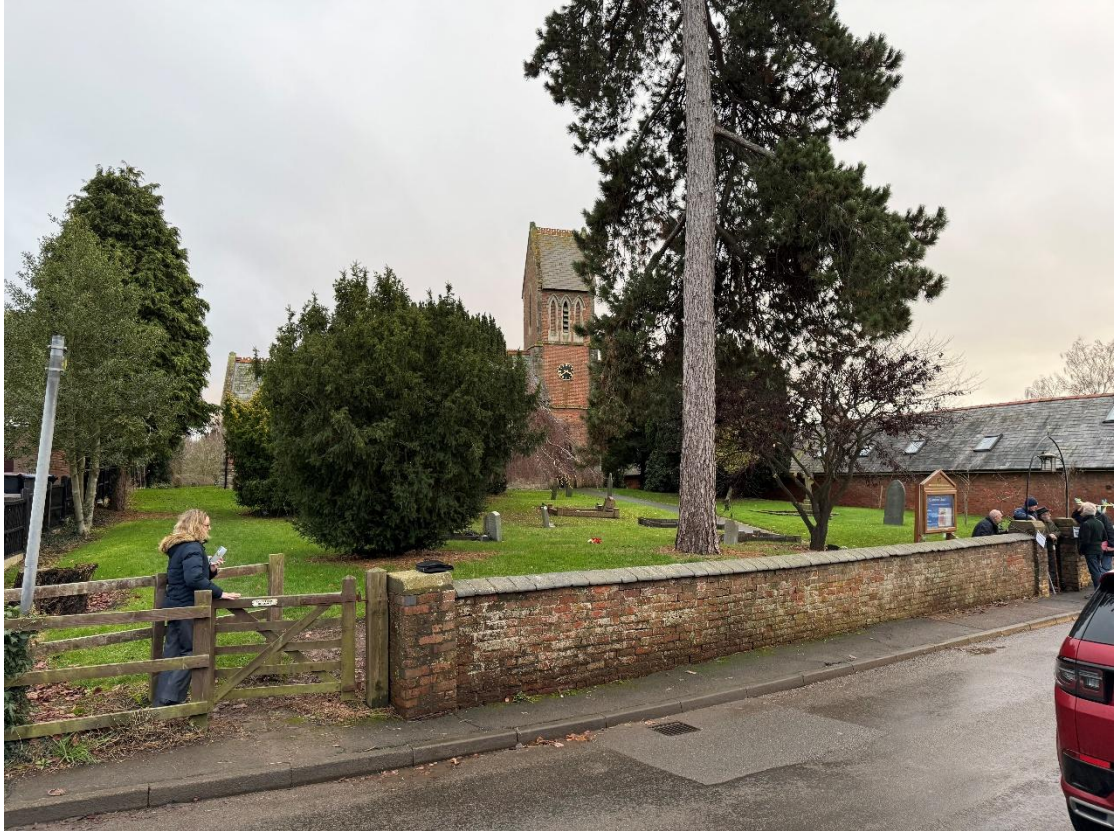
Behind the wall is a 20m high tree which is located 2-3m behind the face of the wall. It is understood that during the investigation works minimal tree roots were encountered.

Image 1 – Image of left hand wall with tree behind

Finally, prior to any works being undertaken it is recommended that an Arboricultural surveyor be contacted to confirm the stability of the tree during any proposed works.

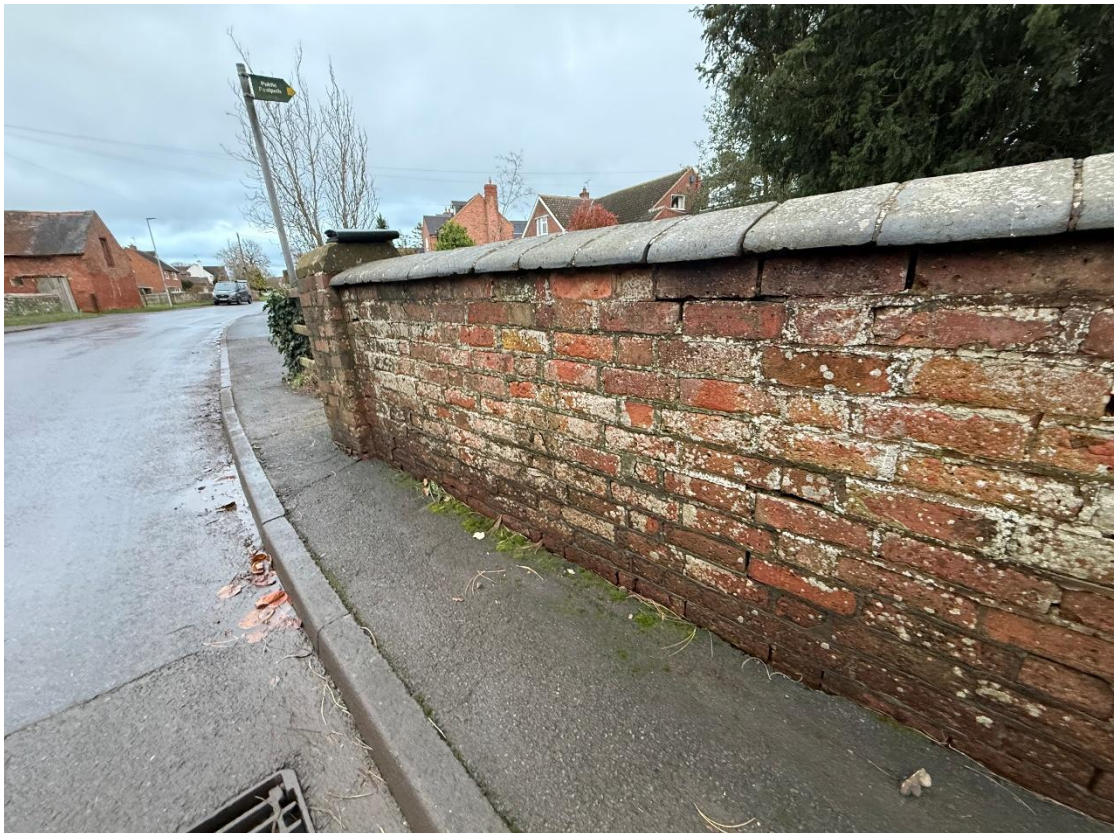
The eastern pier was observed to be in good condition albeit there appears to be rotation of the footing, with the entire pier rotating as one and no additional cracks observed.

Image 2 – Image of left hand wall condition and pier

It is therefore recommended that the left hand wall be taken down and new concrete foundations provided with the new wall reconstructed onto this along with the eastern most pier being rebuilt. The detailed design of the new wall should be undertaken by ana appropriately qualified Engineer.

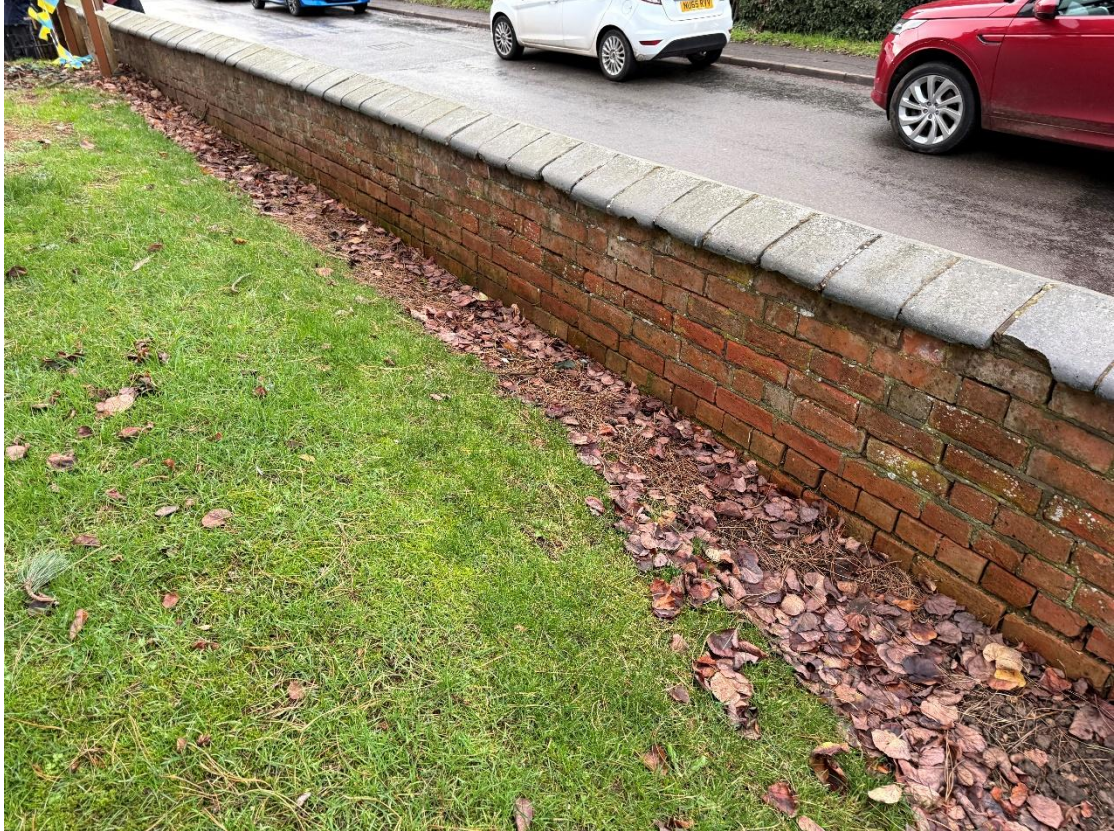
The left hand wall is observed to have rotated with then centre of the wall bulging and the wall leaning towards the highway. For context, the wall is observed to retaining 250-300mm of soil on the Church land. There was evidence that the levels within church ownership have been reduced historically, and it is understood as part of the investigations undertaken by the Parish council 300mm of soil was removed from behind the wall in an attempt to limit the wall movement.

Image 3 – Image of rear of wall showing reduction in levels

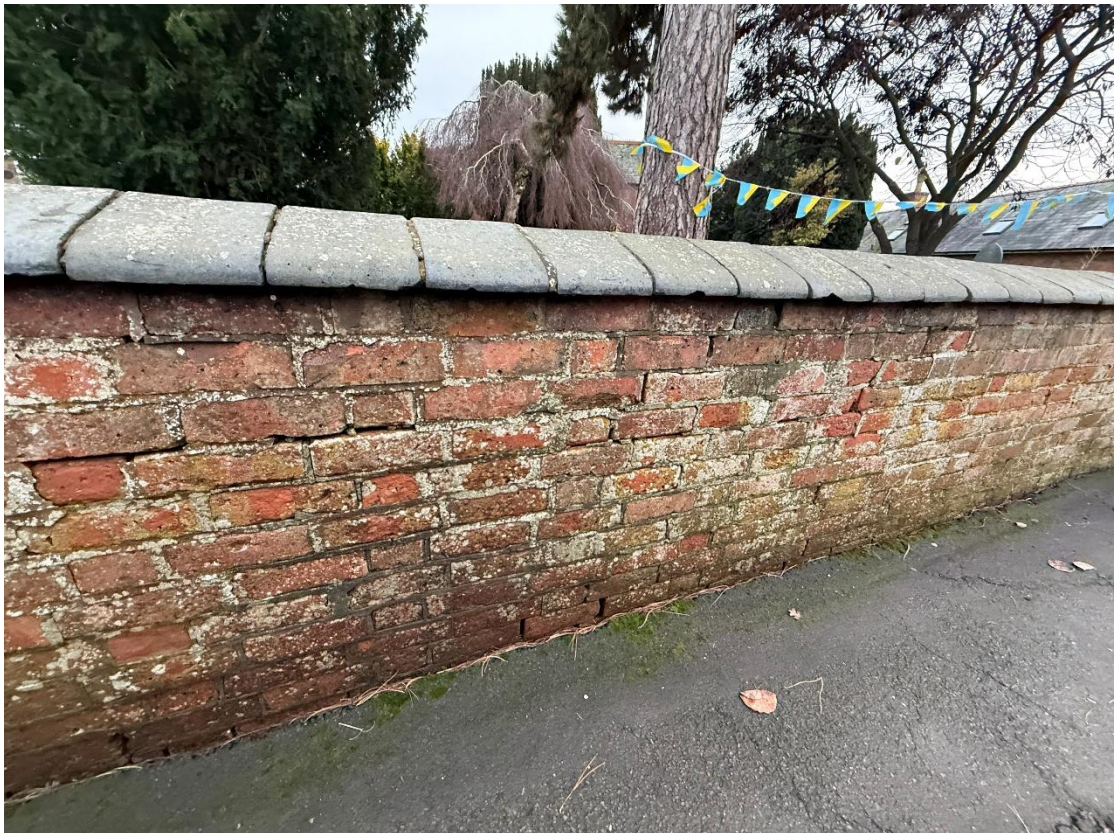
The wall itself is constructed from brickwork and was observed to be 14" thick with blue coping stones. The wall was observed to be suffering from significant mortar loss to both sides of the wall with areas of mortar completely missing.

It would appear that historically mortar repair works have been undertaken with cement mortar observed, whilst the original wall is anticipated have been constructed from lime mortar.

Image 4 – Image of masonry and mortar general condition

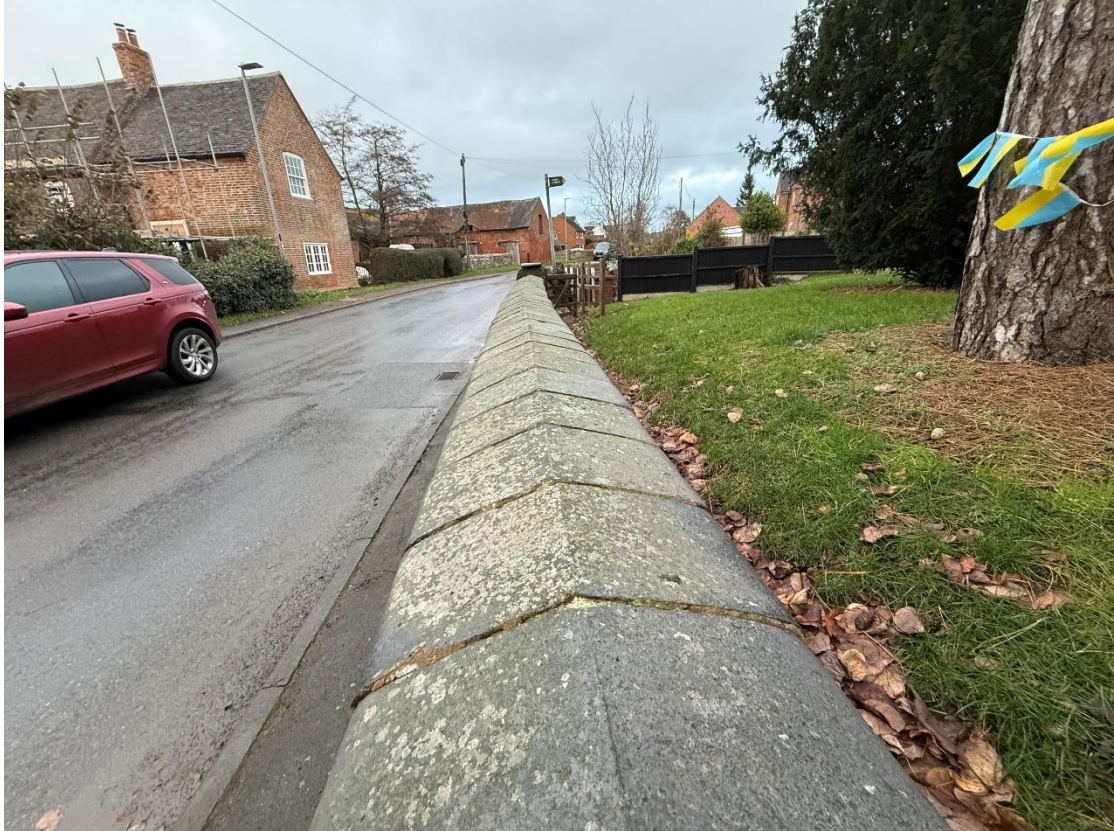
Based upon the information provided and the observations on site we are of the opinion that lateral pressure through root growth, heave of the soils and water build up due to lack of drainage is causing seasonal movement in the wall, however it is believed the continued seasonal movement is causing a rotation of the existing brick foundation which is exasperated with each seasonal movement increasing the lever arm action.

It is acknowledged that the wall is unlikely to collapse in the short term however, repair works are required in the medium term before the rotation of the foundation causes collapse.

Image 5 – Image showing deviation in wall line

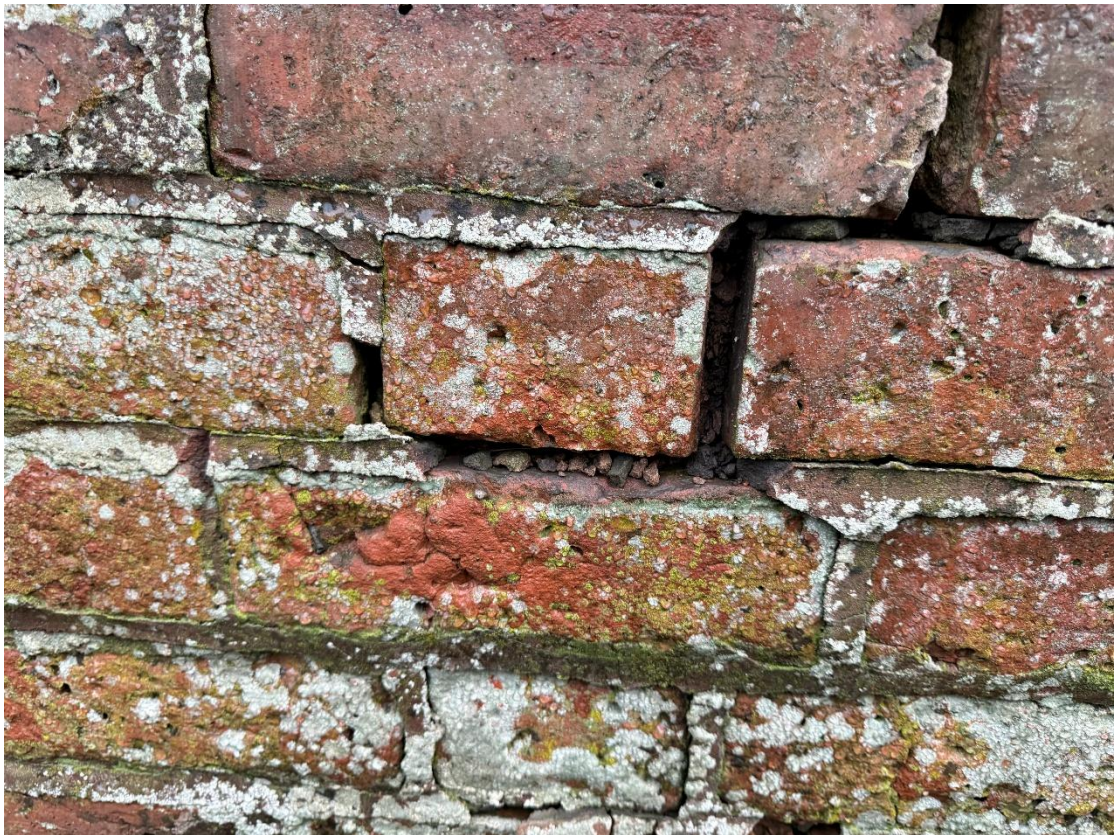
Image 6 – Image showing severe mortar loss

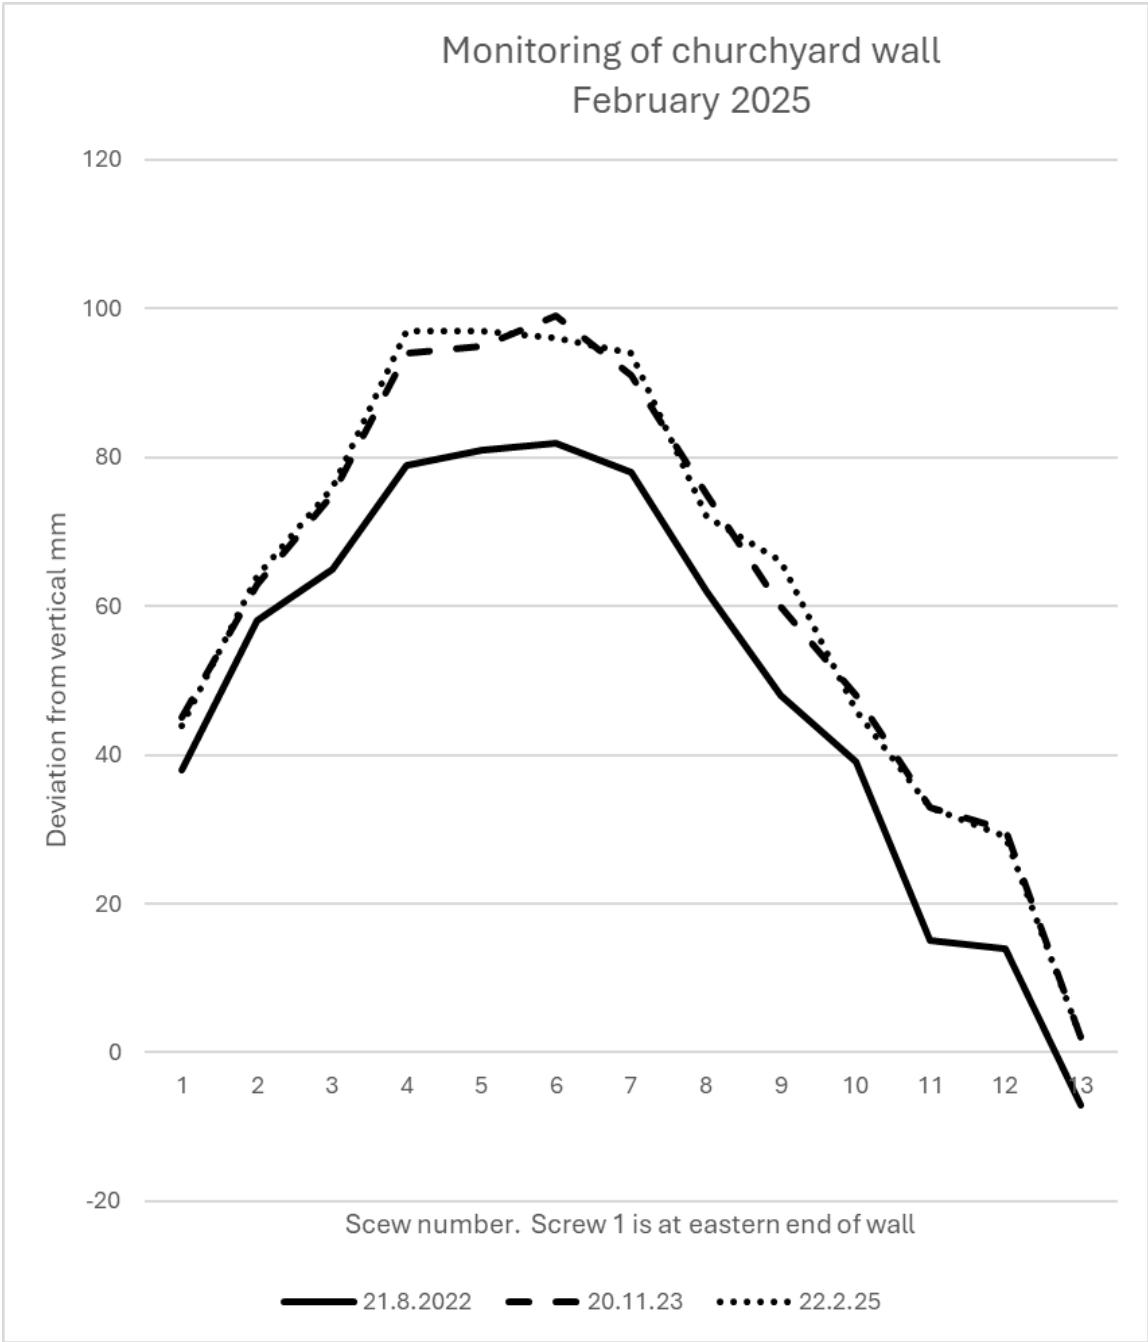
The smallest overhang was measured on 21st August 2022 after a very dry summer; the largest overhang was measured on 20th November 2023 after a very wet Autumn. The overhang measured on 22nd February after a very wet autumn and winter was very similar to the previous maximum.

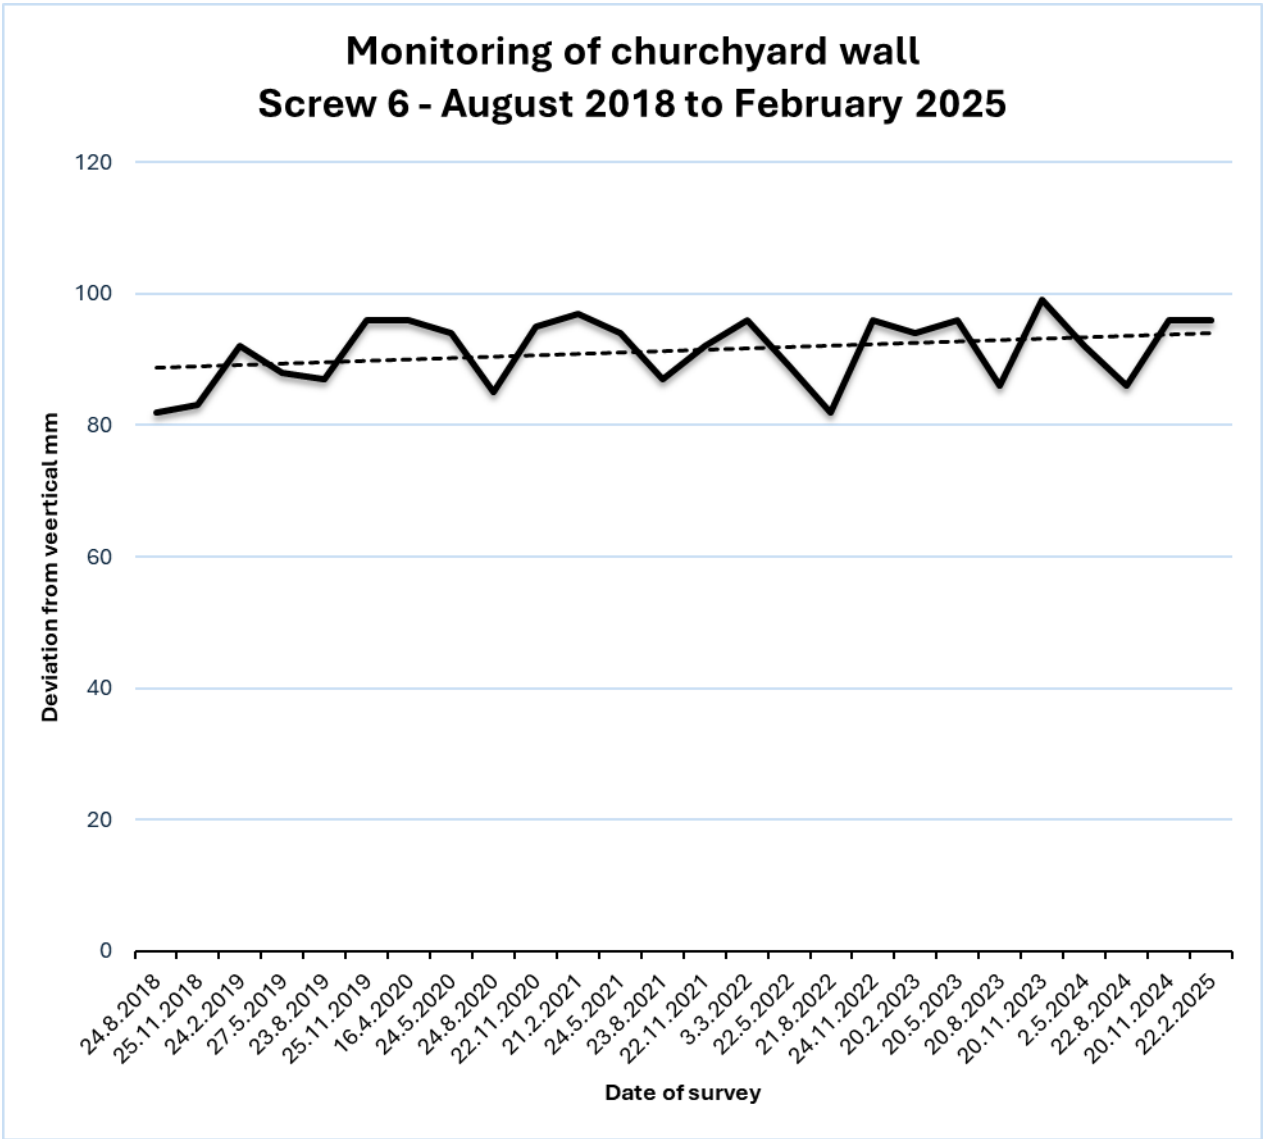
Screw number six is at the centre of the bulge, and has shown the largest deflection (99mm on 20th November 2023). The chart below shows all measurements of the deflection at screw six.

This chart shows the deflection increasing each winter and decreasing each summer. The trendline on the chart above has a positive gradient, from 88.5mm in 2018 to 94mm in 2025, which suggests that the wall is being pushed over by about 1mm each year.

The wall does not appear to be at risk of collapse in the near future, but will need to be rebuilt at some point. It is recommended that monitoring be continued.

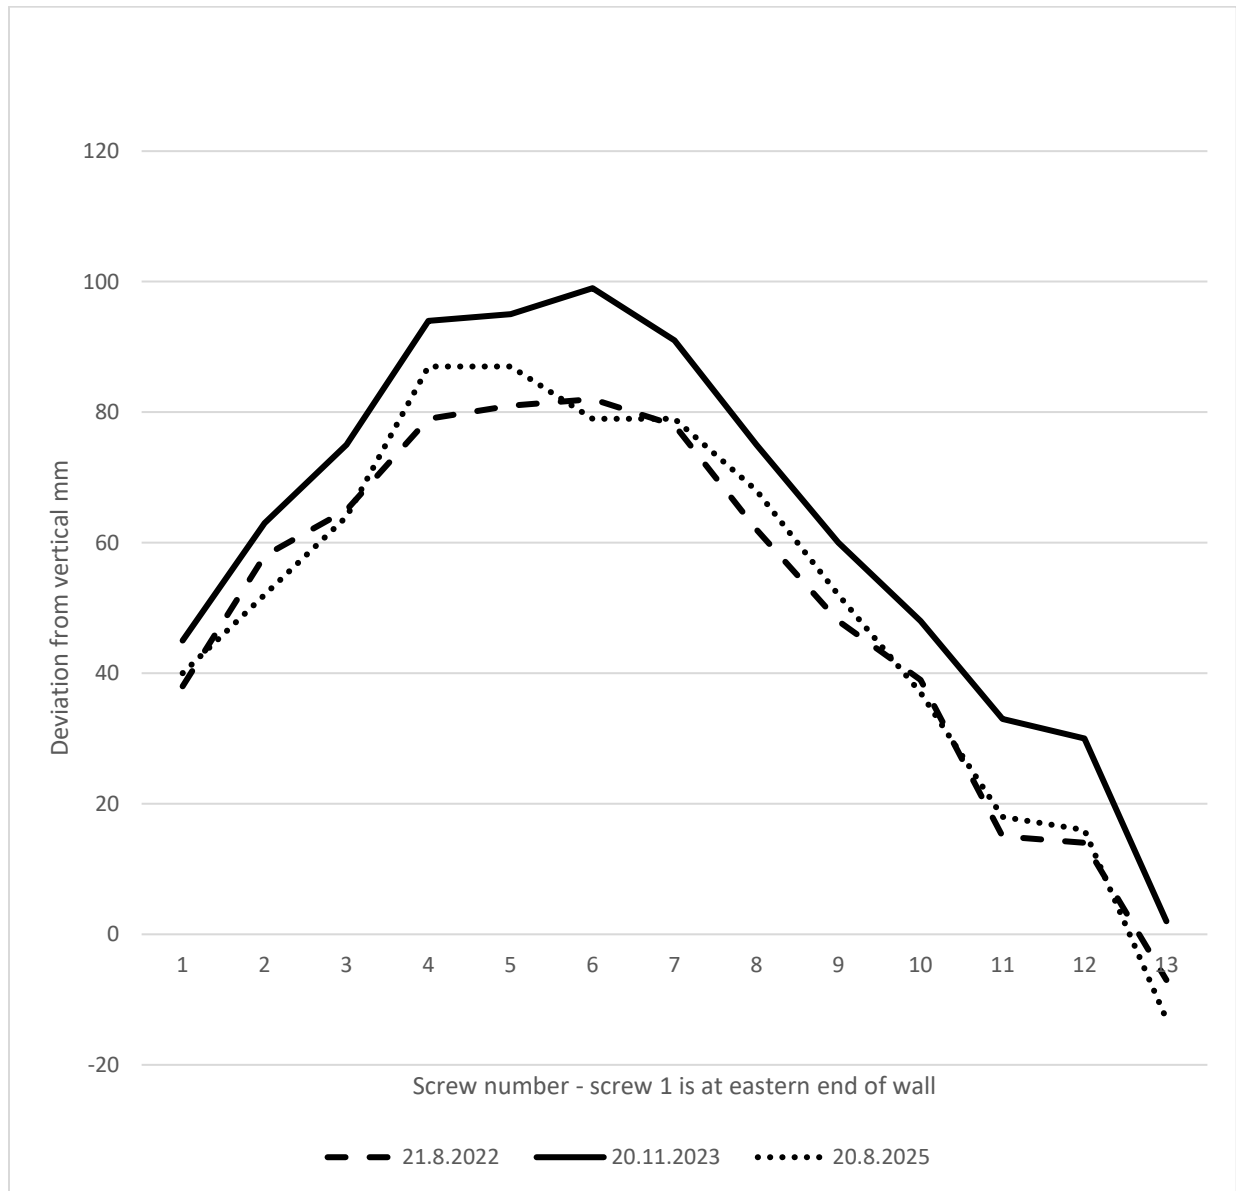
Monitoring of churchyard wall, August 2025

The minimum deviation recorded was in August 2022; the maximum in November 2023.

Measurements were made on 20 August 2025 after a long spell of dry weather.

The deviation from vertical is much the same as the minimum in August 2022, except for screws 4 and 5. The chart from August 2024 also showed an anomaly at screws 4 and 5, and it was suggested then that this part of the wall has lost some flexibility and might be at risk of failure.

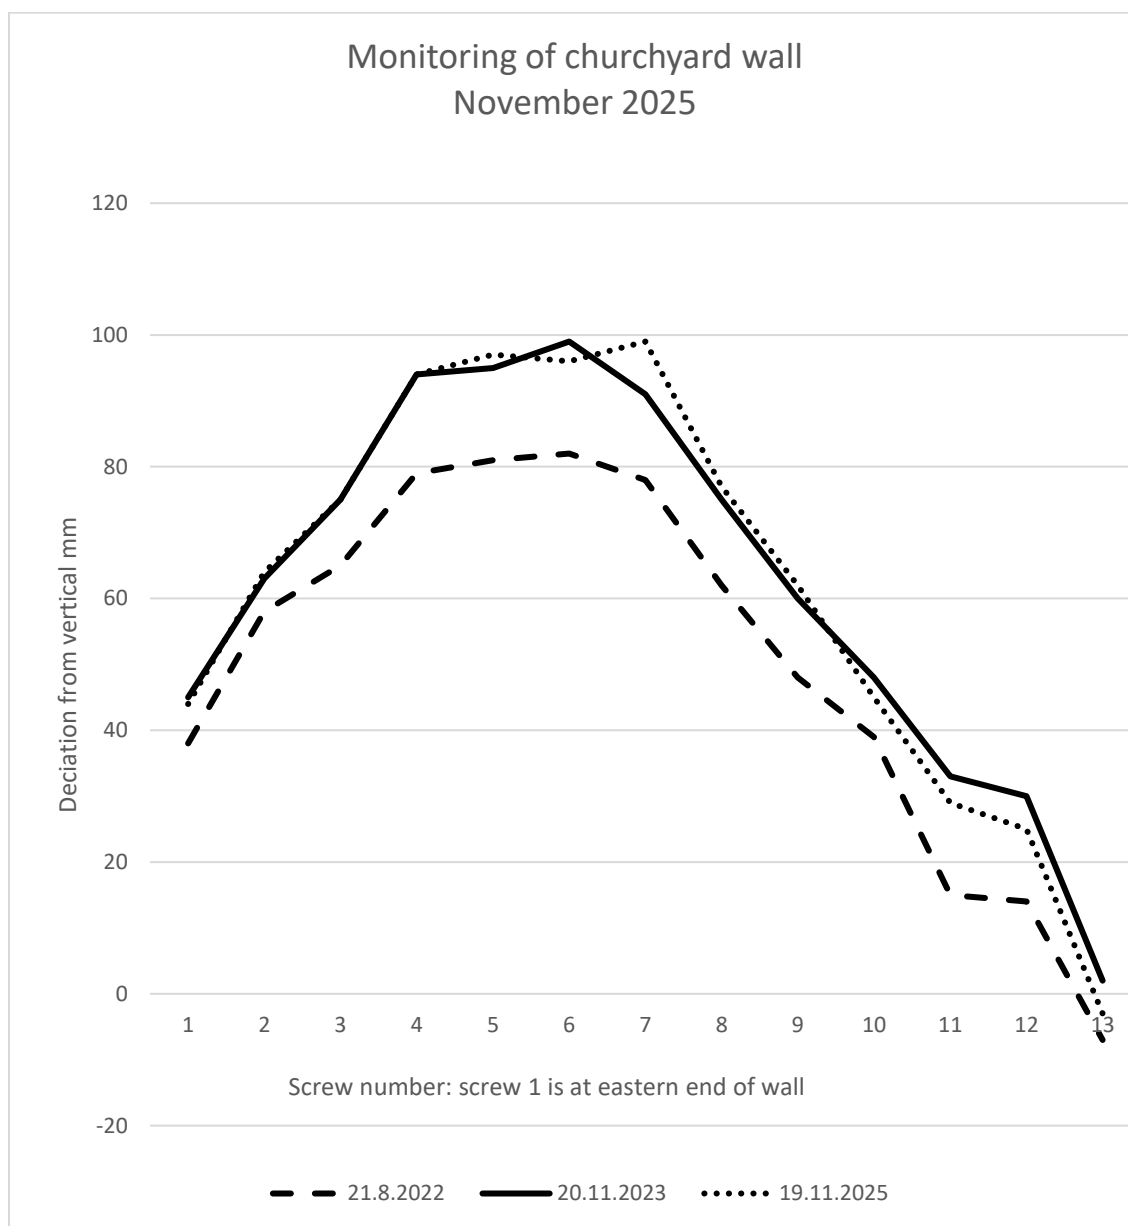
Monitoring of churchyard wall, November 2025

The minimum deviation recorded was in August 2022; the maximum in November 2023.

Measurements were made on Wednesday 19 November 2025 after a spell of wet weather following a very dry summer and autumn. There had been a day of heavy rain on Friday 14 November.

The deviation from vertical is much the same as the maximum observed in November 2023.
