Surveys by Stuart Tupling and Chris Peat

Report written 9th December 2022

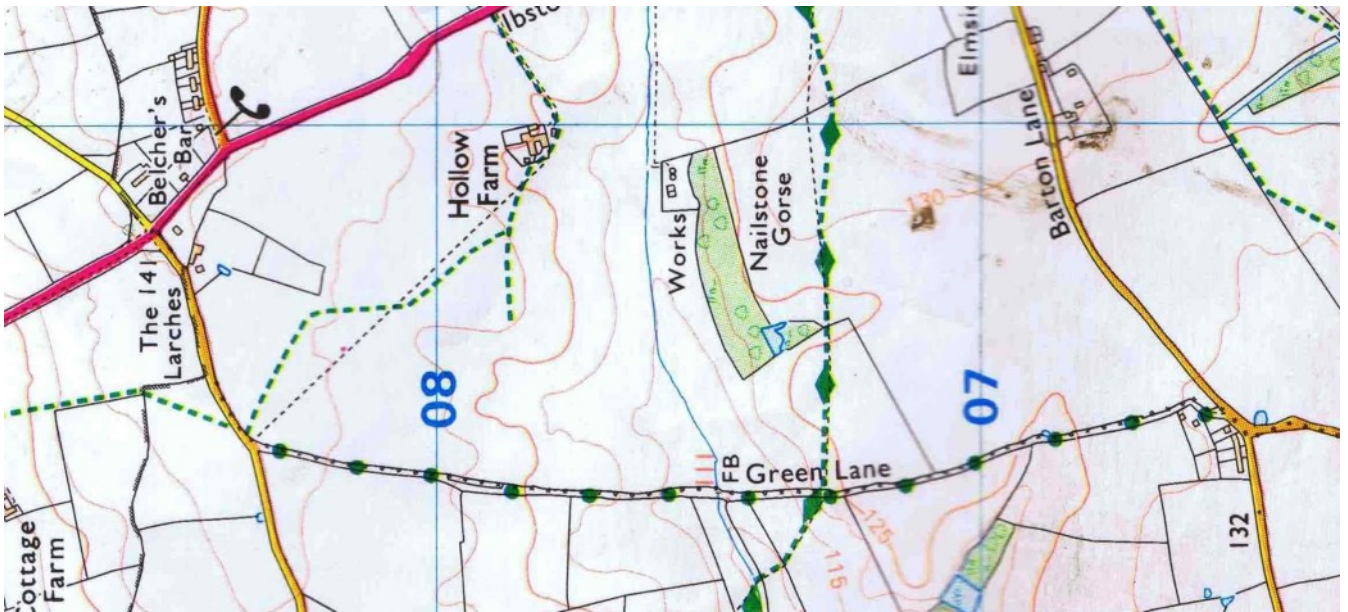
1. Green Lane

The Green Lane was open without obstructions, and with a reasonable surface, though intermittent fly tipping continues to be a problem.

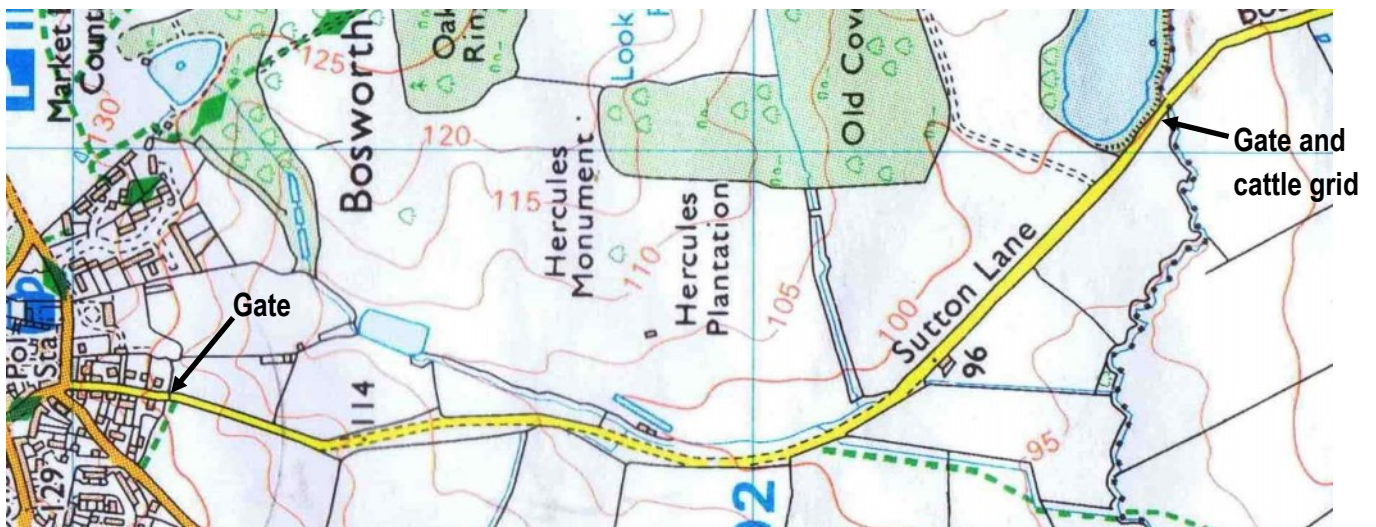
2. The Gated Road, Market Bosworth

The Gated Road is a highway open to all traffic, but is an attractive route for horse riders.

The gate at the northern (Bosworth) end requires adjustment of the hinge bolts so that it closes onto the latch without having to be lifted. The latch handle is short, and it would be more convenient if this could be replaced with a long handle which could be operated from horseback.

At the southern (Sutton Cheney) end there is a cattle grid, with a surfaced route for horses through a gate on the eastern side. The gate requires adjustment of the hinge bolts so that it closes without having to be lifted.

At the time of inspection there was a wide gap suitable for horses on the western side of the gate. However, this gap would need to be closed off if the verges were to be grazed by livestock.

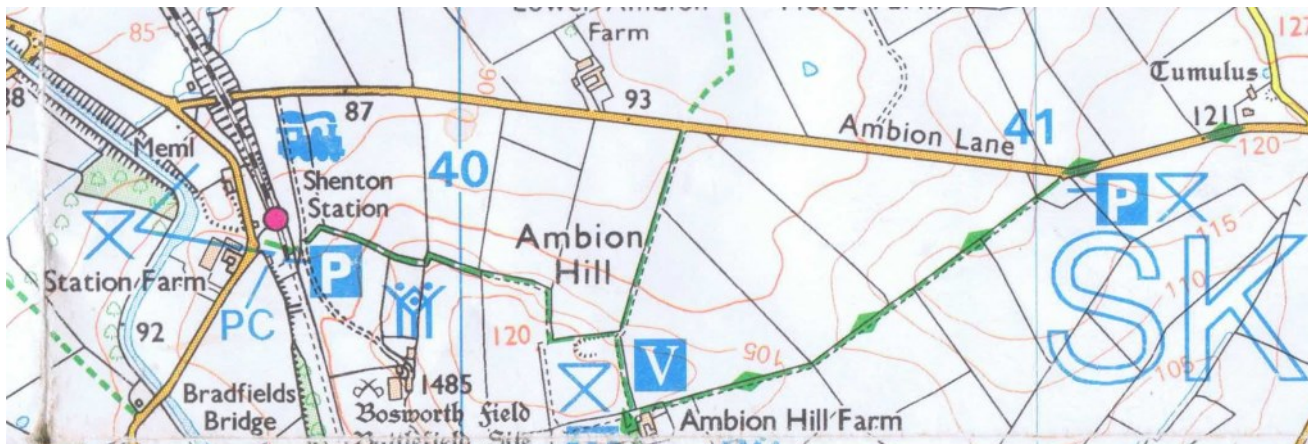
3. Ambion Hill bridleways

Both bridleways were clear of obstructions, and gates were in good condition.

However, the gates in the section between Ambion Hill Farm and Ambion Lane only opened one way and had short handles.

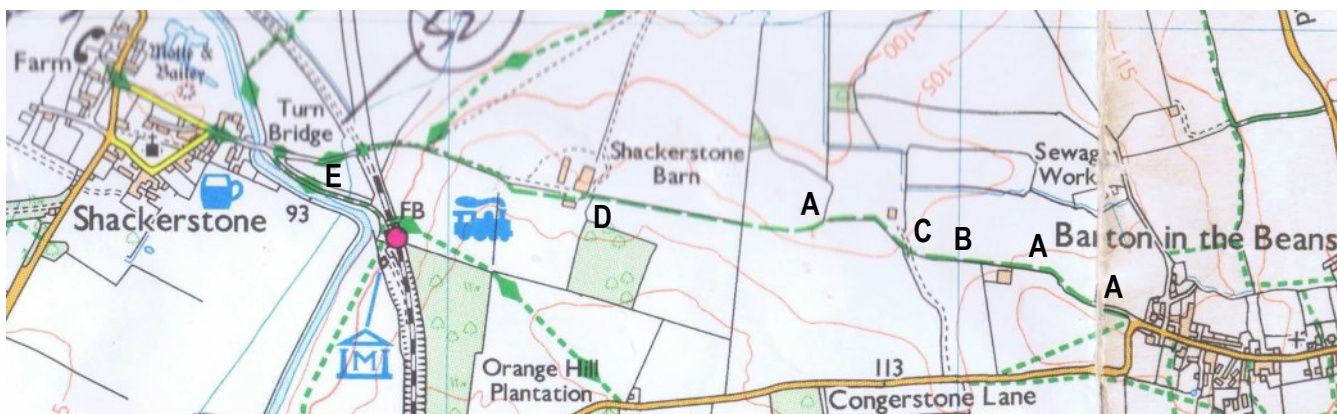
4. Barton in the Beans to Shackerstone bridleway

This bridleway was surveyed on 4th December 2022. There was overhanging vegetation at the places marked 'A', and the surface had been trampled to mud at point 'B'.

At point 'C' a gate only opens to the east and has a low handle. It would be more convenient if this gate opened both ways and had a long handle which could be opened without dismounting.

At point 'D' the bridleway is overhung by a low branch growing from a young oak tree.

At point 'E' there is a locked barrier across the track, with a gap on the southern side. This gap is only just wide enough for a mounted horse.

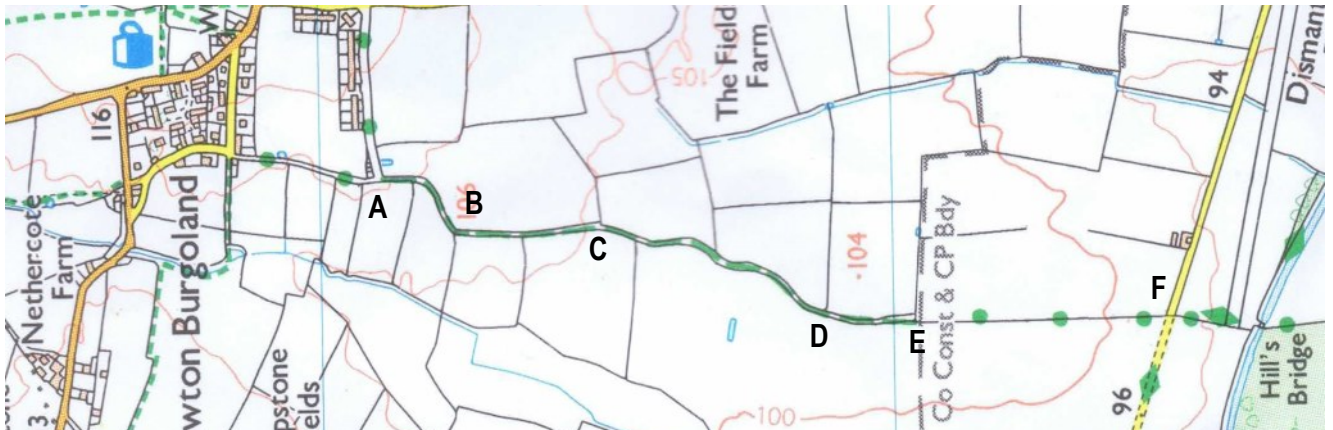
5. Newton Burgoland to Derby Lane bridleway

This bridleway was surveyed on 9th December 2022, after a sharp frost.

Between points 'A' and 'B' the track is surfaced with pebbles and in good condition, and between 'B' and 'C' it has a good surface on the southern side in spite of ruts along the northern side.

Between 'C' and 'D' there is a good surface along the southern side, but very deep ruts along the northern side of the track. There were fresh and deep ruts between 'D' and 'E', in spite of a County Council *Road Closed* sign at 'E'.

Between 'E' and 'F' the track was deeply cut up by ruts, and passage would have been tricky if the mud had not been frozen. Also along this section, blackthorn scrub was invading the northern side of the track.

The status of the track between 'E' and 'F' is uncertain, though the route is well-walked to the Ashby Canal towpath at Hill's Bridge.
