# **Investigations into the Site of Carlton Hall**

Richard and Robert Liddington

December 2017

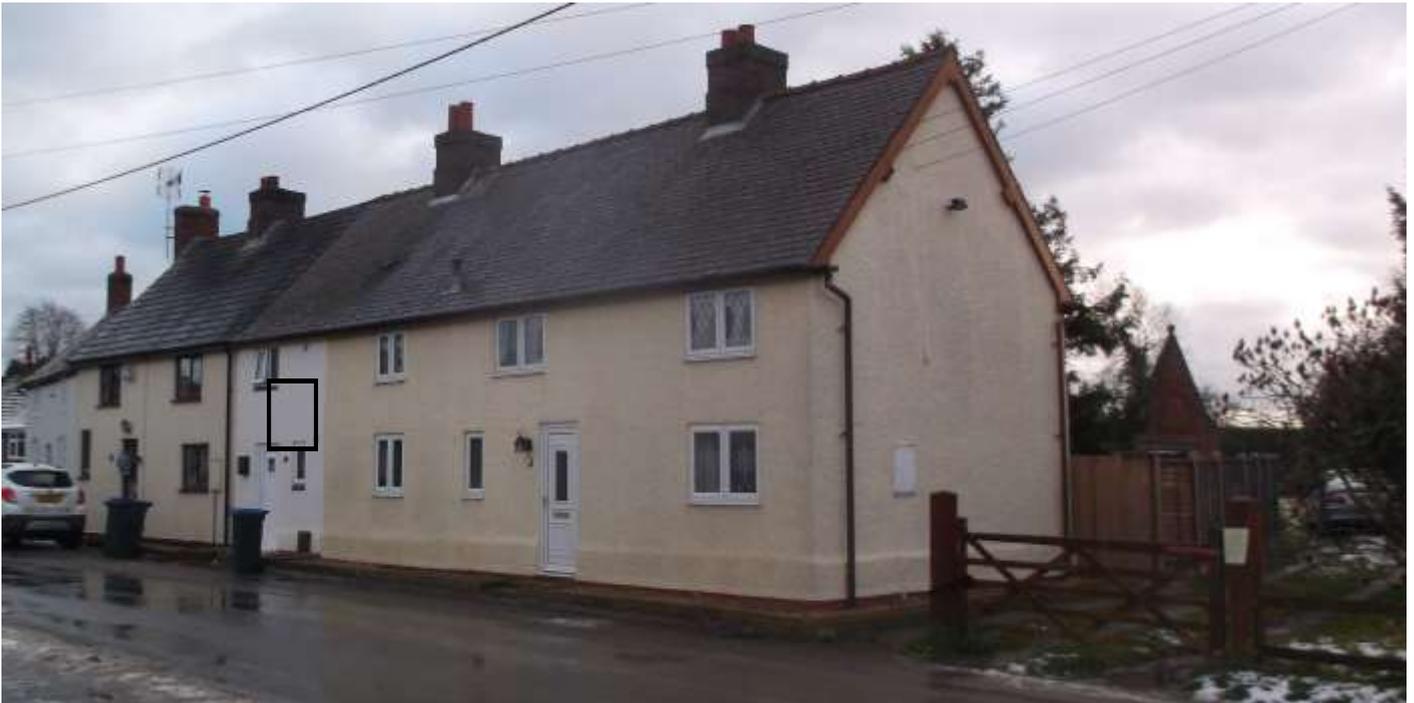
1.2 Hall Terrace currently comprises three cottages fronting the road (Figure 1). On the eastern end of the terrace is Penwood Cottage which is attached but angled back by

Figure 1. Hall Terrace and Penwood Cottage. December 2017. The location of Figure 2 is marked with a rectangle.

some 15 degrees from the road indicating that it is not a contemporary building. The brickwork of Hall Terrace fronting the road showed evidence of arrow-slit ventilation holes, indicating that this building was originally agricultural. The vents were presumably bricked up when the barn was converted into dwellings, and were visible for many years: number 44 was the last to be rendered in 2016 (Figure 2).

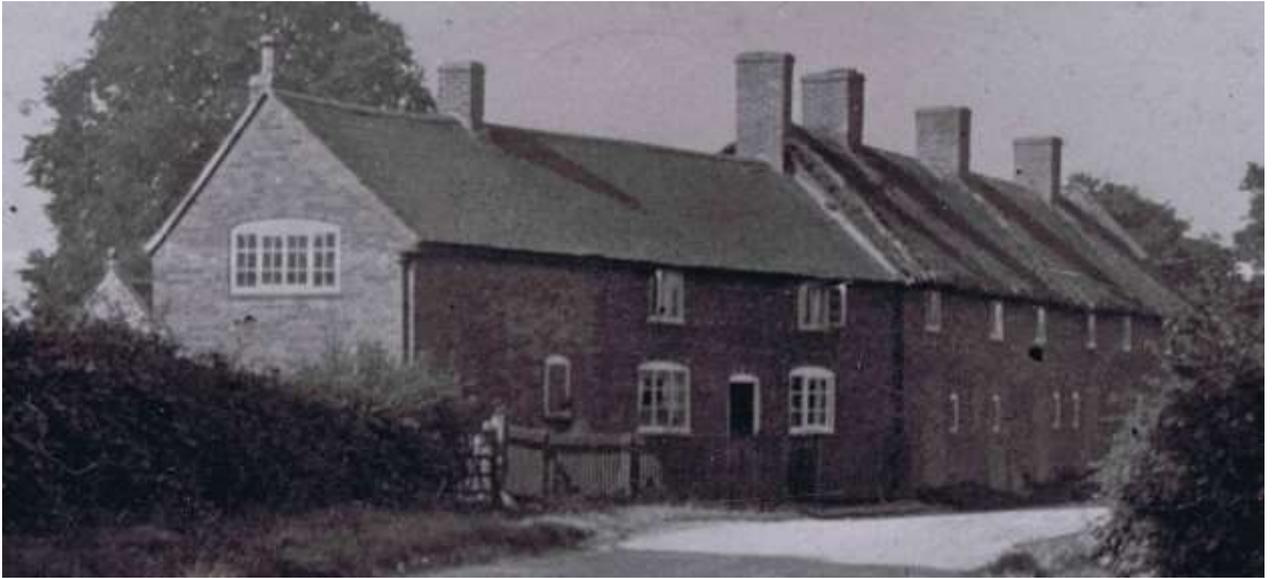
1.3 Another relevant fact is that Hall Terrace was thatched before being re-roofed. A photograph (Figure 3) shows the roof to be a simple steep gable, with eaves above the first floor windows. There are three central chimney stacks.

Figure 3. Penwood Cottage and Hall Terrace, probably c.1920. Hall Terrace is thatched. The first bay of Penwood Cottage has been demolished.

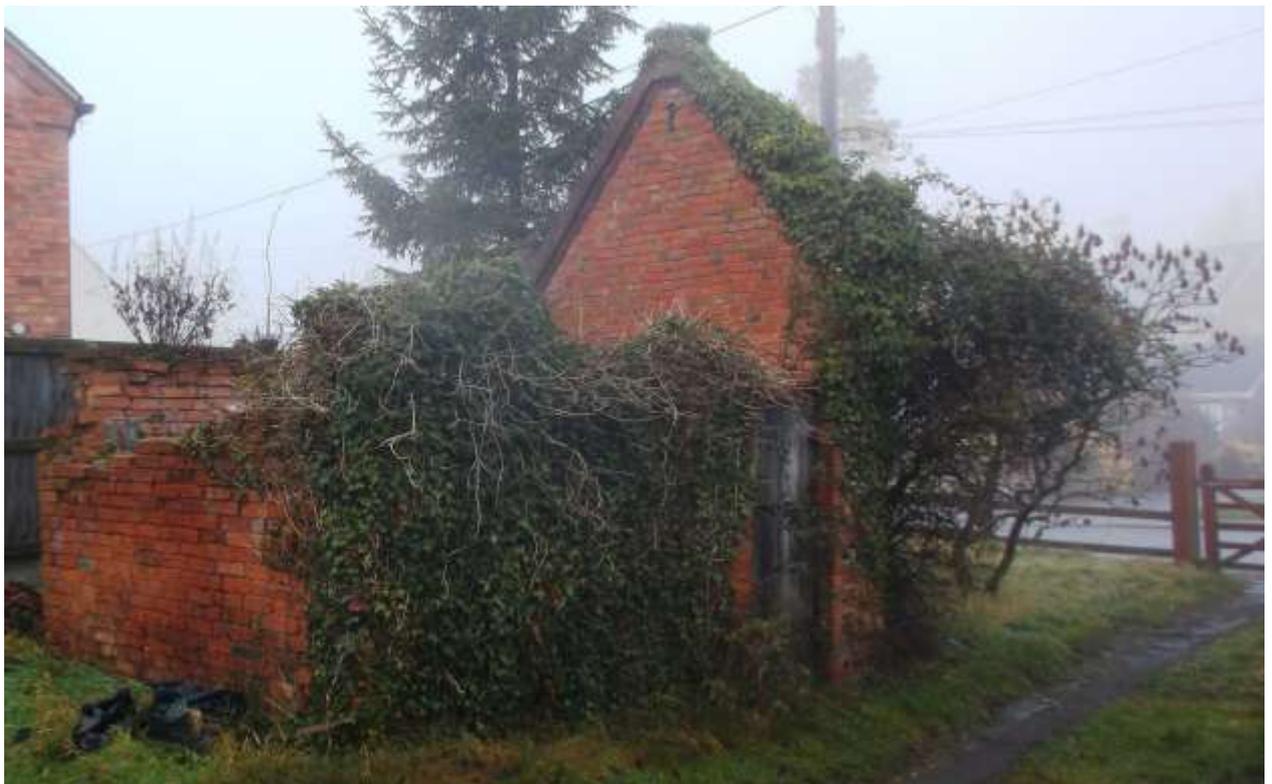
Figure 4. Wash house.

1.4 The site entrance is at the western end of the terrace. Just inside it and set back from the road is the shell of a wash house (Figure 4). The shell of a utility block (Figure 5) is behind the gardens of Hall Terrace. This and the wash house are thought to have been built on the orders of Charles Tollemache-Scott soon after the turn of the twentieth century.

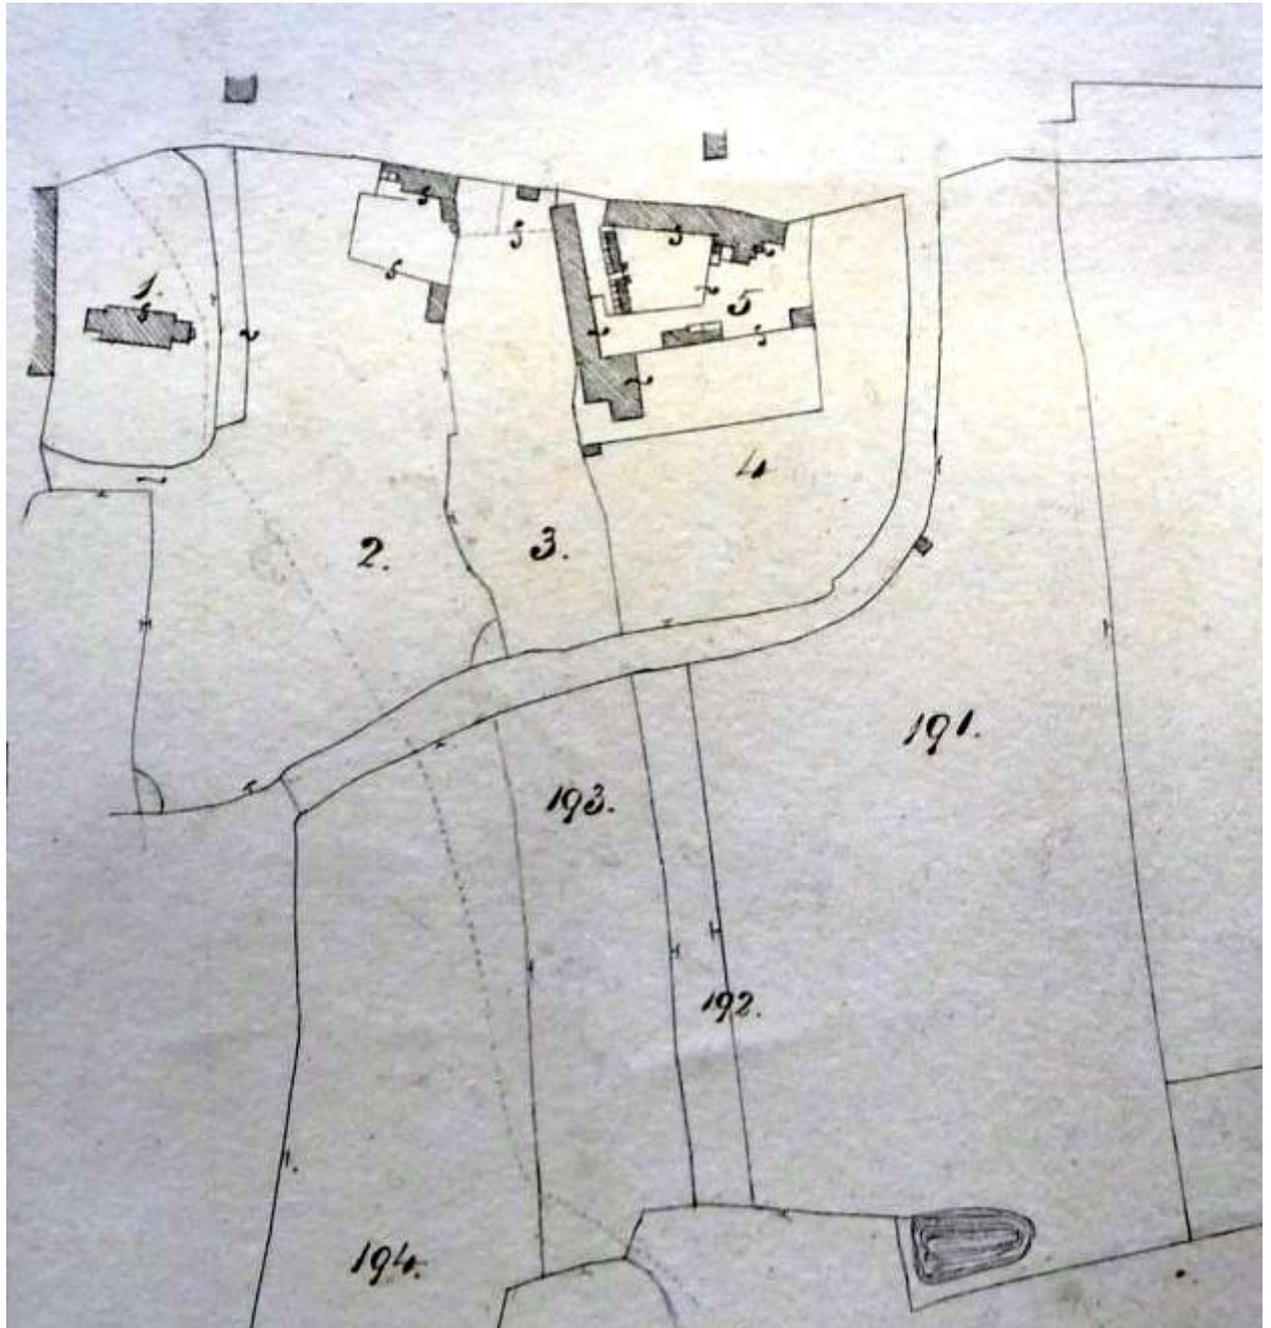
Figure 6. Detail from an appeal hearing map, 1846. Reproduced with permission ROLLR.

The large block to the north, adjacent to the road is Hall Terrace and Penwood Cottage. The two are attached, the building line of the latter being at an angle of some 15°, taking it away from the road at the eastern end. Originally, Hall Terrace was probably an agricultural building.

The biggest block shown on the maps is an elongated building running approximately north to south along the western boundary of the site. The northern end of the block is of similar size to Hall Terrace and with evidence from later maps this is assumed to be six cottages. Perhaps these were later converted into the three of local rumour. To the south, continuing from the cottages, the maps show a building of a similar width which extends over the surviving cellar. At the southern end, the structure appears as a rectangular block minus one of its corners. Its western wall is also offset from the building line of the cottages. It is thought possible that these two more southerly buildings were the Hall itself or the site of it. For future discussions the six cottages are referred to as Block A, the middle section Block B and the most southerly building Block C (Figure 7).

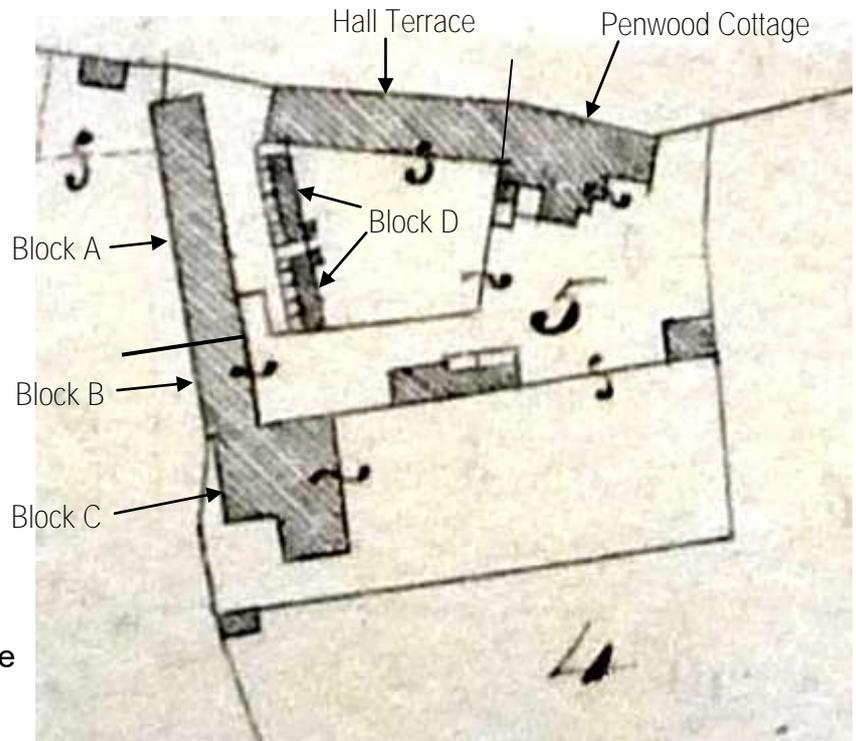
Figure 7. Identification of buildings.

The map also shows a long narrow building structure (Block D) running parallel to Block A. There appear to be a series of open enclosures immediately on the western side of this building which resemble animal pens. Indeed, the whole structure could have been a row of pig sties. They were in two groups, of eight and six with a passage way between the two groups. There was a form of barrier starting at the northern end of Block B, passing along the southern end of Block D and continuing to the wall of Hall Terrace at the junction with Penwood Cottage. The enclosure thus formed is typical of a farm yard in this area.

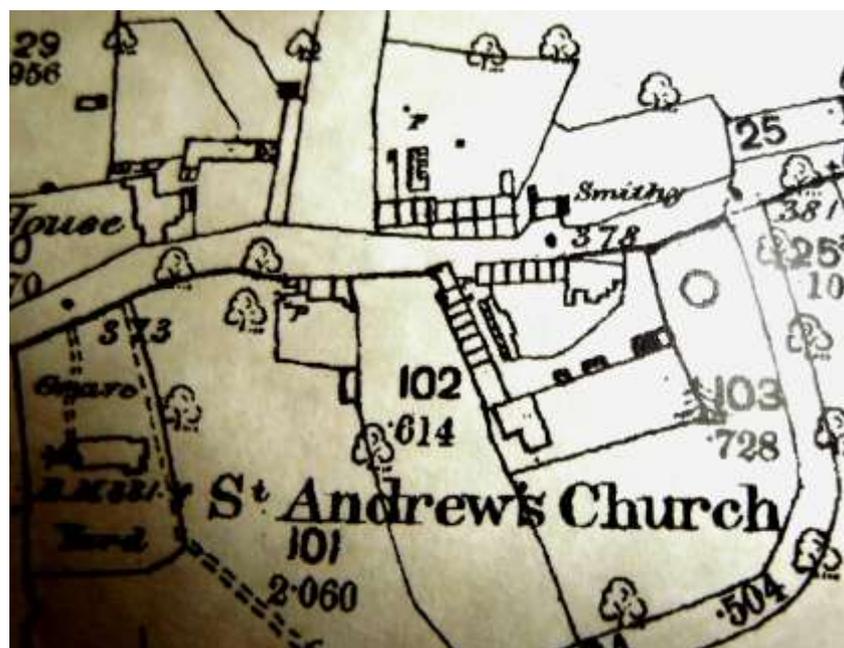
The 1885/6 OS map detail (Figure 8) closely resembles the 1846 map with three differences. Firstly, divisions between the cottages are detailed supporting the previous assumption. Secondly, Block A appears to have been extended by an outlined area which protrudes into the road way. This was probably a garden area surrounded by a fence. Finally, there was also an alteration to the barrier now enclosing Penwood Cottage with the rear of Hall Terrace.

Figure 8. Detail of 1885/86 Ordnance Survey map

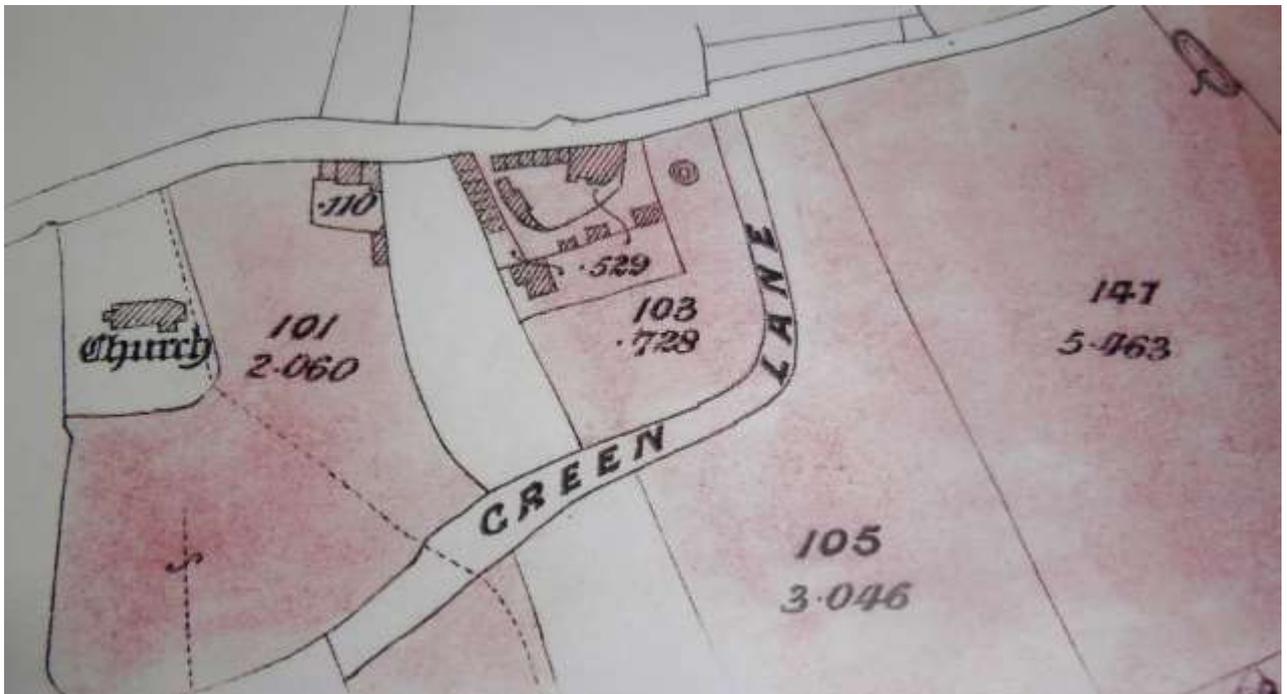
There was a further map produced to support the Knowles family sale but this was in skeletal form concentrating on the relevant land (Figure 9). On it the buildings are shaded with the exception of Block B which was in outline only. However, the 1904 OS map shows normal shading, suggesting an error on the Knowles map. It is also possible that Block B was a shell for a time and later re-roofed.

Figure 9 Detail of the Knowles family sale map. Reproduced with permission Mrs Betty Buck.

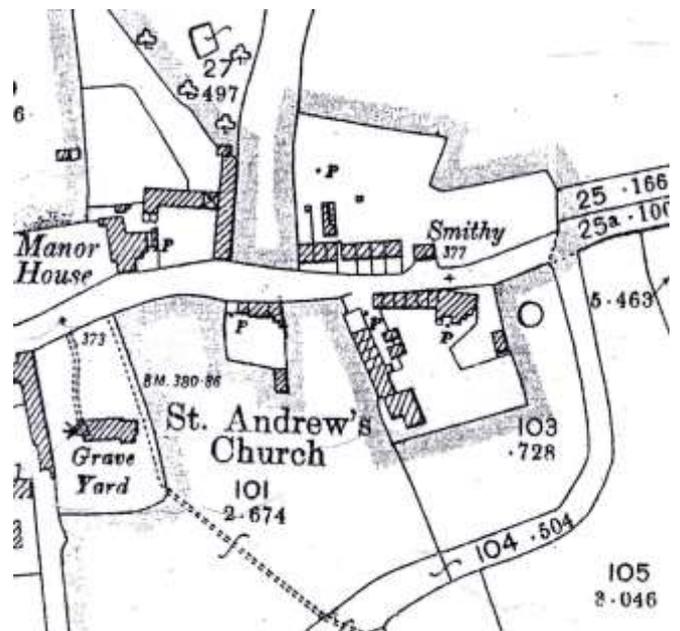
The 1885/6 OS map was subject to a revision started in 1901 and published in 1904 (Figure 10). It shows Block A divided into four sections not six, the northern end of that block shown in outline only. Perhaps some parts of the walls (and floor) of this end section survived. Equally the outline could indicate a garden surrounded by a fence. Block B remains the same size but has a small square resembling a porch attached at the eastern side. Block C looks identical to that on the 1846 map.

There were other changes on the 1904 map. Block D was replaced by two small buildings resembling domestic outhouses and the barriers were altered. Two of the small detached buildings are missing and a third near to Penwood is larger. Block C is now open to the rear of Hall Terrace and there is a barrier from the south west corner of Hall Terrace, encompassing the two new domestic outhouse blocks and the 'porch' of Block B. The barrier around Penwood Cottage is also different, now more closely associating that cottage with the Old Hall site.

Figure 10 Detail of Ordnance Survey map 1904.

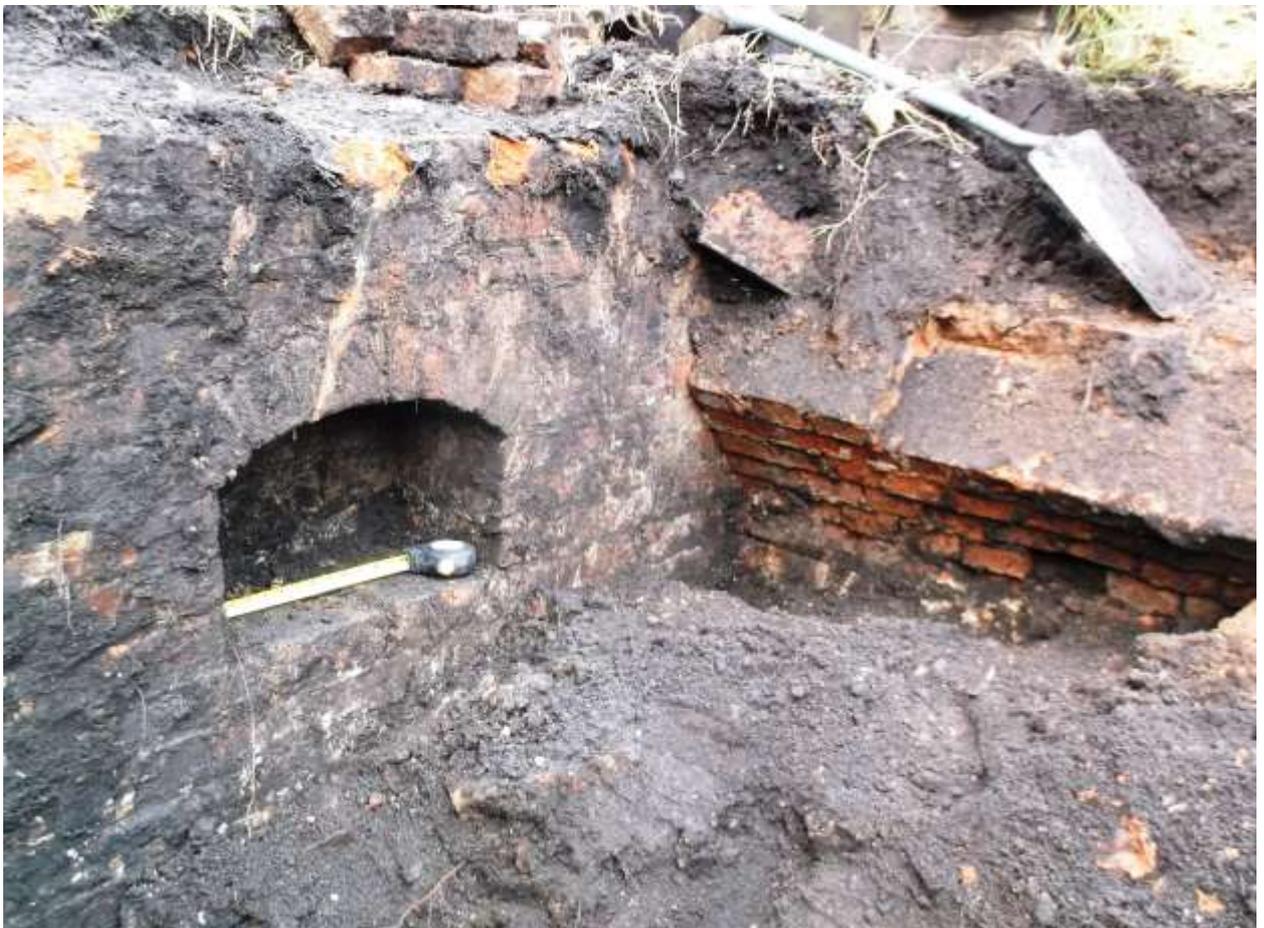
Initially, attention was focused on the hole assumed to be caused by a collapse into an underground void. Expansion of this exposed an underground chamber originally with an arched roof that had partially collapsed onto debris below. At the time this was thought to be either a cellar or an underground water cistern. The peak of the roof was found to run east to west with the end butted up to a substantial wall, later found to be the western wall of Block B. The roof itself was constructed of bricks generally some 225 mm thick. The lower sections, to the north and south, consisted of a few courses of two bricks laid flat one above another as in a sloping wall. The rest of the roof was formed by a series of single bricks laid on end as headers (Figure 11).

Figure 11. North-west corner of the cellar showing recess and bottom of collapsed arched roof.

Further expansion of the hole revealed a recess some 230mm deep formed by excluding bricks from the end wall of Block B. After removal of more waste debris and estimating the size of the chamber, it was decided that manual labour was insufficient. Consequently, a local volunteer excavated the chamber using his own mechanical digger. Unfortunately, with limited space for spoil it was not possible to empty the chamber completely and consequently, the western end was excavated first. After examining and recording the details, the eastern end was opened by depositing the spoil back into the void left in the western end. Eventually, the chamber proved to be some 2750mm by 4750mm and 2000mm high to the apex of the arched ceiling, all measurements being internal. On seeing it partially exposed, the land owner realised that this was the cellar used during WW II and subsequently backfilled.

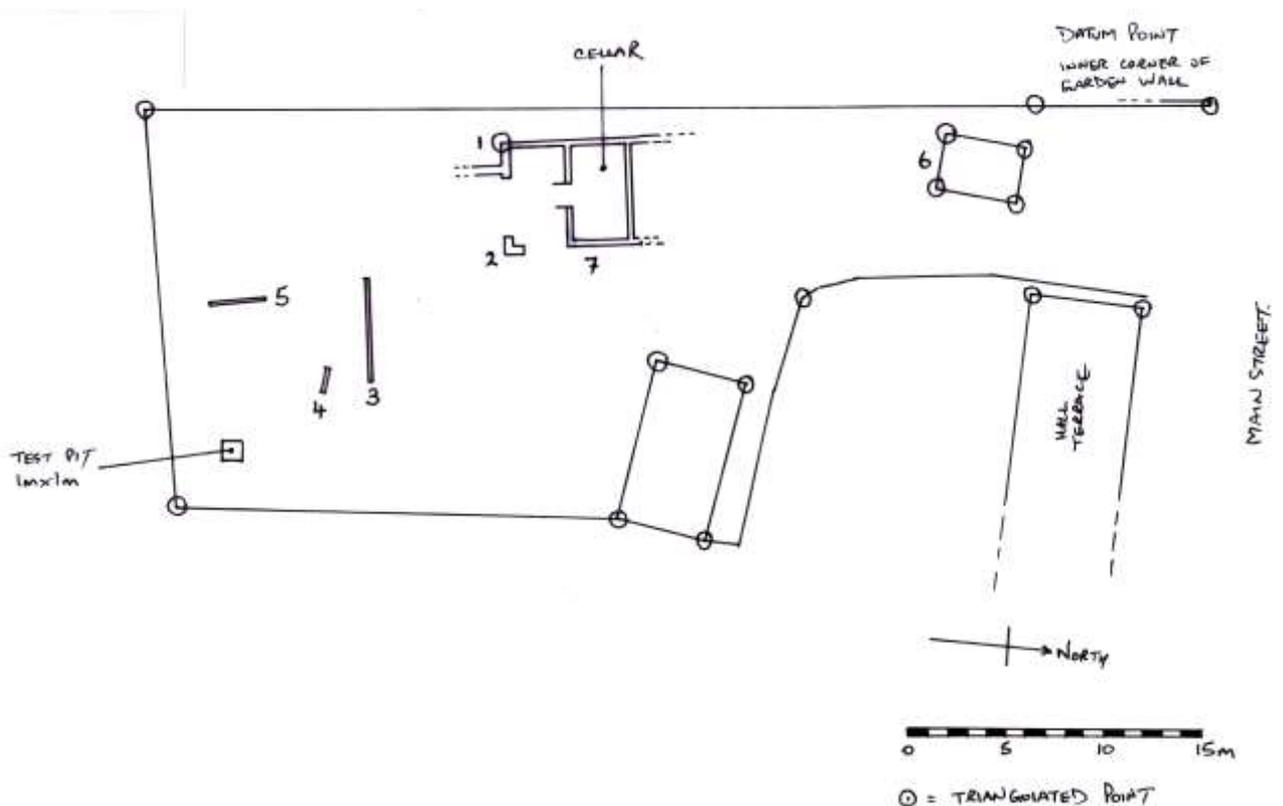
Following the discovery of brickwork as a reference point, the 1904 map was scaled up to predict the positions of the remaining outer walls of Blocks B and C. Four trenches were then planned in hopes of intersecting other walls of buildings (see Figure 12). In practice seven trenches were dug, one of which was simply an extension of one already planned. Trench 6 was intended to investigate the ground level near Block A and Trench 7 to expose the outside of the eastern wall of the cellar.

Figure 12. Site plan showing excavation trenches and cellar.

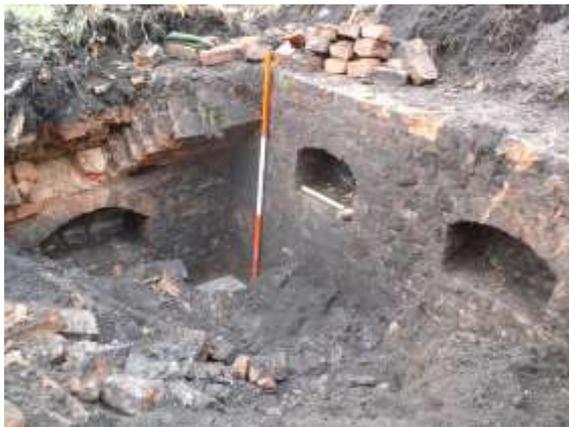
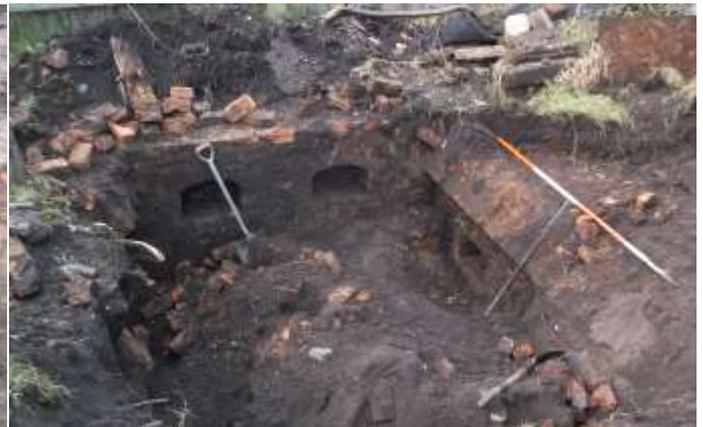
Mechanical excavation of the western end of the cellar revealed a discontinuity in the original brickwork of the southern wall which was thought at the time to be the entrance to the cellar. A total of four wall recesses were also revealed, one in each of the north and south walls and two in the western end (the wall of Block B). All four were of similar construction with arched tops but the one in the south wall was wider (630mm) than those in the west and north walls (430mm). What was noticeable was each recess was as high as practicable from the floor. The niches were formed by leaving out bricks from the two inner courses such that the outer course formed the back of the recess (Figure 13A & B).

Figure 13A SW corner of the cellar.

Figure 13B NW corner of the cellar.

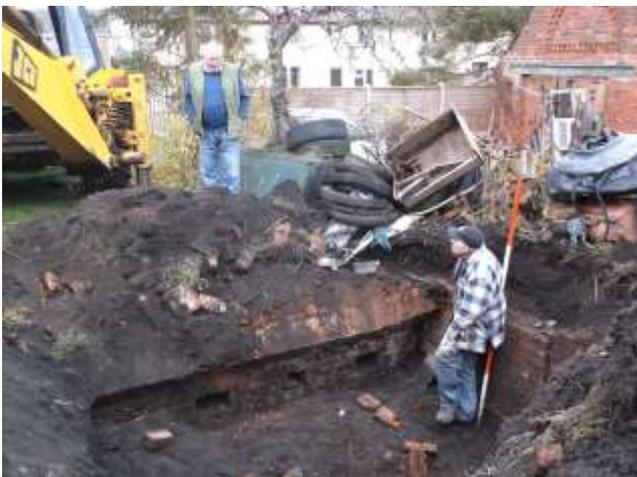
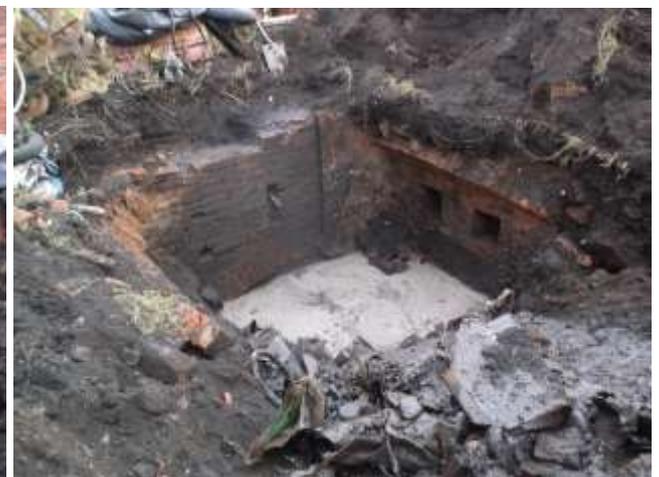
Exposure of the eastern end of the cellar revealed a corresponding corner in the brickwork of the southern wall, again consistent with this being the edge of the cellar entrance. At a later date, the upper steps of the cellar entrance were excavated. Each step consisted of a layer of bricks on edge over a lower course lying flat as in a wall. This resulted in a rise of some 170mm and tread of 225 mm. The flight was approximately 750mm wide.

There were also five more recesses, two in the southern wall and three in the northern wall. Strangely these were dissimilar in size, some being formed by omitting three courses of bricks and one recess only two. All of them had flat tops rather than arched and no obvious support for the bricks immediately above the recess (Figures 14A & B). A total of nine niches were found: running clockwise from the entrance stairs, they measured 630, 430, 430, 430, 280, 220, 250, 320 and 300 mm wide respectively.

Figure 14A NE corner of the cellar.

Figure 14B SE corner of the cellar.

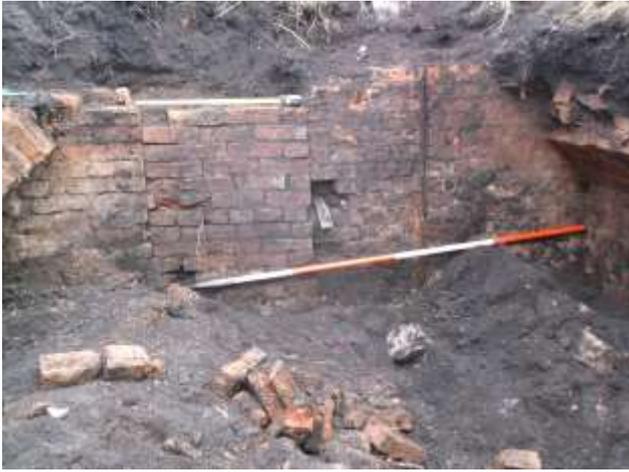
Exposure of the east wall of the cellar displayed some curious features. Starting from the north end it was as expected but after some distance there was a vertical straight joint in ten courses in the upper section of the wall which could have continued upwards in the top course which had been removed (Figure 15). Further south was a second straight joint but the brickwork south of that joint was set back behind the main face of the wall by about 50 mm. That setback continued for about 700mm southwards before the line of the brickwork once again followed the main line of the wall (Figure 16).

Figure 15. East wall of cellar. Note lead pipe and straight joint in brickwork.

The section of brickwork between the two straight joints was narrower and not to the same standard as the rest of the brickwork; this may represent an infilled aperture. The thickness of that section and for some distance either side was only 2 bricks not 3.

Protruding from the wall above the well was a lead pipe which the owner said was the remains of the suction pipe to the well which he had removed when the cellar was filled in. The pipe had been added after the wall was built as it was not mortared into the wall.

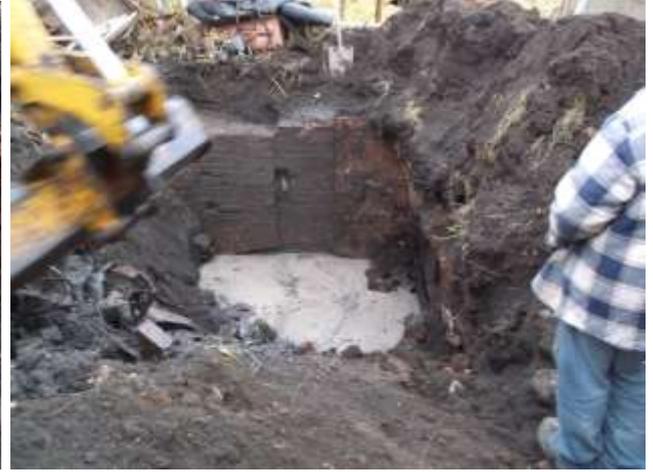
The 50 mm setback in the line of the bricks started at the floor of the cellar and continued to the top of the wall. Built in to the wall was an arch consisting of 2 courses of bricks on their edge and appearing to start at floor level and peaking at the centre of the well. This arch was to take the weight of the wall off the edge of the well to prevent the side of the well being pushed in by the weight of the wall. This was common practice in this situation.

Figure 16. East wall of cellar. Note top of arch just above water level.

A key feature of the eastern wall is the 50mm vertical step in the internal surface running from top to bottom of the cellar. This, again, implies an intended feature. The outside surface of the wall was flat, the offset being taken up within the thickness of the wall. The offset in the wall suggests a specific use for the cellar demanding the installation of a particular piece of equipment. It was noted the offset was not central to the arch and therefore the well. No further explanation is yet available.

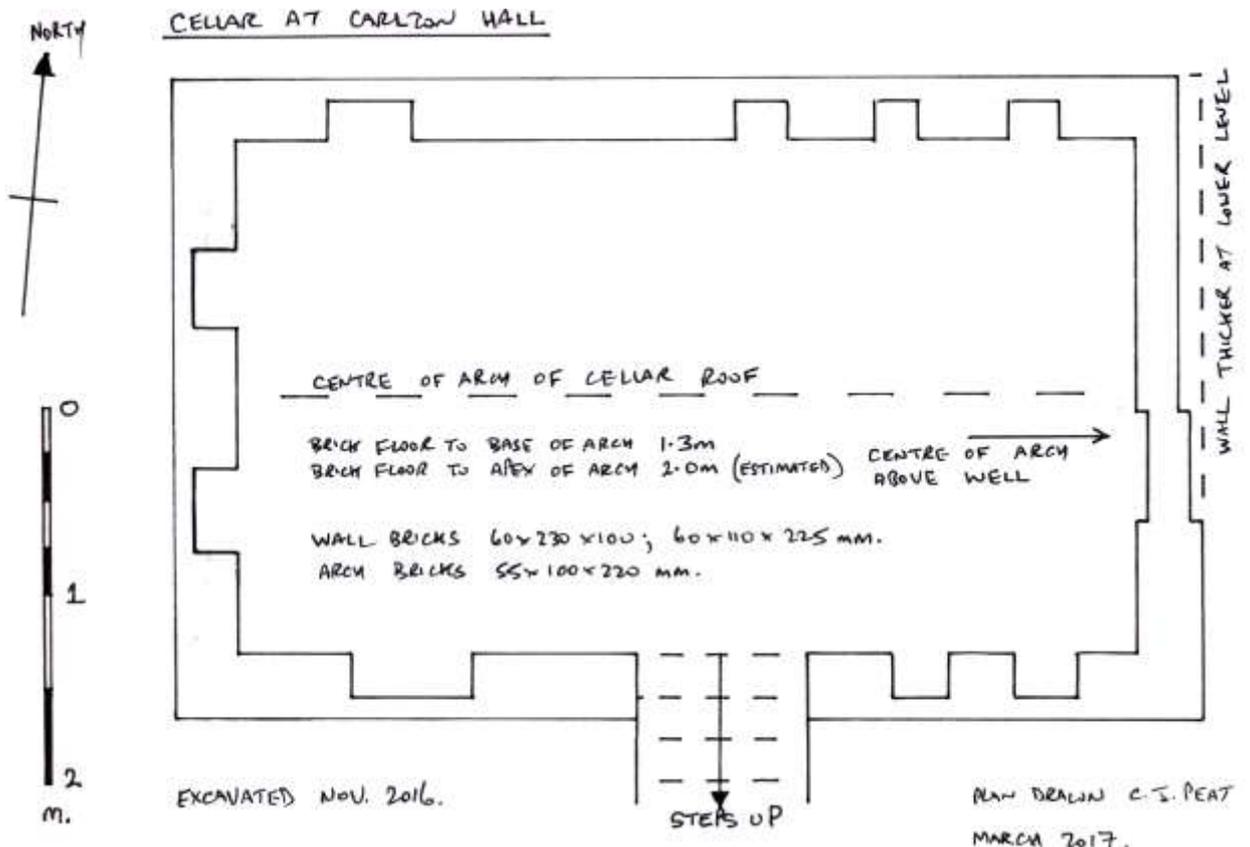
Three different brick sizes were used in the cellar: 60x220x110mm, 60x225x110mm and 55x220x110mm, the latter being used only for the roof. The arch was butted up to the two end walls of the cellar such that none of the roof was above the walls. With this configuration the walls could be continued upwards to form the structure of a building above.

Figure 17. Plan of cellar

However, in this case the overall length of the cellar was 5480mm including walls; the equivalent dimension of Block B, the building above, was 5890mm. The difference of 410mm virtually precludes the use of the cellar wall as a foundation for either an external or internal wall of Block B.

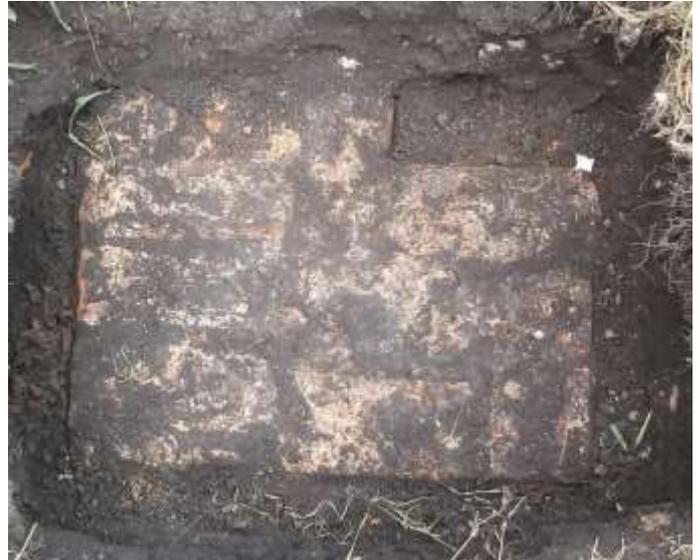
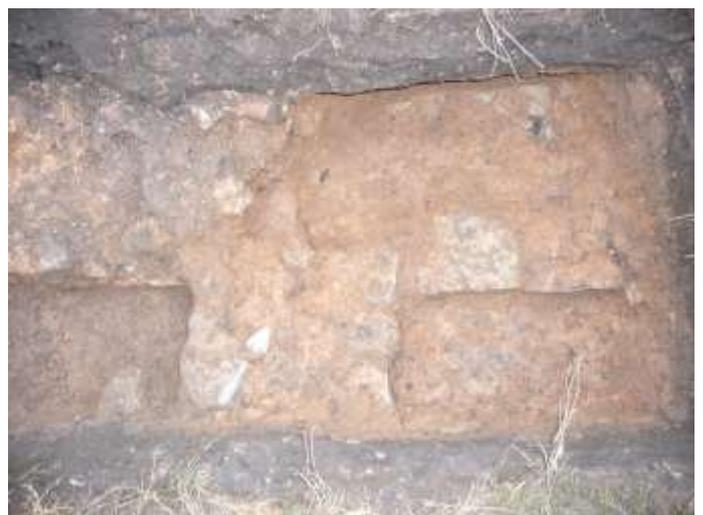
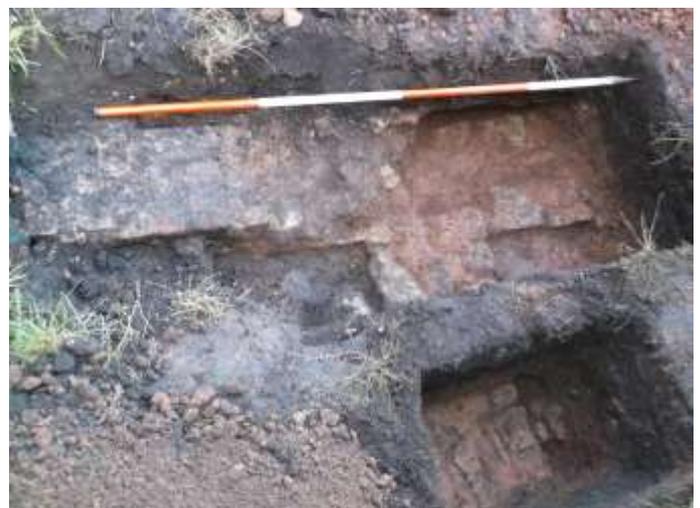
This trench was dug to confirm the interaction of the walls of Blocks B and C, two sections of which were thought to be the walls of the house. The 340mm wall already discovered, being the western wall of Block B, continued southwards for several metres before arriving at the south western corner of Block B. This is consistent with the maps. Beyond the corner the wall headed east being the southern wall of Block B. After only about 600mm the wall had been removed (Figure 18). The trench was further extended in an easterly direction and to a lower level. This exposed a foundation of Carlton stone (Figure 19). Some 1000mm away from the outer corner, a second wall foundation continued south as expected from the maps, this being the discontinuity in the building line of Blocks A, B and C. Again the junction of the walls was of stone but slightly further south the wall was constructed of bricks (Figure 20). There was a deposit of used mortar lying on top of the masonry but not the amount expected if a substantial wall had been removed. Indications were that the two walls had been built concurrently as there was no obvious joint line in the stones. None of this masonry was disturbed.

Figure 18. Trench 1. Corner of building.

Figure 19. Foundation of Carlton Stone.

Figure 20. Connection of brick wall to Figure 19 above.

Trenches 1 and 2 exposed the common wall between Blocks B and C and the junction of the two west walls of those blocks. Foundations were partially of Carlton stone and partially of brick and were substantial implying a quality building. The south eastern corner of Block B was exposed but there was no evidence of the northern wall of Block C beyond that point. Trench 1 contained both brick and stone foundations, Trench 2 contained only brick, but two stones were found in the extra hole between the two trenches. The pottery was generally above the foundations, and could not be used to date the structure. There appeared to be insufficient demolition mortar for the expected size of the wall above.

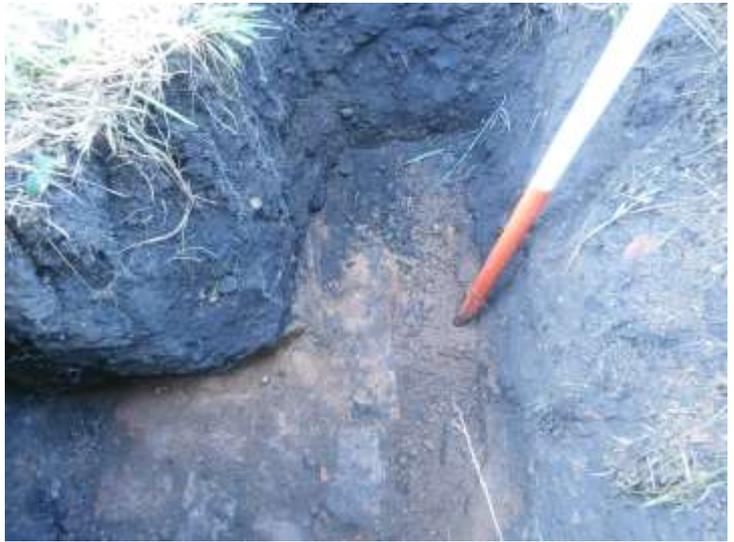
This trench was dug to confirm the width of Block B and the continuation of the north wall of Block C. The east wall of Block B was exposed at its predicted limit, revealing a single layer of bricks forming the corner with the east wall (Figure 21). One brick was removed temporarily in order to test the supporting material by probing with a trowel. This met a compacted layer of clay but no masonry. There was no evidence of the southern wall of Block B continuing to the east as the northern wall of Block C as shown on the maps. In particular, the eastern surface of the wall was smooth giving no indications of bricks having been tied into another wall. However, the exposed corner was very close to the modern, concrete retaining wall at the side of the garage. Remains of the wall could have been destroyed when this was installed. A little more used mortar was found in this trench but again much less than expected from the demolition of a substantial wall.

Figure 21. South east corner of Block B.

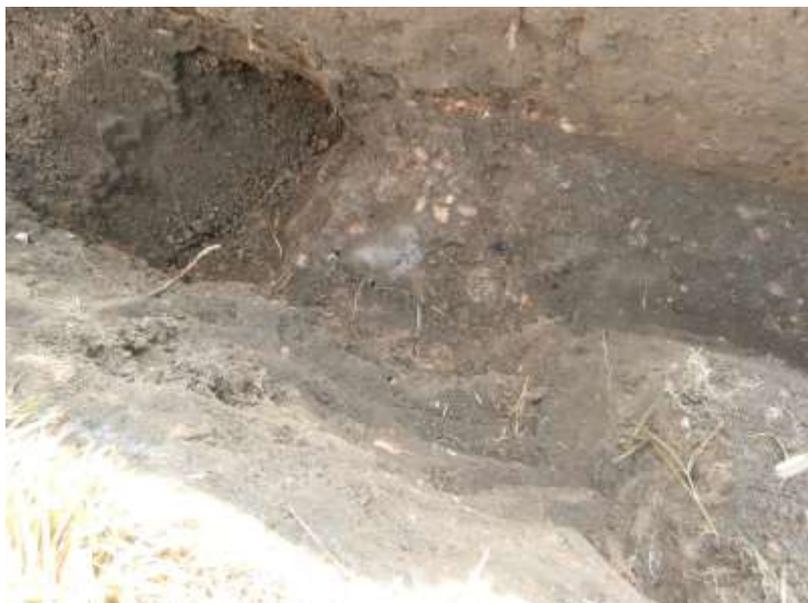
At one point the layer had been cut by a shallow trench (Figure 22). This was quite narrow and intersected trench 3 at an angle of about 30 degrees. Clearly, this excavation was more modern; the fill included early 20<sup>th</sup> century glass bottles with square bases, rusty metal tins etc. There was also a metal object resembling a window fitting. At the east end of the trench the layer of light brown soil ceased, being terminated by a 150mm flat stone. Unfortunately the trench could not be excavated further east due to the presence of a concrete path. It is possible that this trench was insufficiently deep to expose the remains of the wall of Block C.

Figure 22. Trench 3. Layer of stones and cross-cutting drain.

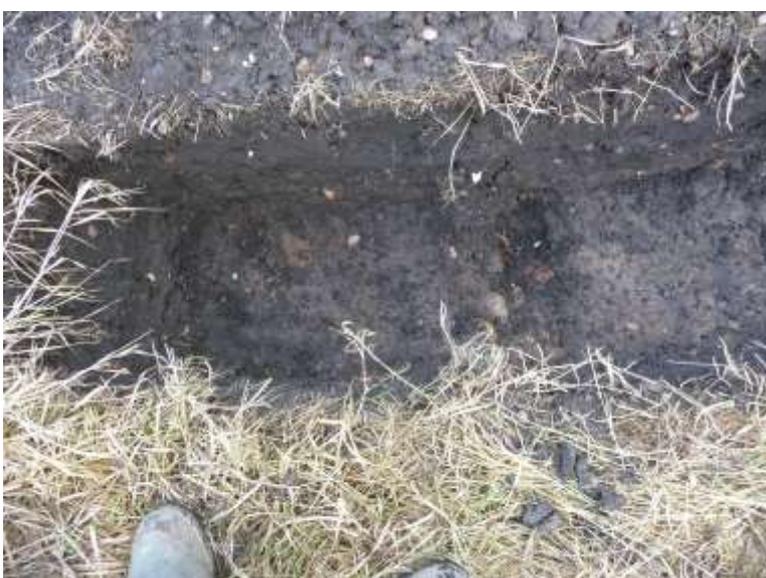
This trench was excavated across the south side of block C. At the southern end of this trench below the garden soil there was undisturbed natural heavy clay. Further north along the trench was evidence of an earlier shallow trench at right angles to the excavation trench (Figure 23). On the edges of this trench infill were medium sized stones.

Figure 23. Trench 5. Stones and shallow cross-cutting trench.

Trench 5 exposed a layer which, arguably, could have been the base of the south wall of Block C. It was certainly in the position predicted from the maps. Pottery dated from the 17<sup>th</sup> century was found at the side of the inner face of the wall but there was no indication of the light brown layer of soil seen elsewhere. The natural sub-soil in the area is either heavy clay or red shale; this trench produced both in close proximity.

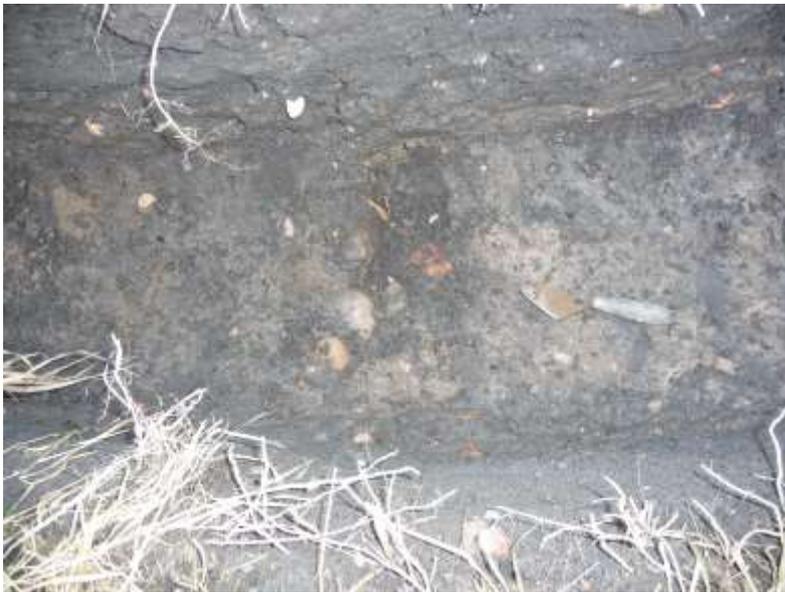
The natural clay soil continued to the north of this shallow trench but had been cut by another shallow trench parallel to the first one. Above this were remnants of bricks, and in this trench were broken bricks. At the same level at the side of this trench was a collection of sherds of pottery, and infill with soil (Figure 24). Further north along the trench was compacted red sand/ shale but at a higher level. This sand resembled the natural sub soil found in a test pit dug some

Figure 24. Trench 5. Layer of stones.

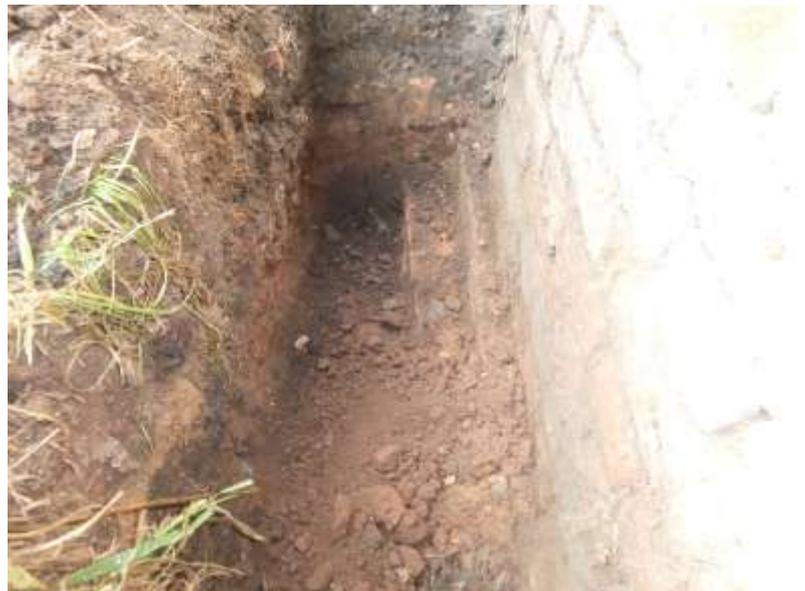
This trench was intended to investigate earlier ground levels on the site. It was dug along the southern wall of the wash house. The blue brick damp course of the building was used as a horizontal reference, this being at the current ground level along the east wall. Further to the west, the blues were several courses below ground level implying that material had been deposited since the wash house was built. This suggests that the walls and floors of the cottages are quite deep underground on the west side (Figure 25).

Figure 25. Trench 6. Southern wall of Wash House.

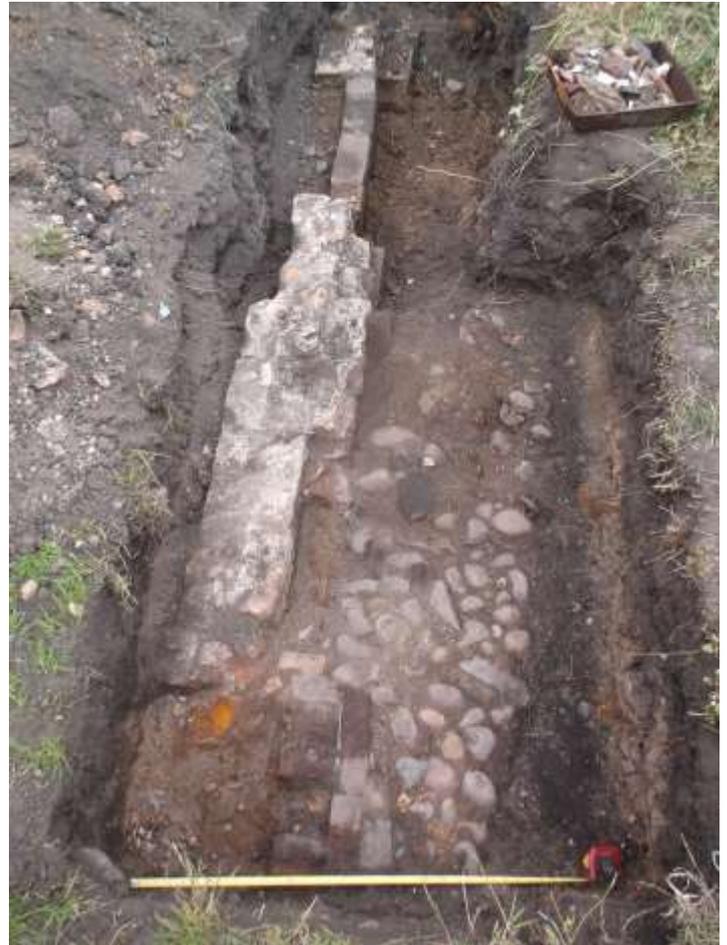
Figure 26. Trench 7. Outside of eastern wall of cellar.

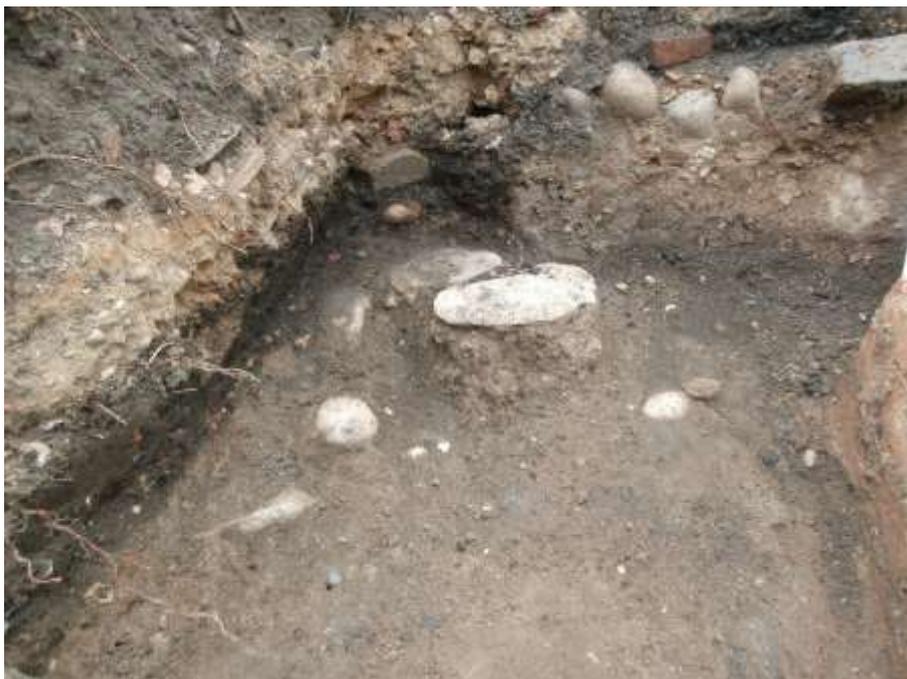
Further to the east of these cobbles there was a layer of gravel containing plastic wall plugs. Clearly, this had been disturbed in recent years. On the west side beyond the cellar wall there was a rubbish deposit of square-based glass bottles, rusty tins and the remains of electrical batteries. A metal rod, approximately 250mm in length, was discovered within the layer of stones. It had been driven vertically downwards between the stones.

Figure 27. Trench 7. Exposed stones.

Although the walls were very close to the modern concrete panel fence, it is possible that the 3 stones uncovered below the stone path were part of the building foundations. They were in the predicted position of the eastern wall of Block B and at an appropriate depth but outside the width of the cellar.

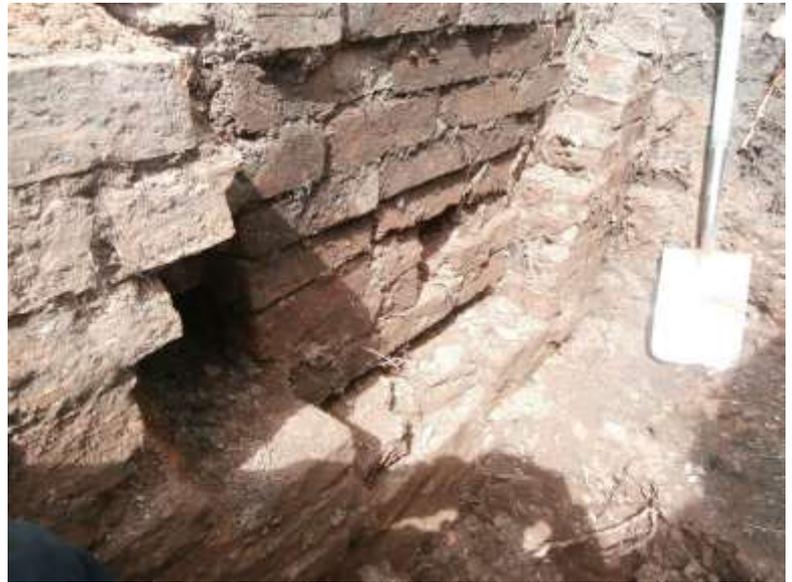
Below the layer of stones the soil was extremely sandy and contained full and broken bricks and pieces of orange roof tile. As this was removed, the structure of the outer face of the end wall was exposed. It gave the impression that originally the whole wall had been three bricks thick but the outer layer had since been removed (Figure 28). The area of bricks that had been removed was centred on the area containing the straight joints (aperture). The bricks had been removed beyond and below the edges of the original aperture and below the bottom of the aperture.

Figure 28. Trench 7. Outside of east wall of cellar.

The indications from the excavation finding and various soil mixtures may be as a result of work carried out in connection with the aperture. The removal of the outer courses of brick suggests that the aperture was inserted sometime after the wall was built. Construction of the aperture would have resulted in some bricks being replaced along its edge. This gives the indication that there was a straight joint to the north of the aperture in the original construction. However that could be misleading. At the south side the aperture also indicates a straight joint but here there was a 50mm step back in the wall to be accommodated.
