# **Investigations into the Site of Carlton Hall**

Richard and Robert Liddington

December 2017

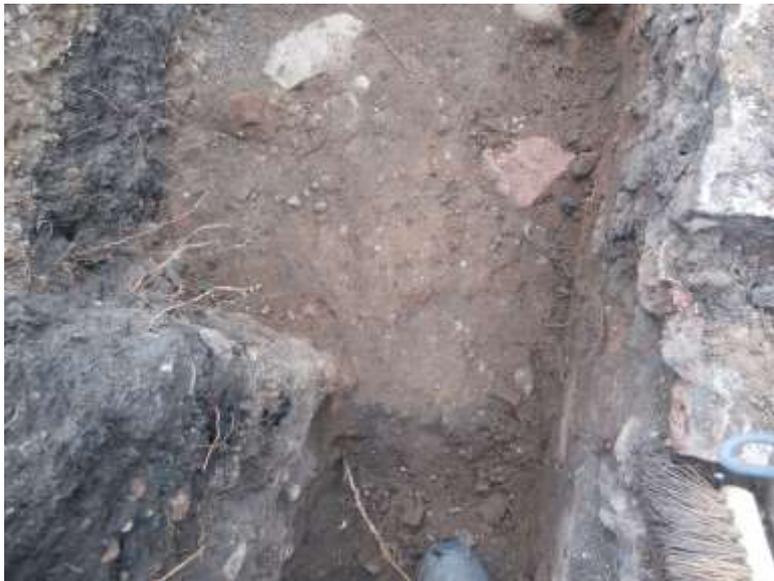
Figure 29. Trench 7. Slope of stony soil.

As the trench was excavated, the sandy soil continued to be present in the northern end of the trench, but a layer of stony soil progressively appeared in the southern end of the trench. As the sandy soil was removed, the stony soil appeared at a lower level producing a steep slope towards the centre of the aperture (Figure 29). It was not a consistent slope but was in steps. A line of large stones also appeared across the trench, i.e. from the cellar

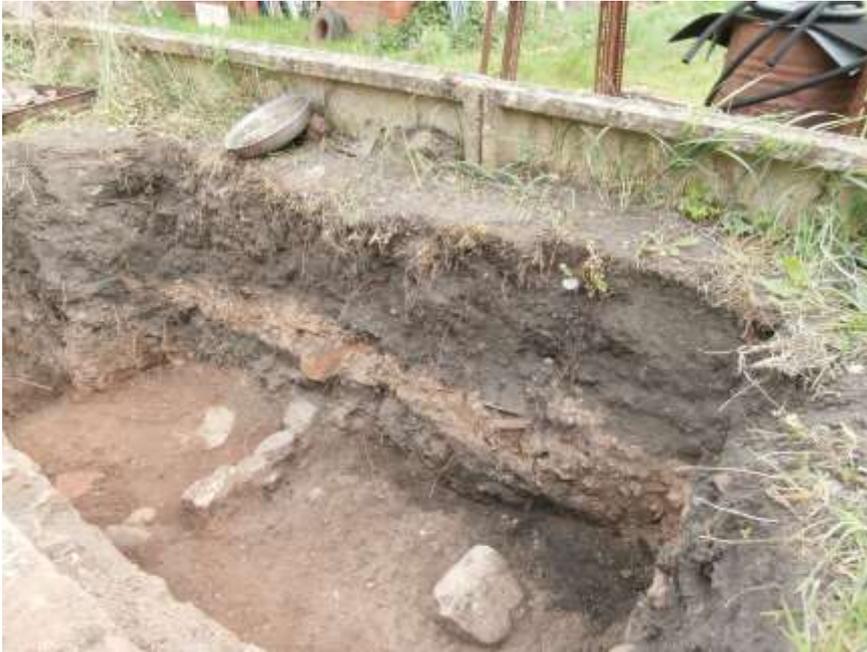
wall to the outer side of the trench (Figure 30). It was also noted the bottom layer of the 10 courses of bricks was laid on soil not mortar.

Figure 30. Trench 7. Outside eastern wall of cellar. Row of stones.

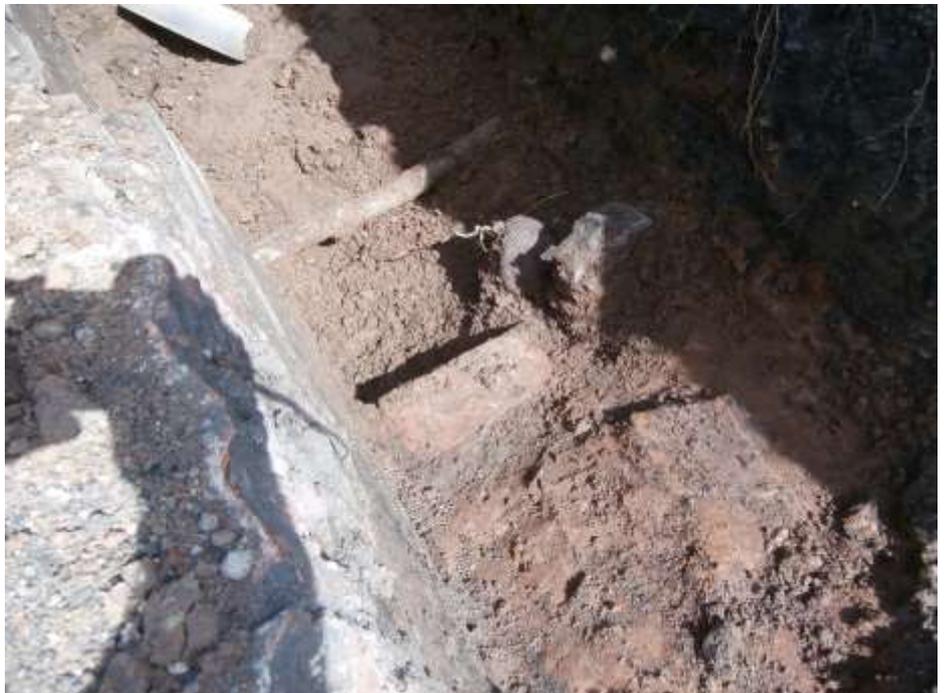
Figure 31. Trench 7. Outside eastern wall of cellar. Layer of brick and tile debris.

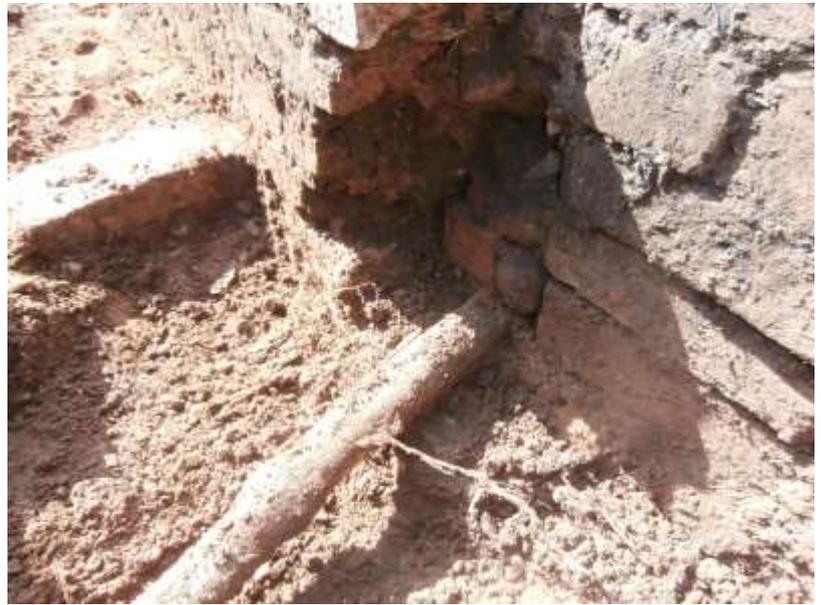
During the digging process the lead pipe revealed in the cellar was found to continue through the trench, declining slightly towards the eastern edge. It also turned north slightly in the direction of Penwood Cottage. There was a wiped joint in the pipe run near the cellar wall. This would have been used to allow the bend to be put into the

pipe where it turned downwards after passing through the wall (Figure 32).

Figure 32. Trench 7. Outside eastern wall of cellar. Lead pipe with wiped joint where it passes through the cellar wall.
