Carlton Parish Council

Our Reference: 25133-TDC-XX-XX-LT-Z-0001-P01

RE: EXTERNAL BOUNDARY WALL INSPECTION - ST ANDREWS CHURCH, CARLTON, NUNEATON,

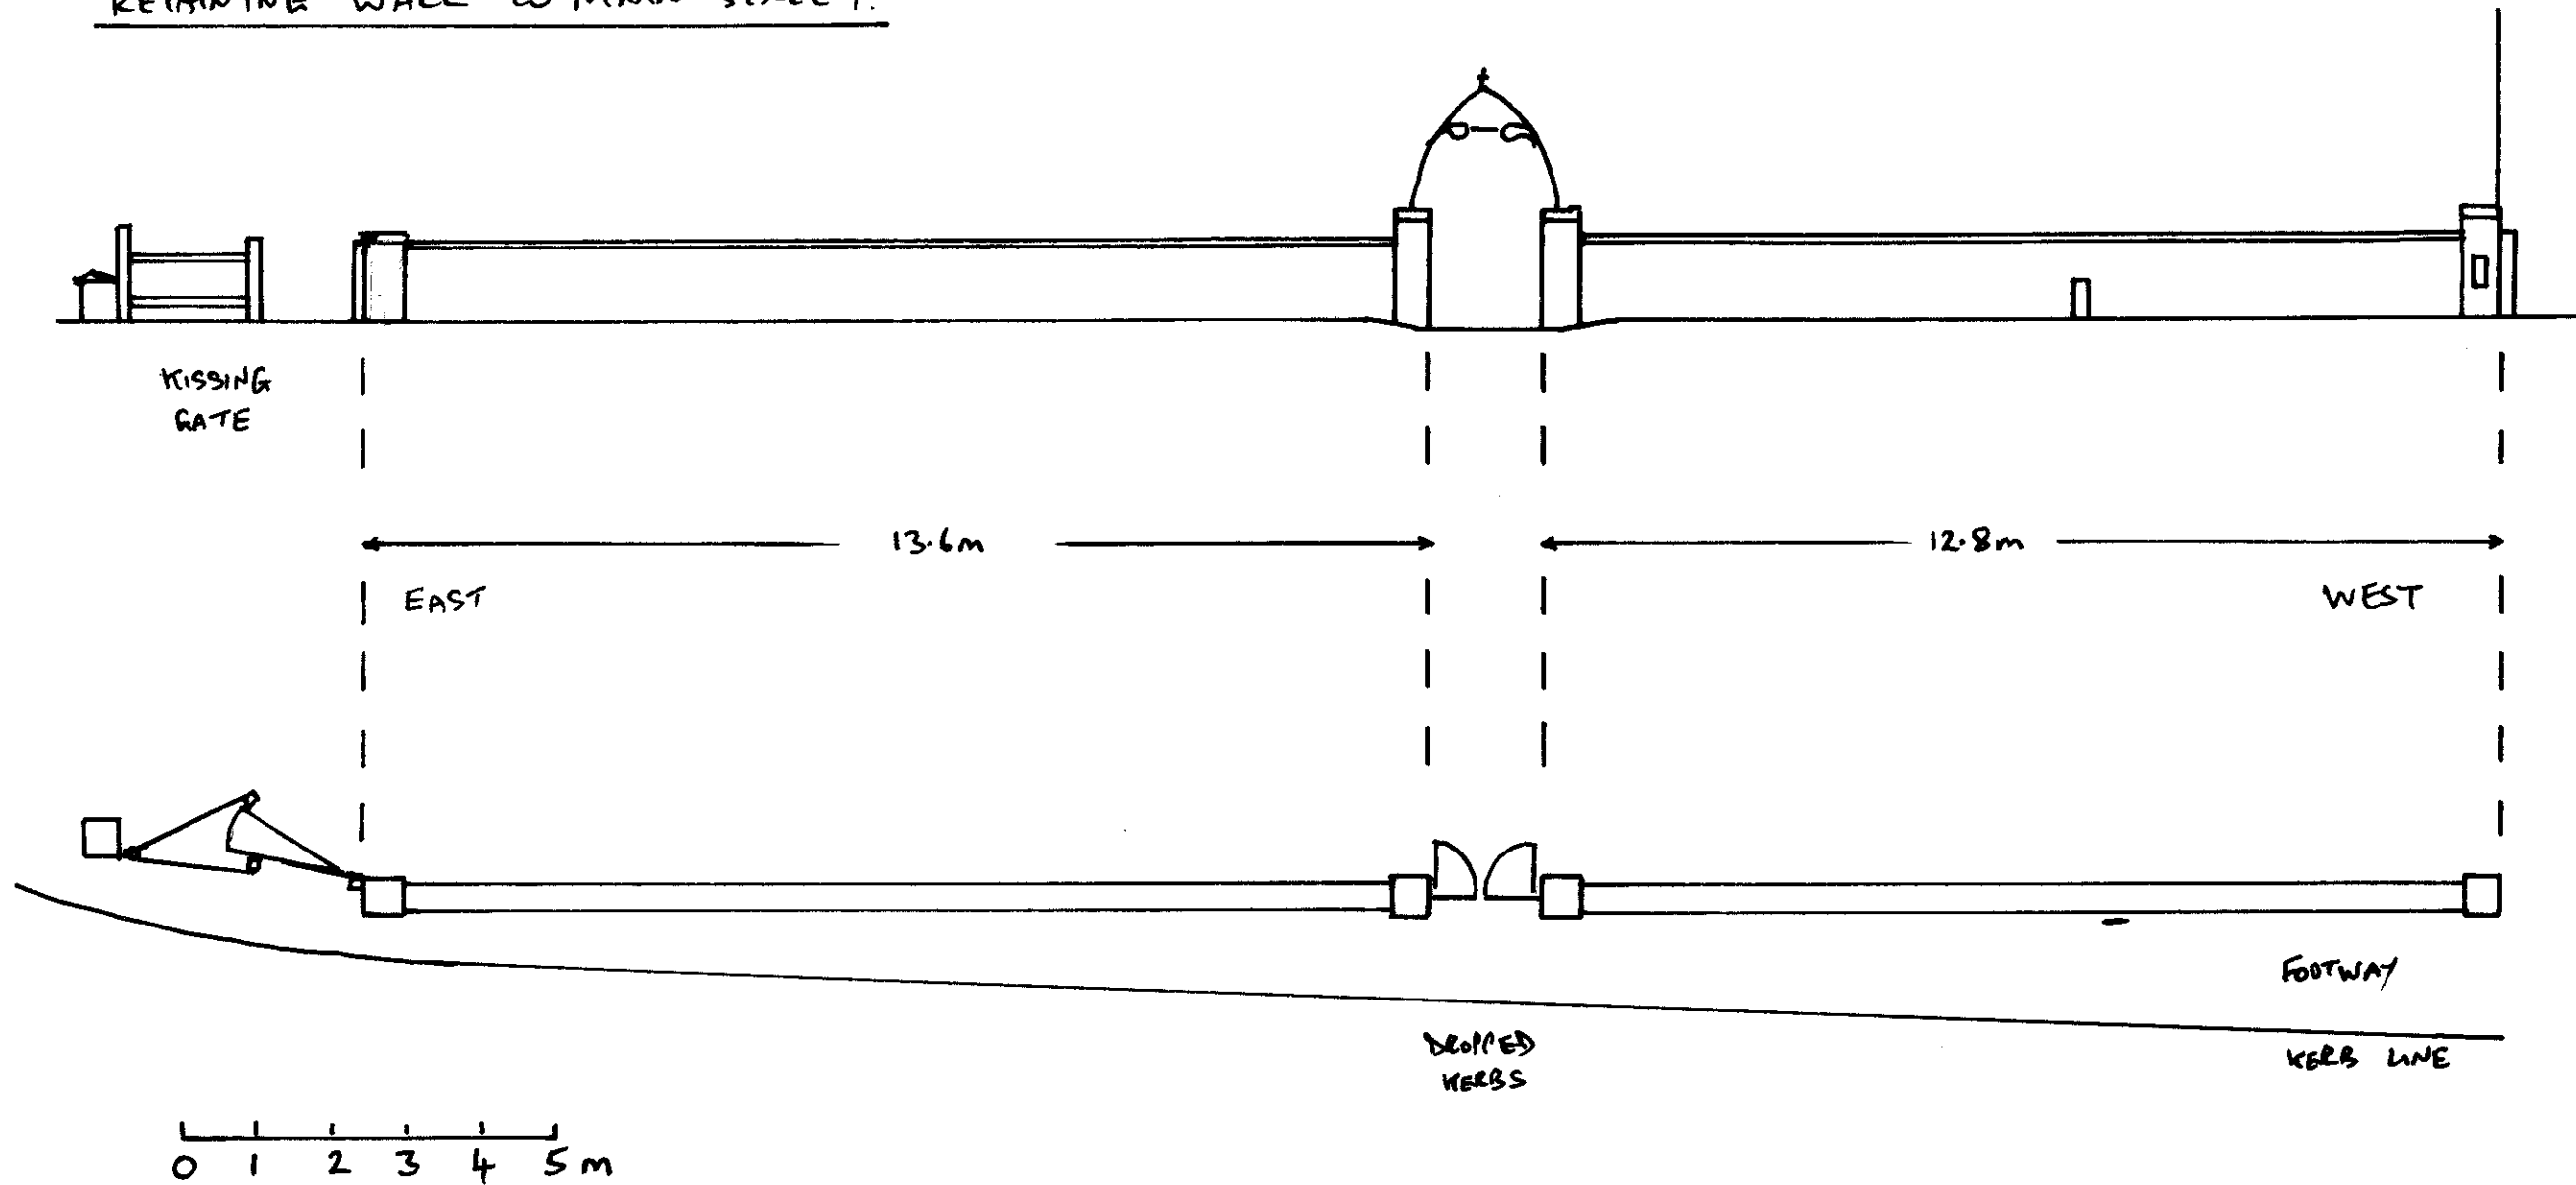
RETAINING WALL TO MAIN STREET.

The movement in the wall is resulting in mortar spalling out from the joints in the brickwork: this is most apparent in the area of the bulge, and will be weakening the wall.

The wall does not appear to be at risk of collapse in the near future, but will need to be rebuilt at some point. It is recommended that monitoring be continued.
